HISTORIC PRESERVATION COMMISSION STAFF REPORT

APPLICATION: CA2017-01

TITLE: Certificate of Appropriateness CA2017-01;
HL-107/MA-101

REQUEST: Review the exterior renovations on a single-family Craftsman residence which includes new wood shingles and clapboard siding, replacement of window and door surrounds, repair of overhanging eaves, rafter tails and gabled front porch roof. Review the exterior remodel of the rear (north) building elevation.

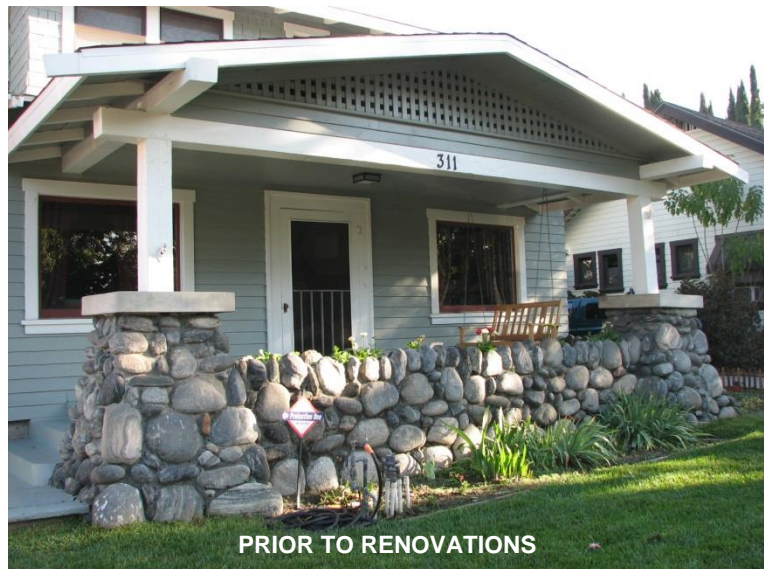
The extent of repair work that has occurred on the structure includes removal and “in kind” replacement of the exterior wood shingles and clapboard siding and replacement of the window and door surrounds. The original windows and front door were retained.

The back service porch on the north side of the residence has been remodeled and painted with the colors proposed for the residence. The rear door and non-original aluminum window were removed and replaced with new double (single-paned) doors with sidelights. Three

rectangular fixed windows were installed above the double doors and two triangular fixed windows were installed above the three windows under the roof eave.

The remaining work to be done is repair and “in kind” replacement of termite damage and dry rotted wood under the roof eaves, fascia boards and front projecting gabled porch. The exposed ends of several rafter tails will be repaired or replaced depending on the extent of damage.

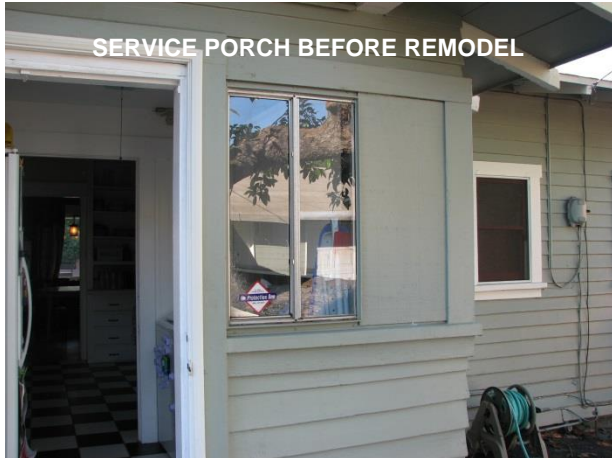
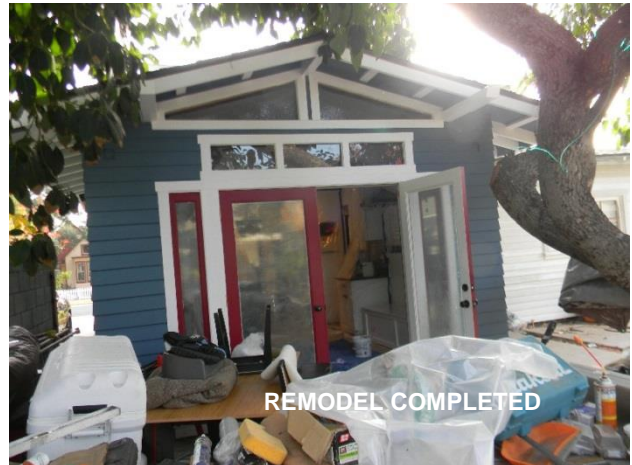
The north (rear) elevation is where “in kind” repair and replacement work has evolved to a complete exterior “remodel.” An original single rear door was removed and a larger single-paned double door with side lights was installed in its place. Above the double door the property owner chose a more modern application and installed five fixed windows to allow light into the kitchen area which now has a vaulted ceiling. The one side window on the west

elevation of the service porch is vinyl. The Sanborn Maps confirm that the original footprint of the house included this rear service porch area.

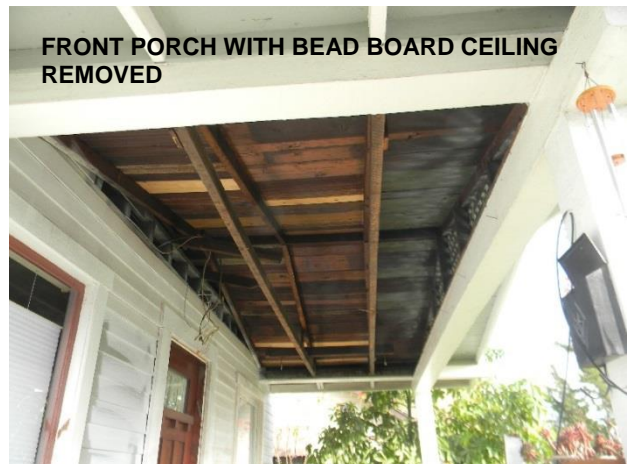
Repairs that are necessary and remain to be completed consist of the replacement of the fascia boards on the south and west elevations, eave repairs where the wood is dry rotted and a re-roof with the same color and type of composition roofing material that is currently on the structure. Furthermore, the front porch will require the repair of the gabled roof. The bead-board wood ceiling of the porch has been removed exposing the roof structure. The porch has been inspected by the property owners' Architect who has indicated that there is a possibility that major repairs will be needed to make it structurally sound and in compliance with the Building Code. If the porch cannot be repaired from underneath the roof structure, it will have to be removed and rebuilt. The bead-board ceiling will be replaced.

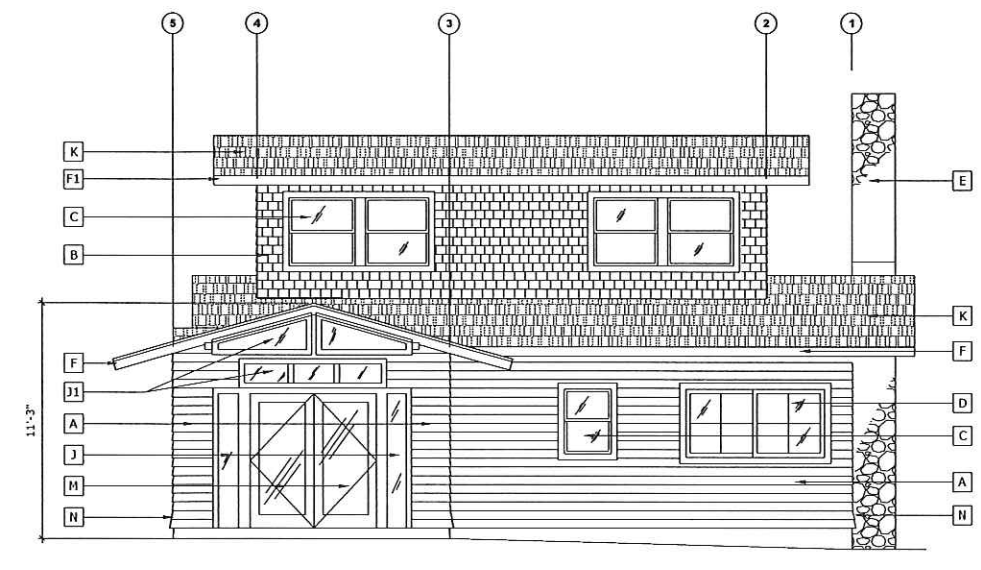
EXISTING REAR ELEVATION

The rear (north) building elevation changes are not of a Craftsman architectural design, and therefore do not satisfy the criteria for issuing a Certificate of Appropriateness. It is a remodeled elevation with a modern design application and cannot be considered a restoration. For this reason, staff recommends that the remodel not be part of this Certificate of Appropriateness (CA2017-01) application and instead an ad hoc subcommittee of two members be appointed to assist both City staff and the property owner on reaching an appropriate improvement plan for the rear elevation. Any recommendations of the subcommittee along with a revised elevation proposal from the property owners would be brought back to the Historic Preservation Commission for review and final approval of a separate Certificate of Appropriateness specific only to the remodel.
