HISTORIC PRESERVATION COMMISSION STAFF REPORT

APPLICATION: HL-125/MA-134

SUBJECT: Mills Act MA-134 for Historic Landmark HL-125
101 East Greystone Avenue

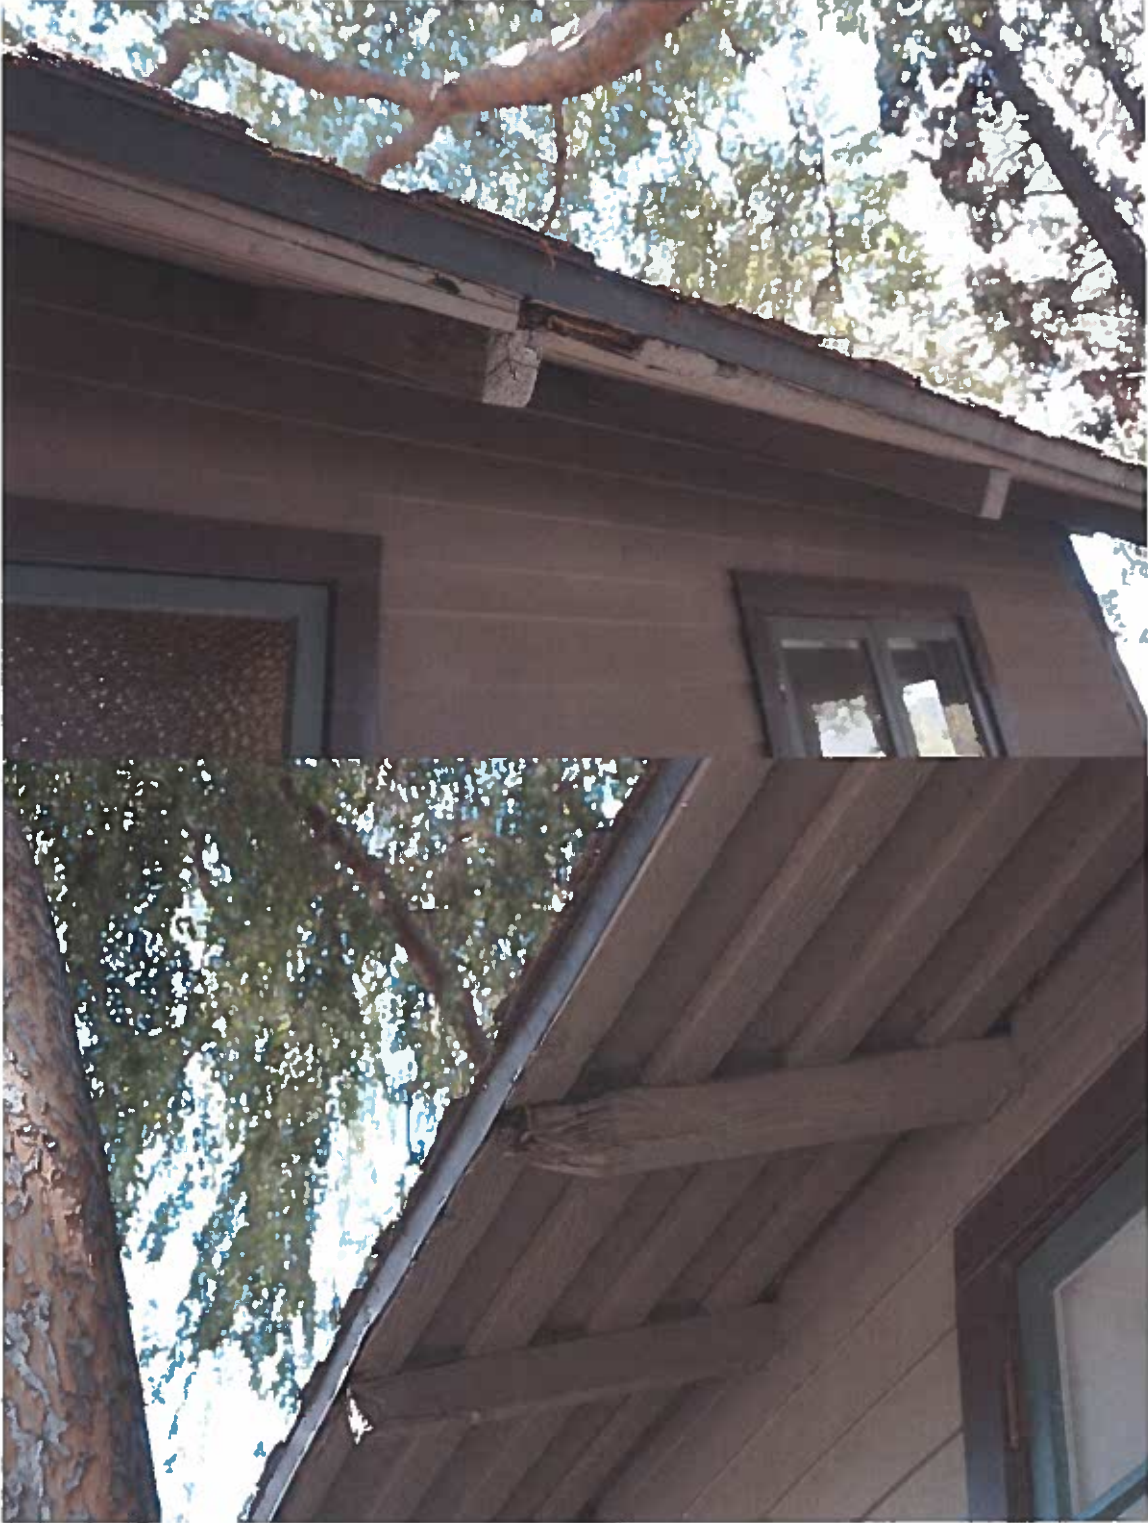
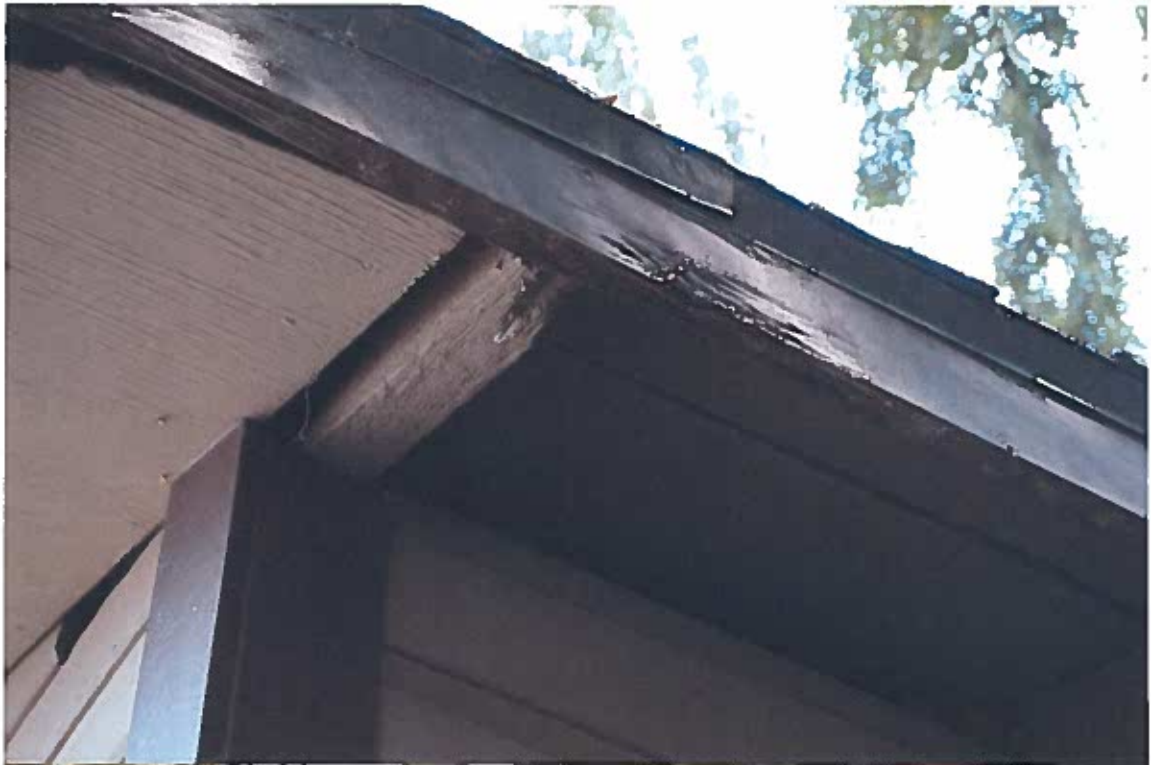
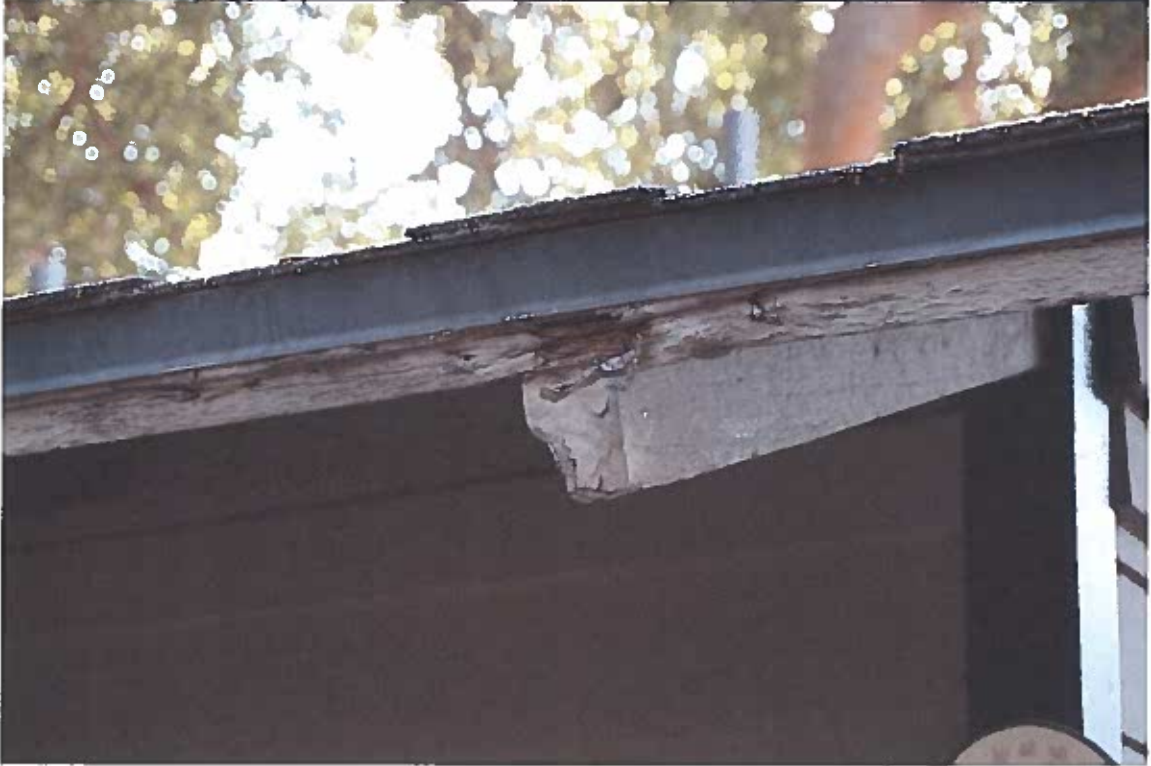
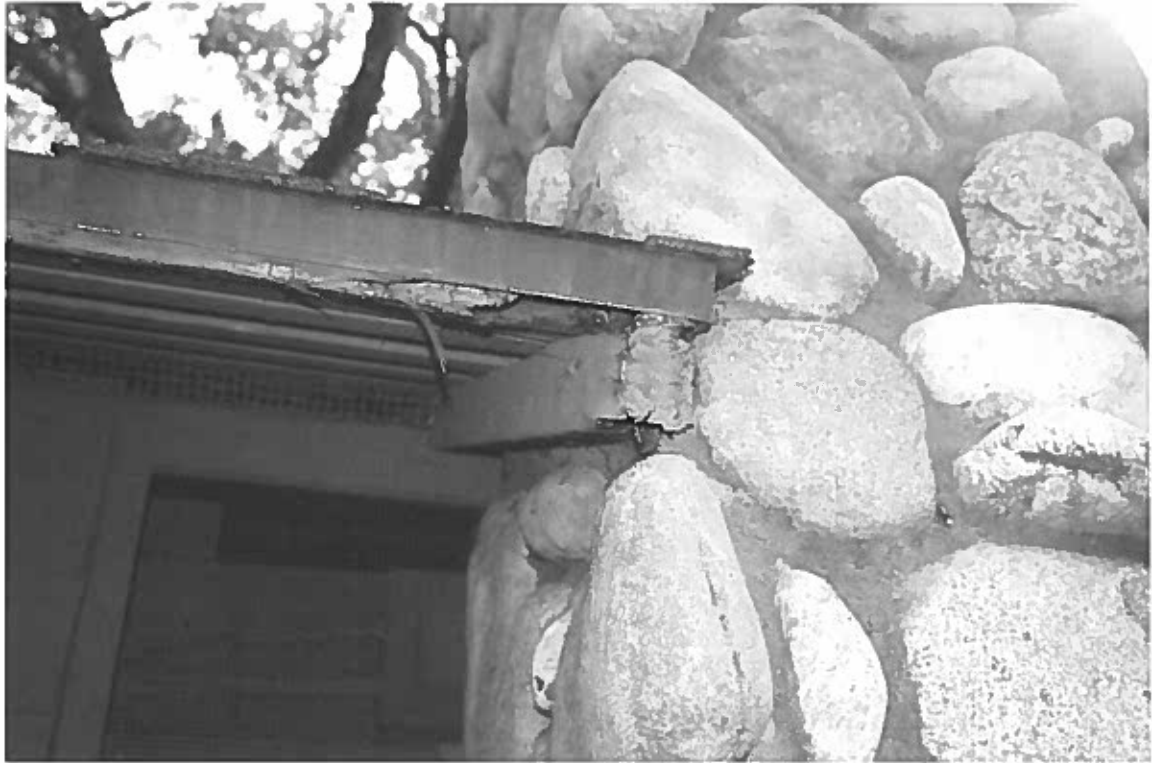
1) Termite Damage

ANALYSIS: Upon acquiring the subject property, the property owner identified several items in need of repair. The exterior of the house, particularly several of the exposed rafter tails, has some damage from termites and rodents. Additionally, two of the windows at the front of the home are non-original and should be restored. Also, several of the roof beams in the garage were removed, making the roof structure unsound. The property owner's 10-year work plan is provided in Exhibit "B".

1. There has been termite damage as Teresa and Sheri documented in their photos. I believe there was also subterranean termite damage. Please see the attached inspection report. Since then I have had the house tented so the termites are gone but the damage remains.

- a. Repair decaying wood panels and beams within 2 years.
2. There are two windows that have an anachronistic 70's style bubble yellow glass that ought to be replaced.

8. *Exterior Beam Repair.* The missing and damaged exterior wood beams and exposed rafter tails shall be repaired or replaced within two (2) years.

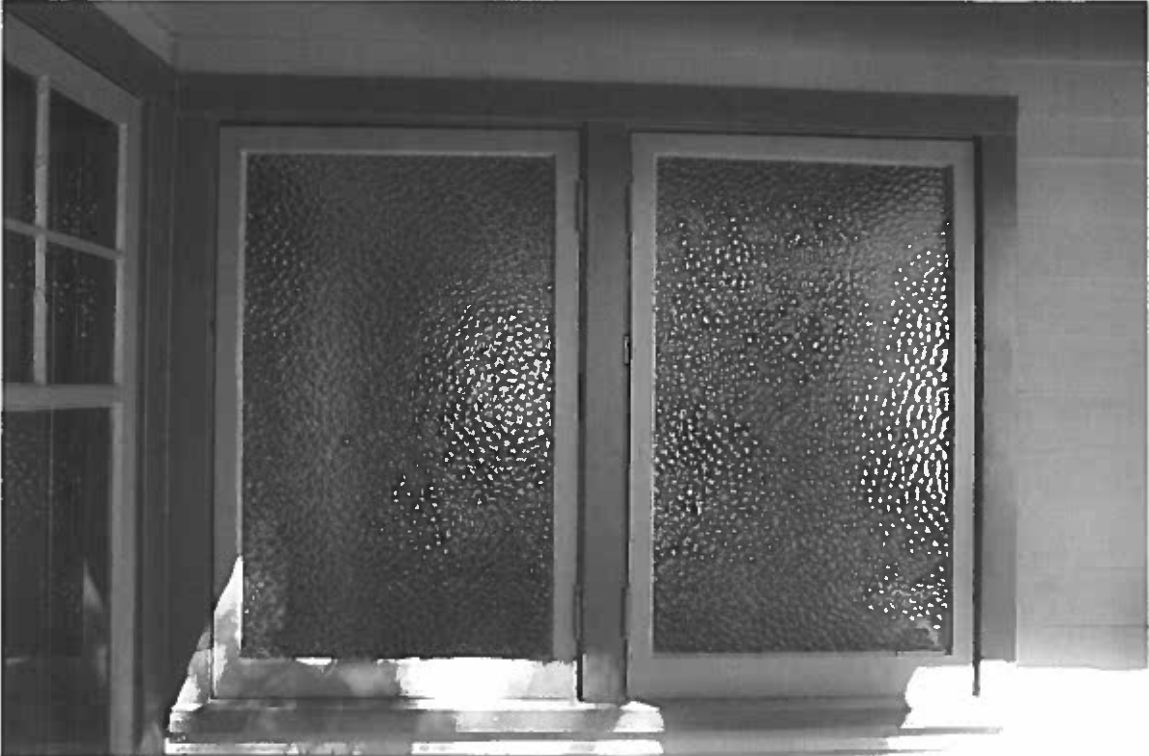
2) Weird Windows

Groovy. Disco forever.

- a. Replace windows with period-appropriate panes (possibly even stained glass) within 5 years.
3. One of the electric outlets doesn't work.
 - a. Fix outlet immediately.

6. *Window Repair.* The non-original windows shall be replaced with architecturally appropriate windows within five (5) years.
7. *Seismic Retrofit.* Documentation by either a building permit or building inspector's report must be submitted verifying completion of a seismic retrofit. If the house has not been seismically retrofitted, it shall be retrofitted within ten (10) years of the date of the City Council approval. Seismic retrofit shall be at minimum the bolting of the house to an approved foundation.

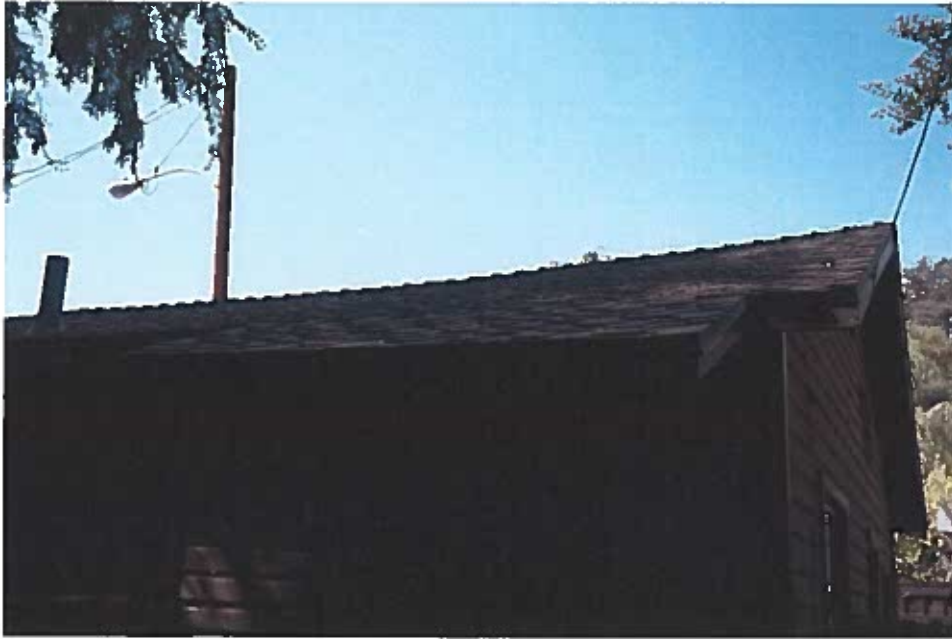
4) Garage Roof

4. The garage roof is structurally unsound. Several beams were removed from the A-frame at some point and roof is slightly bowing inward.
 - a. Restore the beams for structural integrity within 2 years.

Notice the sloping of the roof.

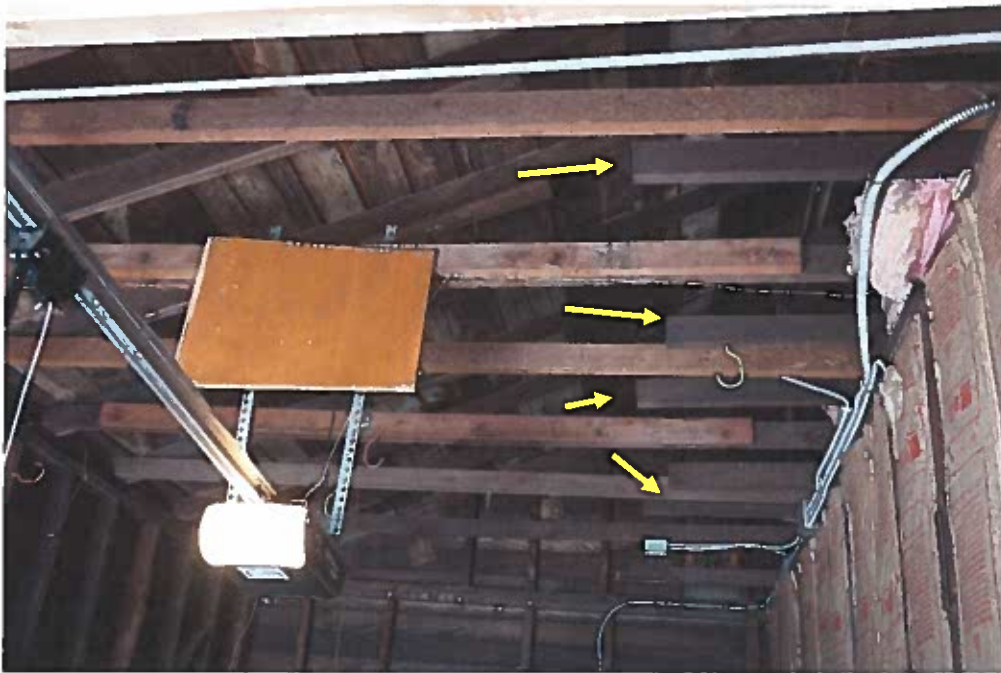
Half of the beams don't span the whole length!

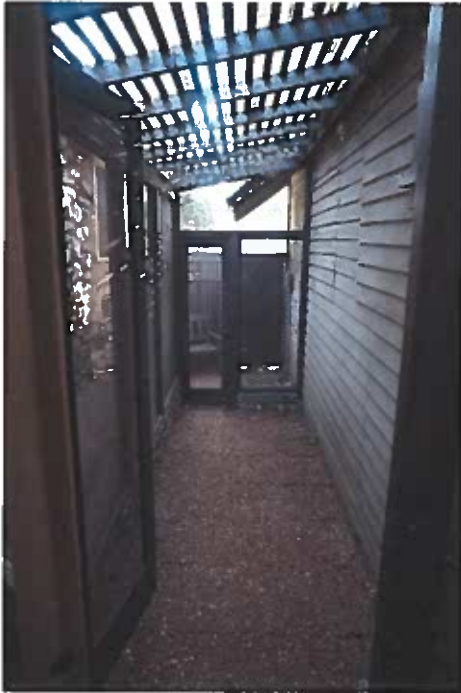
7) Weird Mudroom?

- a. Install gasline within 2 years.
7. The side of the house has, what appears to be, a mudroom that doesn't appear to be original. The mudroom is surrounded in screens but is exposed fully to elements by being open-air from above i.e. no roof. The space is currently not functional really for much of anything.

The wall is a screen, but the roof is open air.

- a. Get city approval to construct a pantry/storage closet. Design in craftsman style.

- b. Build pantry/closet within 8 years.
8. I have recently discovered that my house has a rat infestation. According to the pest control I need exclusion work done to keep out future pests. His fee is \$4,200.

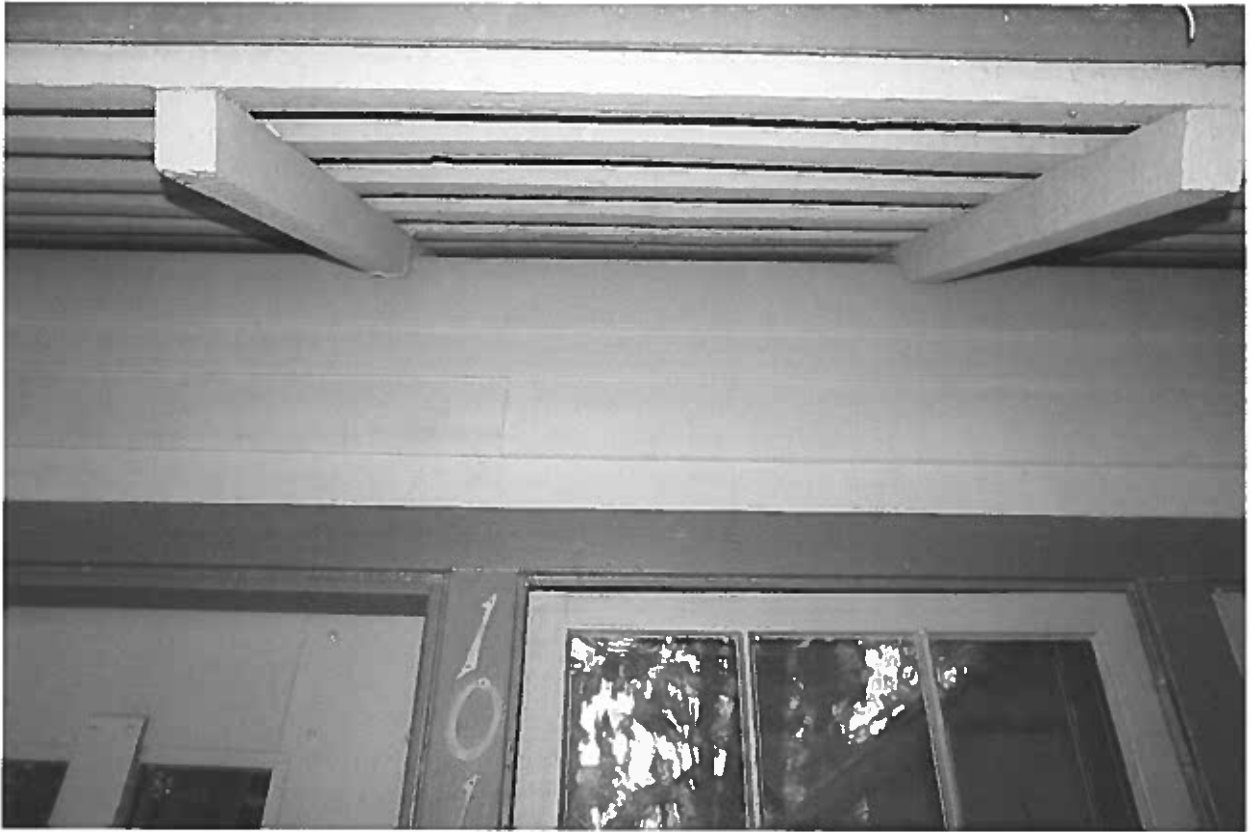
8) Rat Evidence

Throughout much of the perimeter the attic is exposed. There is a gap between the wall and the roof, perfect for rats to sneak into.

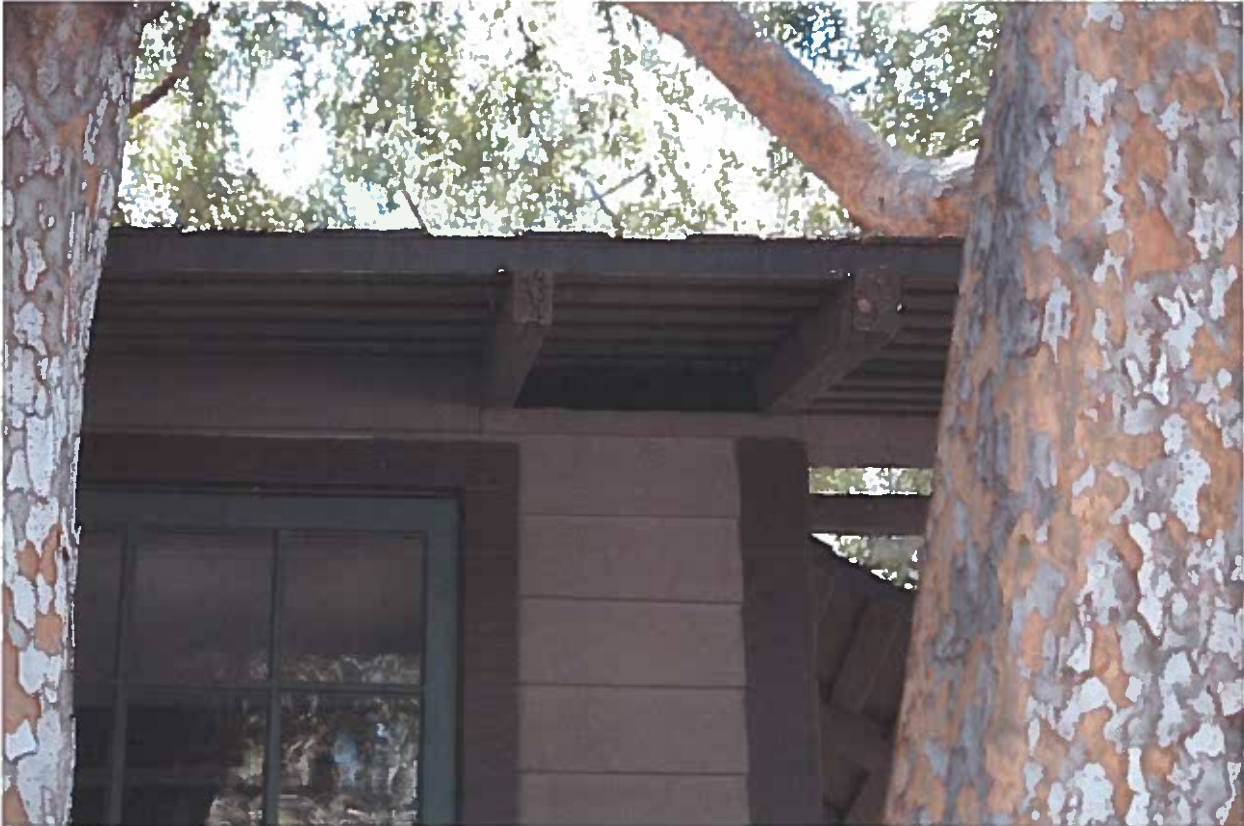
Big gaping hole between the roof and the wall. If I were a critter I'd want to live in there.

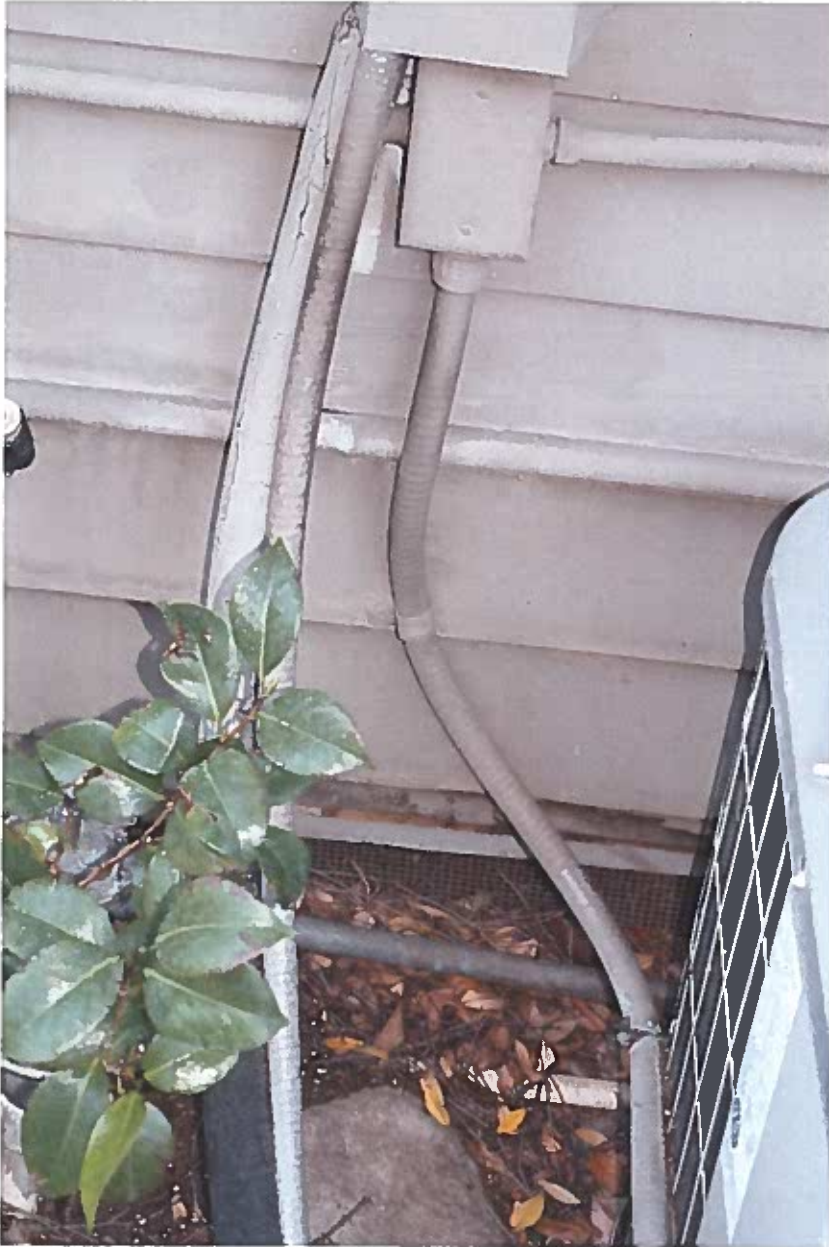
According to the exterminator the dirt on the pipes is caused by critter traffic.

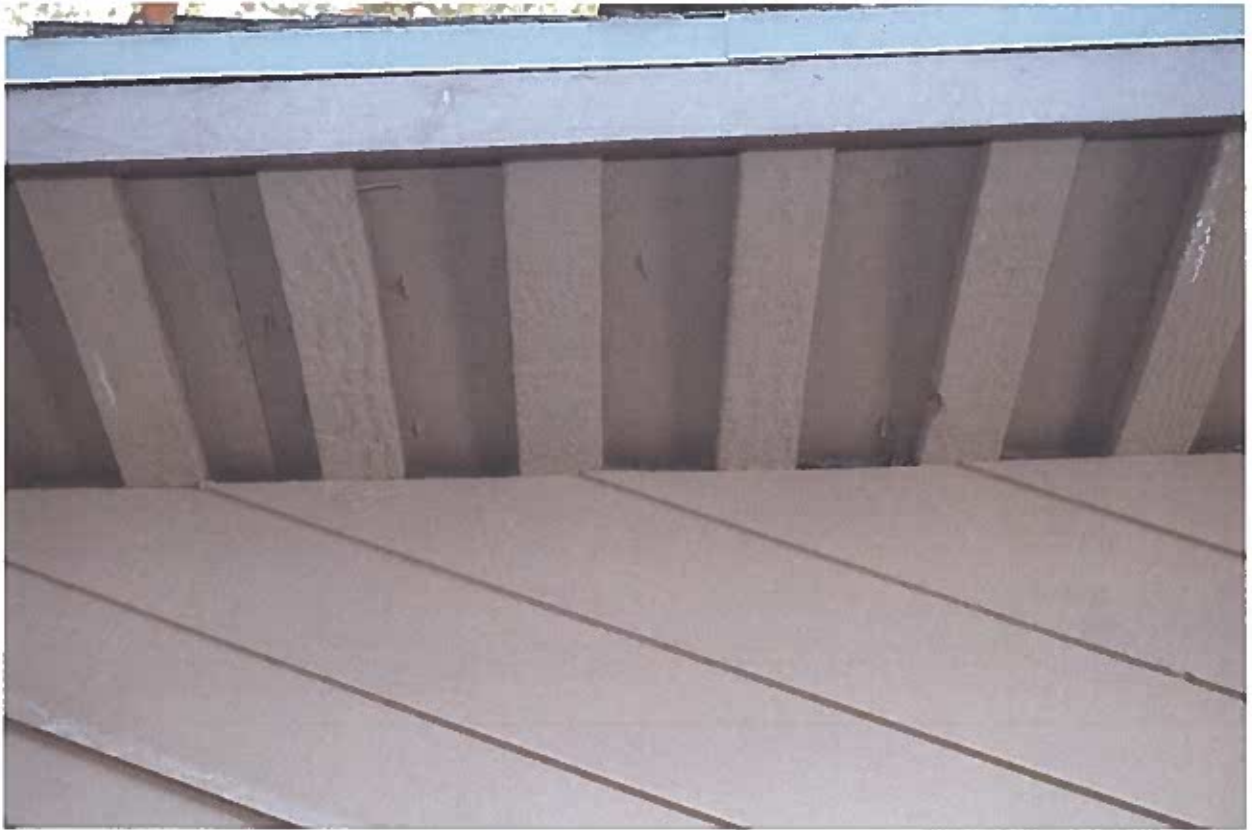
More gaps along the perimeter. Nice balcony for a rat.

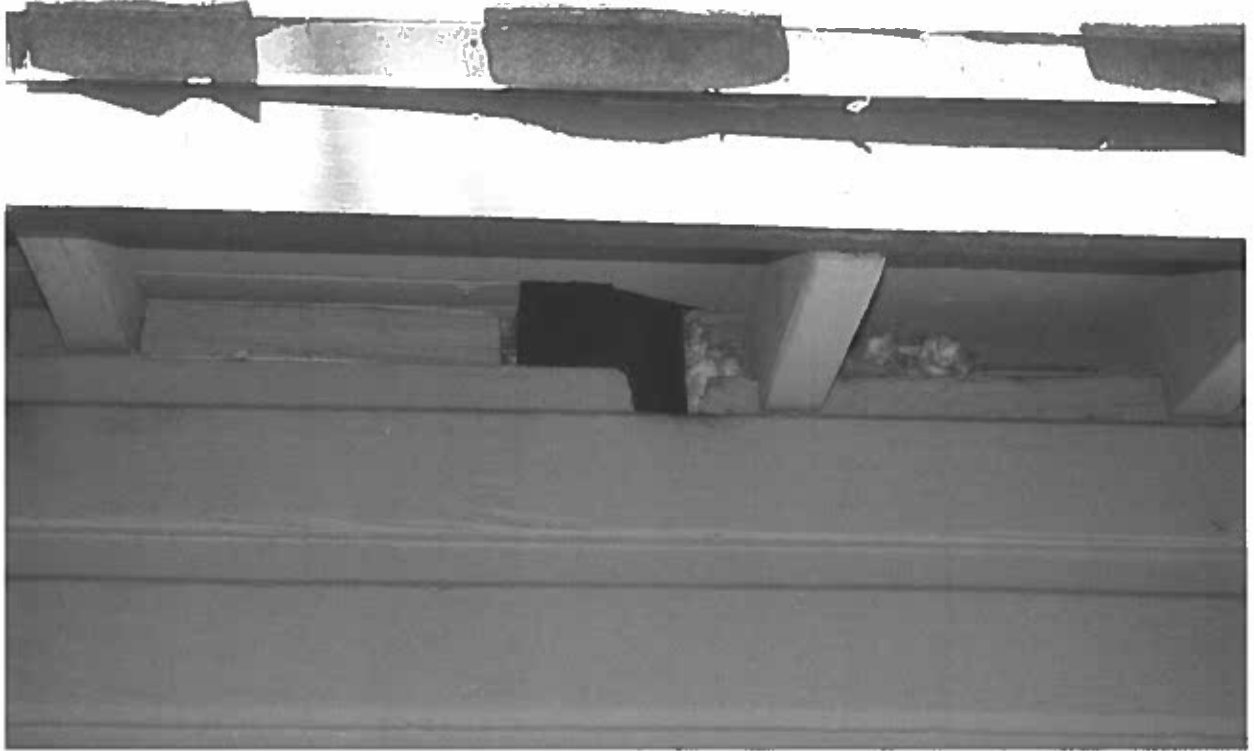
This beautiful geometric hole exhibits an elegant simplicity. Design by I.M. (a rat) Pei.

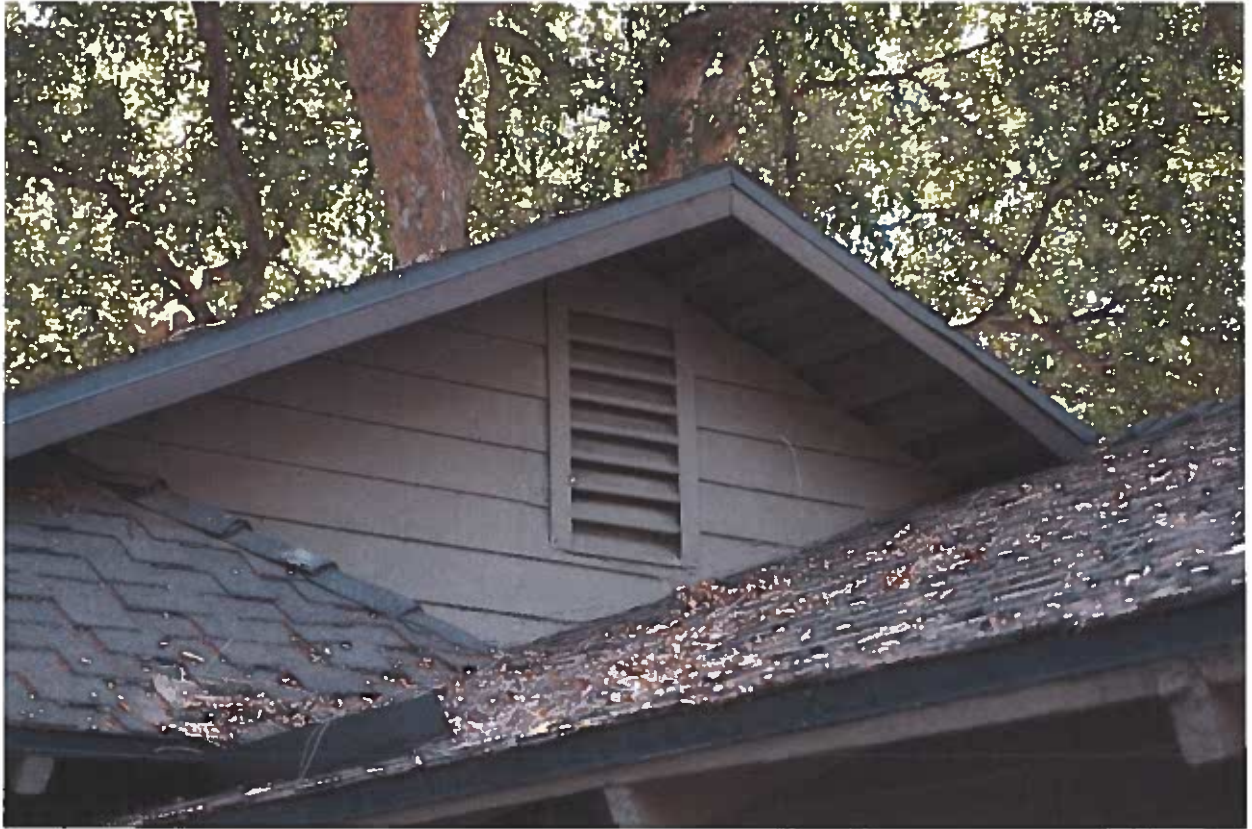
Human and squirrel homes by design! Maximum Occupancy: Humans (1), Squirrels (99).

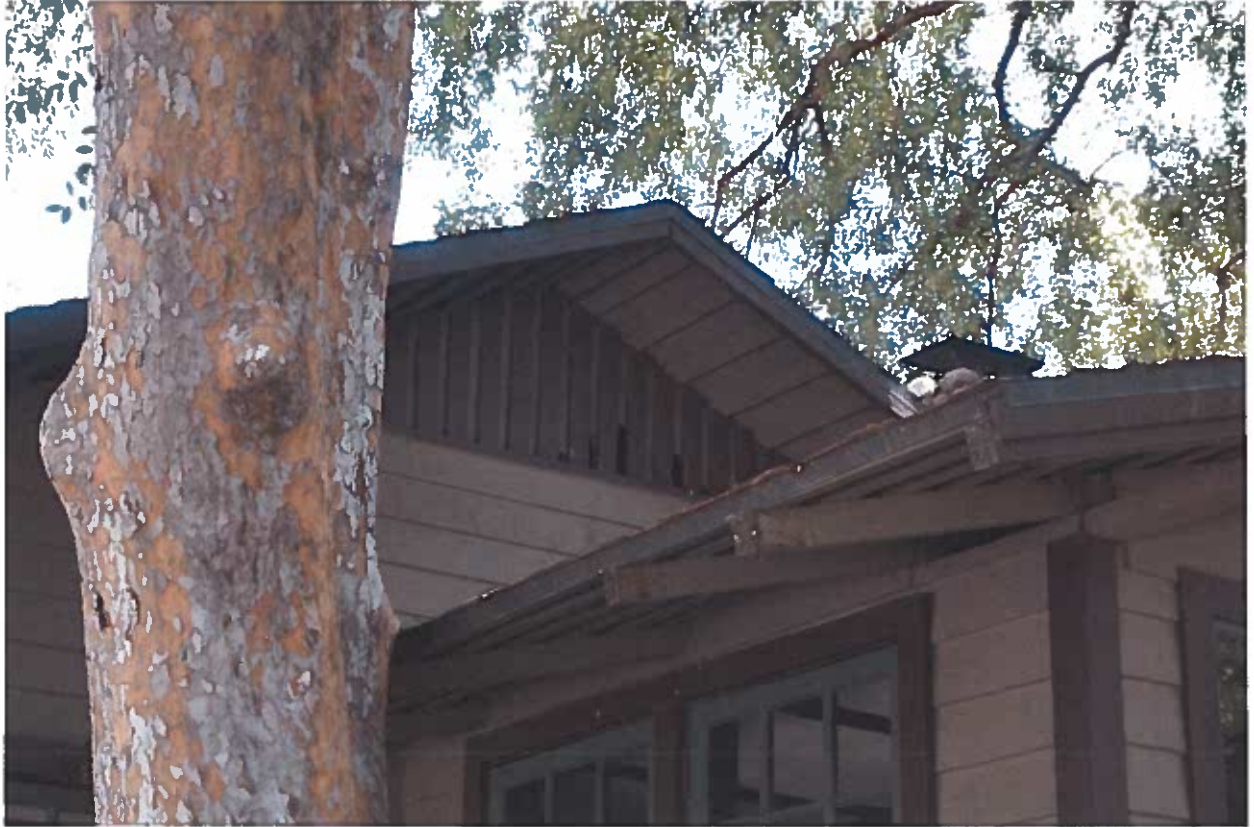
Gaping holes

This beautiful adaptation of human housing for rodent comfort is a classic demonstration Frank Lloyd Rat's integration of natural elements with modernity.
