# **HISTORIC PRESERVATION COMMISSION STAFF REPORT**

**APPLICATION:** CA2018-02

**TITLE:** Certificate of Appropriateness CA2018-02; HL-143/MA-133  
228 West Olive Avenue

## Maintenance and Restoration Proposal 2018

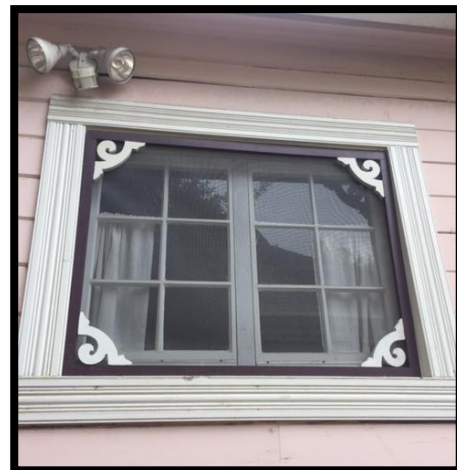
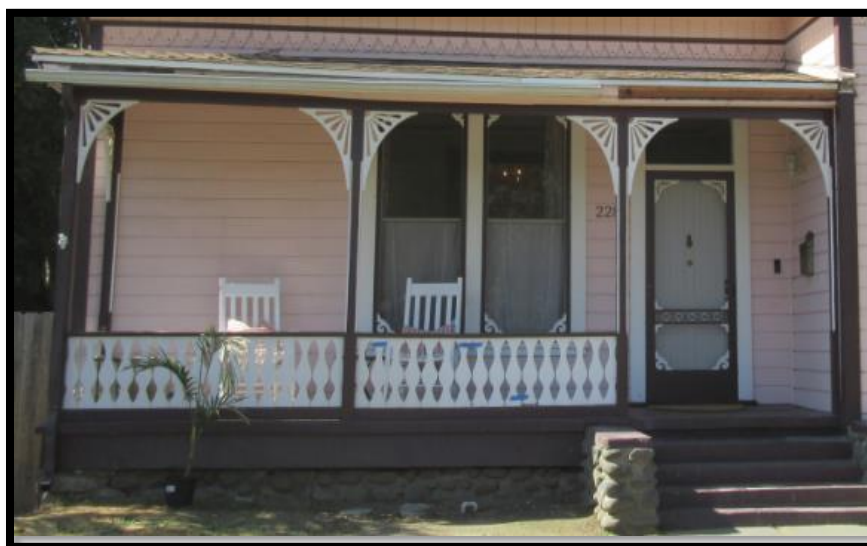
**ANALYSIS:** The homeowners are proposing to replace two window surrounds on the east elevation of the single family residence. Neither of the existing windows are original to the home; one window is located within an area of the home that was part of a 1980 addition, the other window appears to have been enlarged and relocated during the same time period. The existing window surrounds have an elaborate grooved pattern and lack a window sill and apron, which are details that are inconsistent with the original window surrounds. The applicant proposes to replace the 1980 window surrounds with custom redwood window surrounds, sills, and aprons that will match the originals in size, shape, dimension and material. They will also be painted to match the trim color of the house.

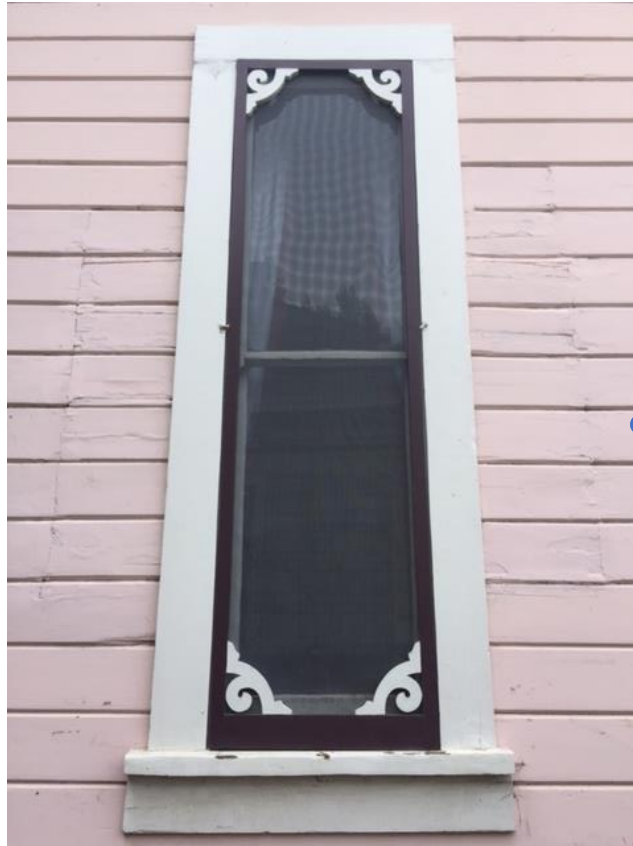
Replicate this type of window frames (location 1C)...

**1. Restoration—Windows.** The frames and sills of the windows that were put in during a 1970s addition do not complement the original windows on the front and west of the house. We want to have exterior frame and ledge of old window (above) put on the windows on east side of house

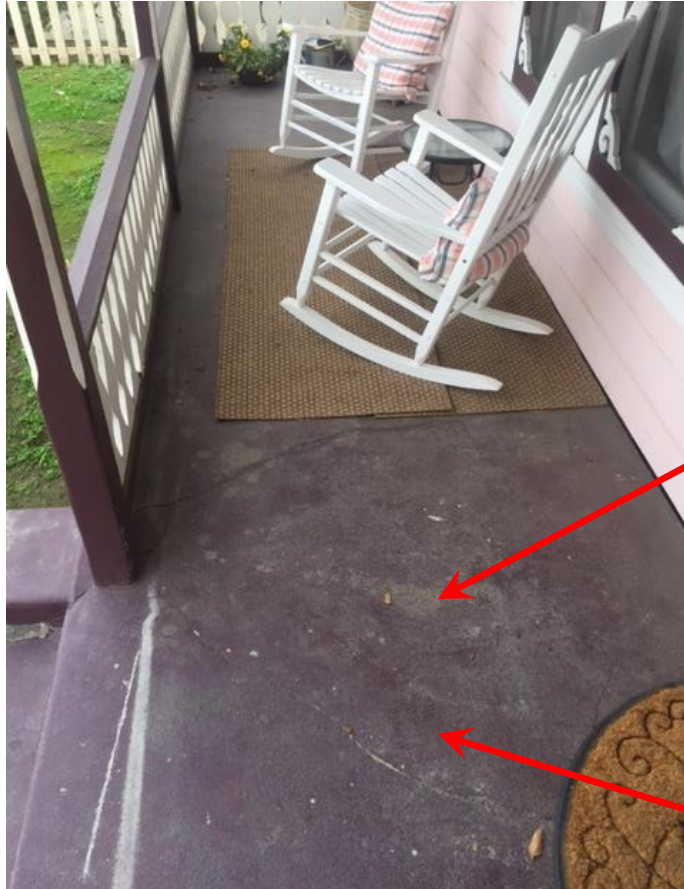
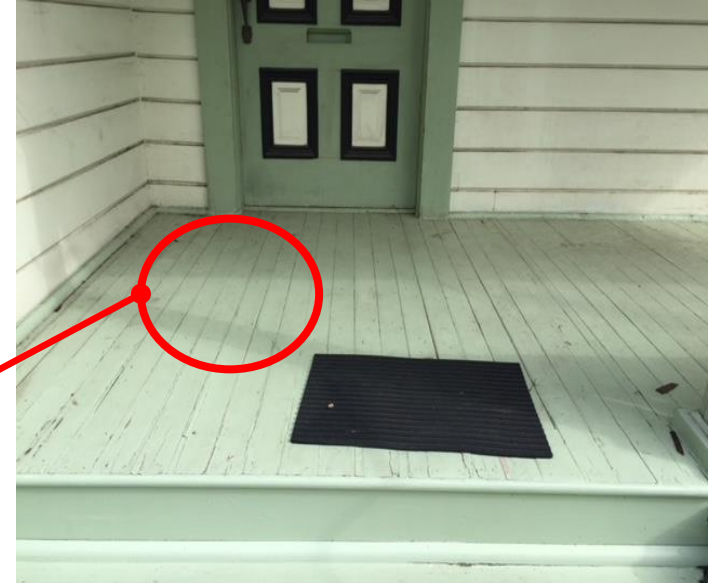
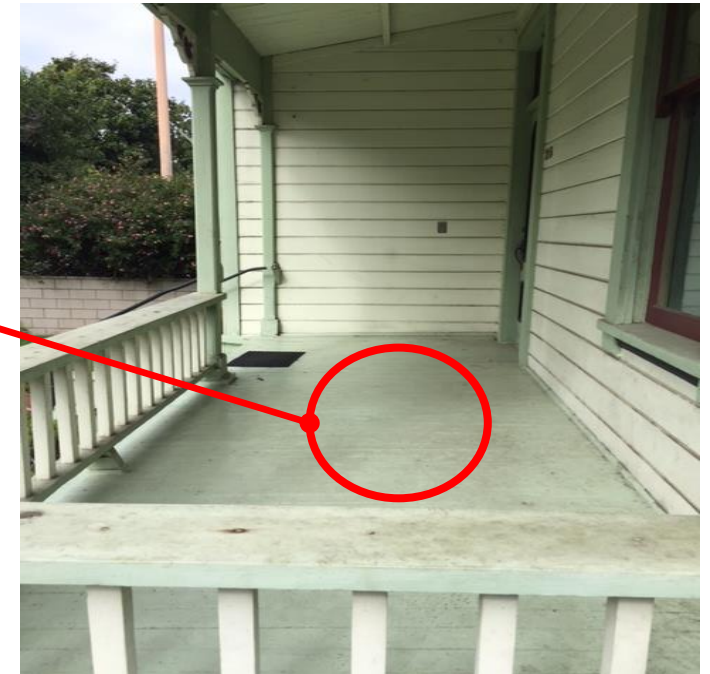
**2. Restoration—Porch Deck.** Remove cracked and splintered concrete topping of front porch and restore deck with Douglas fir planks. Douglas fir is the same material as the original hard wood floors inside home. End goal is to have porch look similar to historical Andersen House on Lime Street (right).

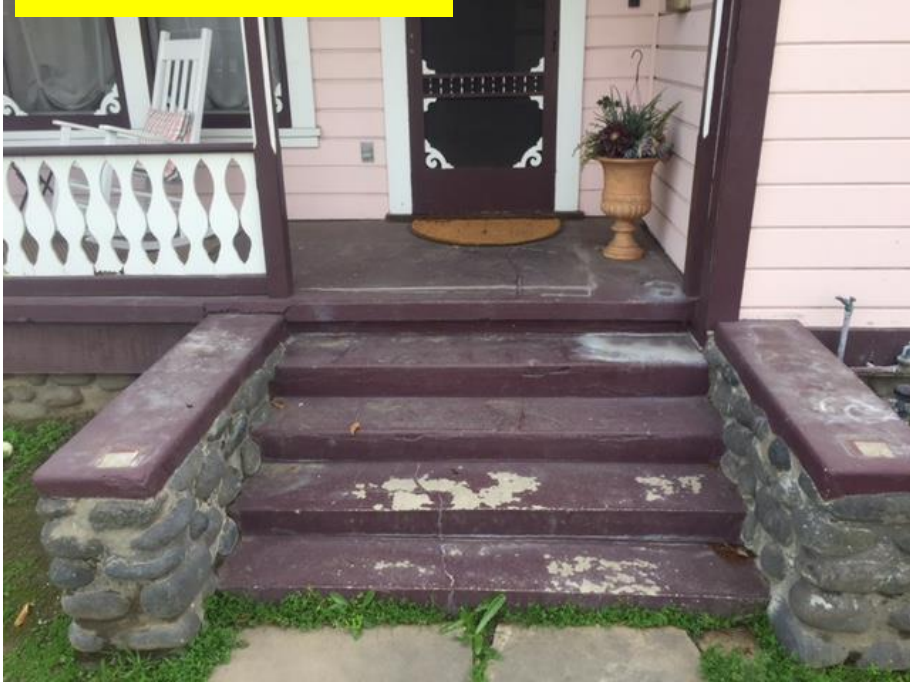
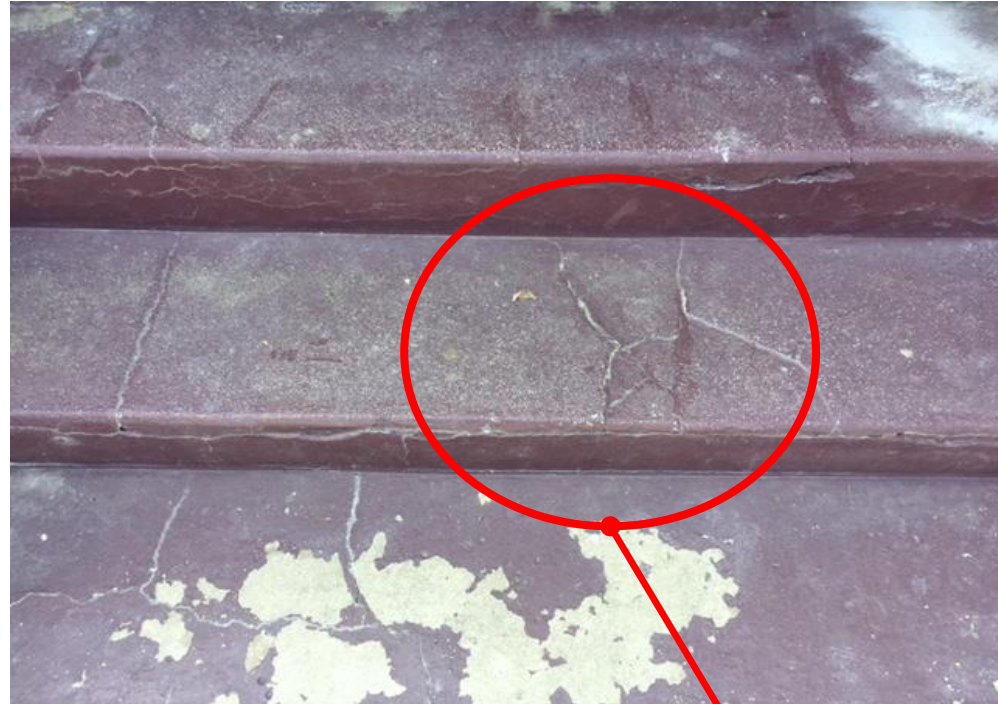
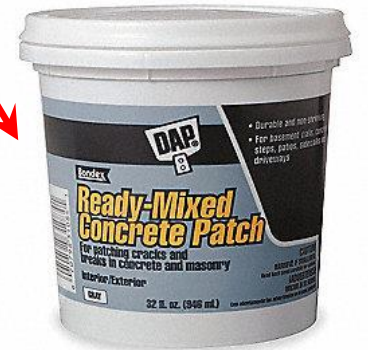
**3. Restoration—Porch Stairs.** Concrete on the steps is cracked. Remove paint, patch with concrete patching compound, and repaint.

Will use patching compound to fill cracks in concrete (similar to right)

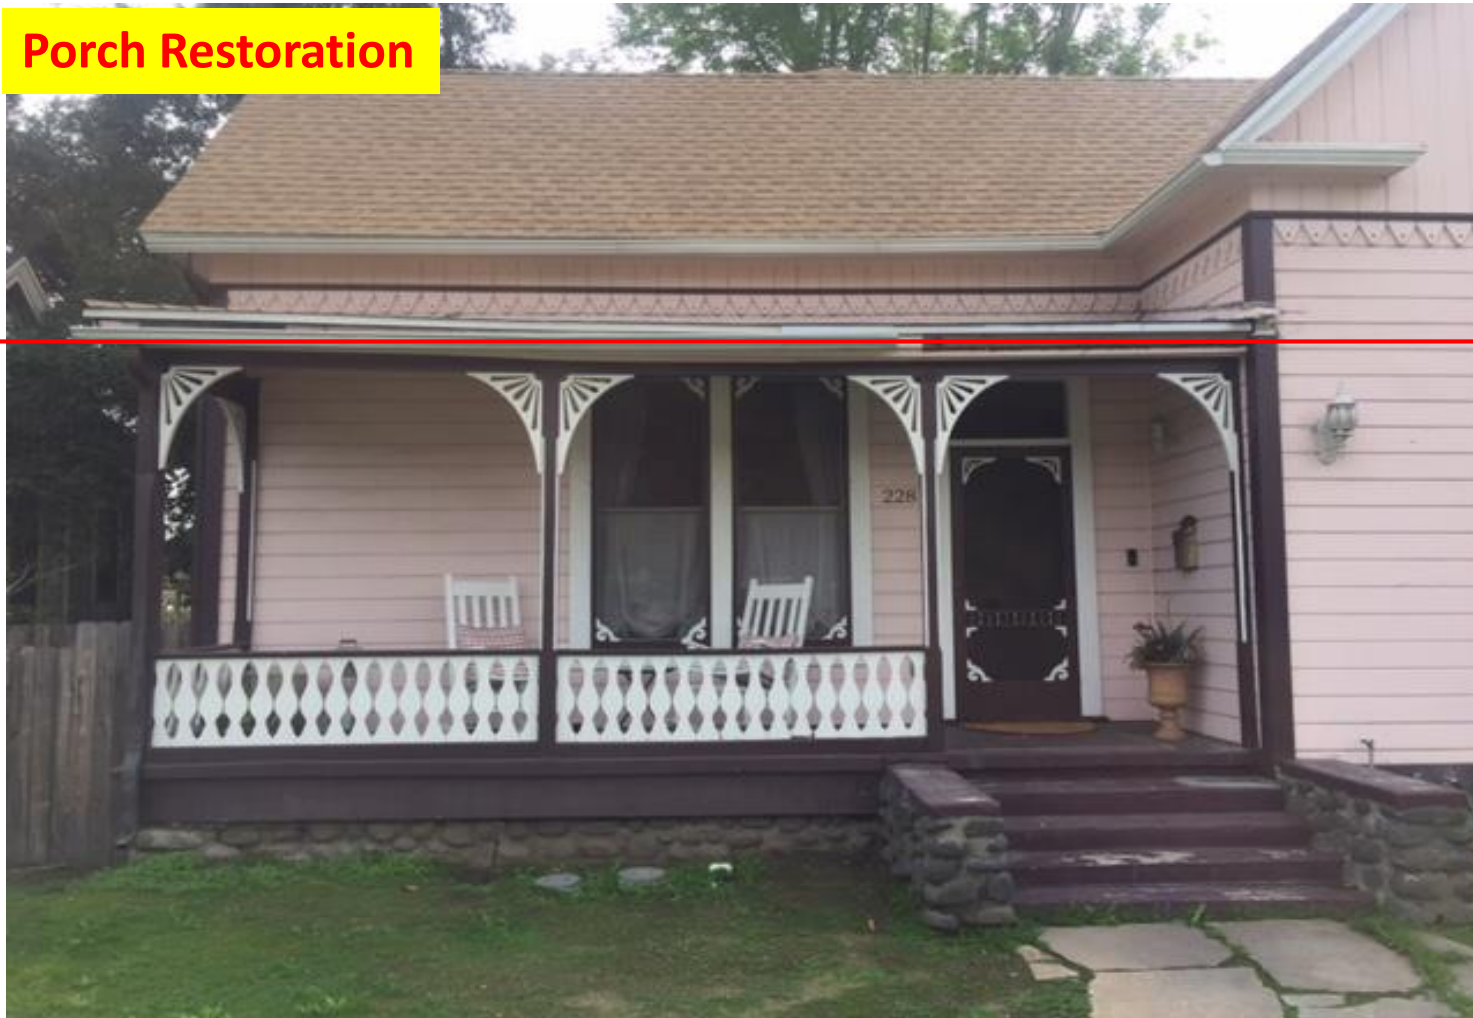
**4.a. Restoration—Porch Roof.** Level roofline of sagging porch. Support pillars of deck in middle have shown evidence of rot, so we would repair these pillars to raise and level roofline. Additionally, we would repair the wood flashing below roofline.

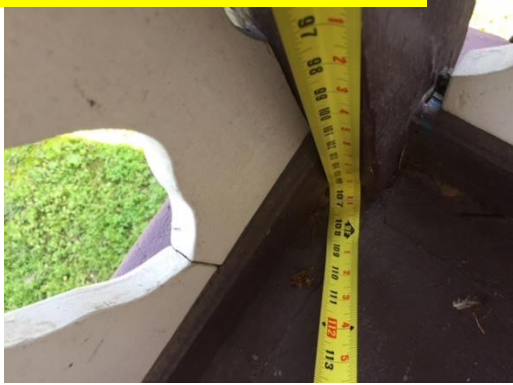
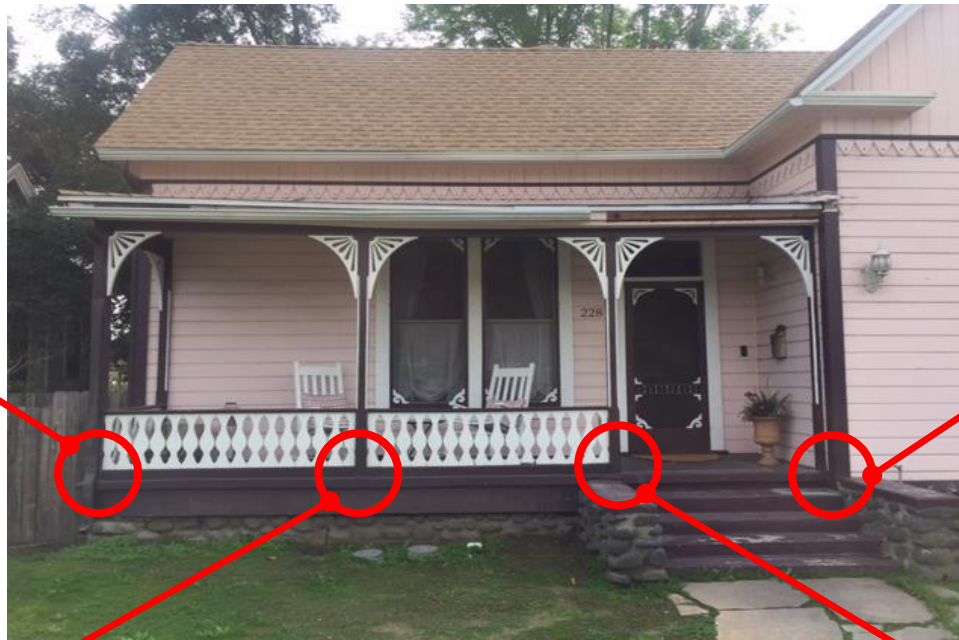
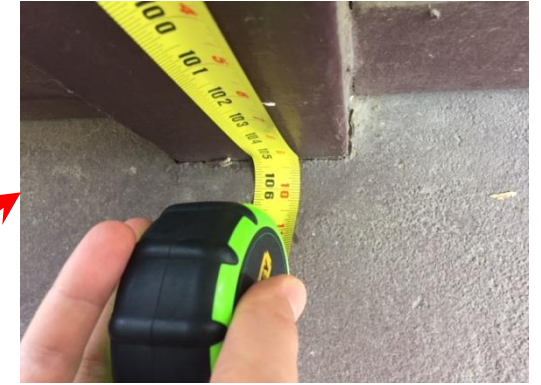
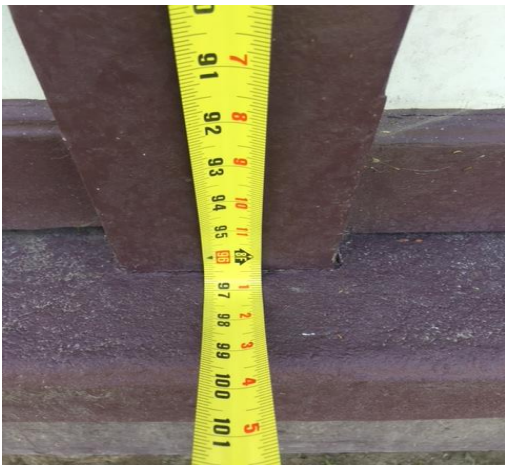
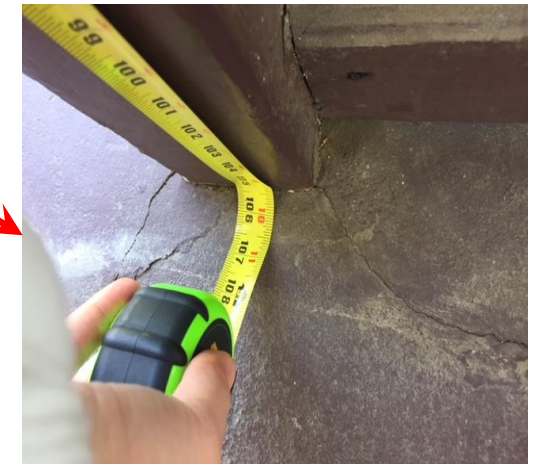
**4.a. Restoration—Porch Roof (continued).** The posts that hold up the roof are uneven. After a level porch is established, wood blocks would be used to make the posts and the roof an even height.

Current heights (left to right): 107", 96.5", 106", 105.5"

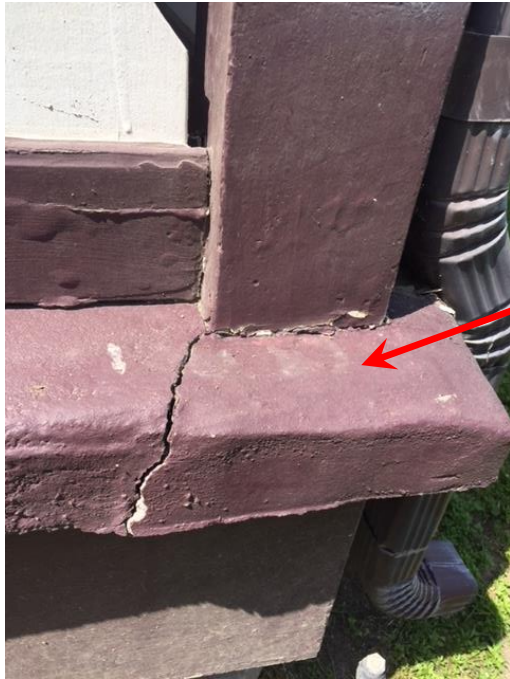
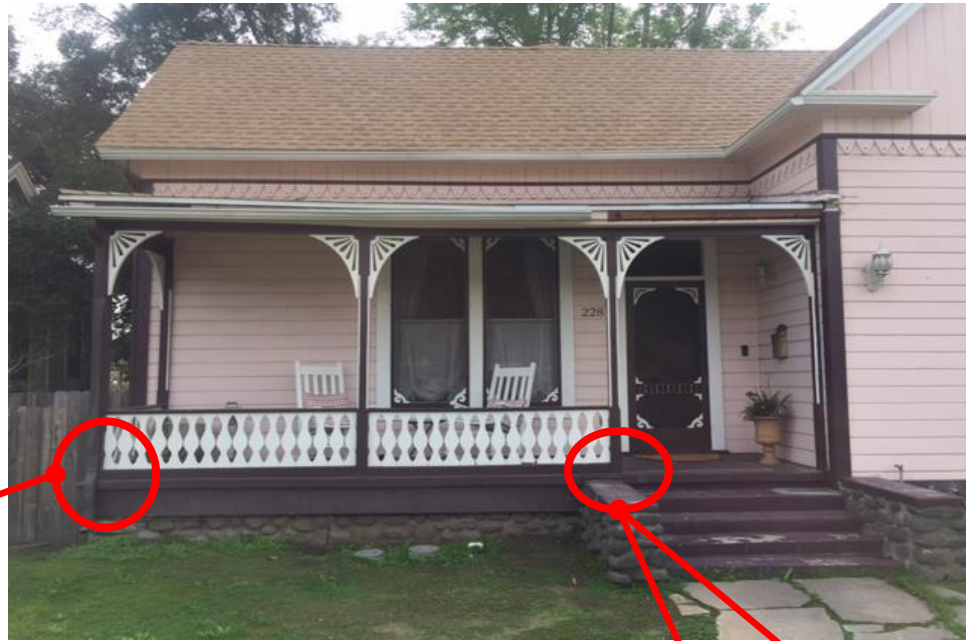
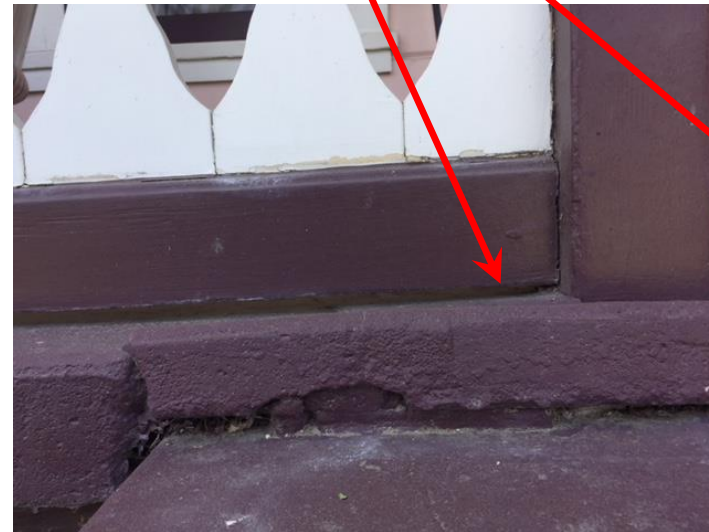
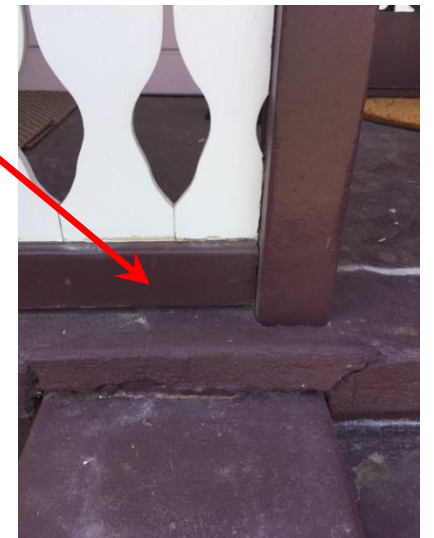
**4.a. Restoration—Porch Roof (continued).** The posts that support the porch roof sit atop the concrete, but the concrete has cracked and crumbled. The concrete needs to be removed and a level base needs to be established. The posts will be leveled and anchored directly on the new wood porch.

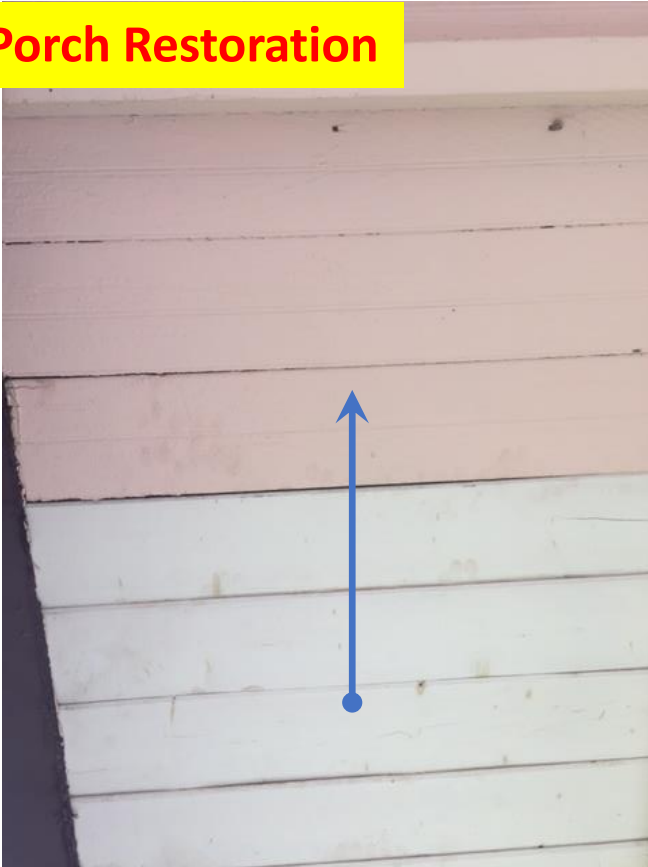
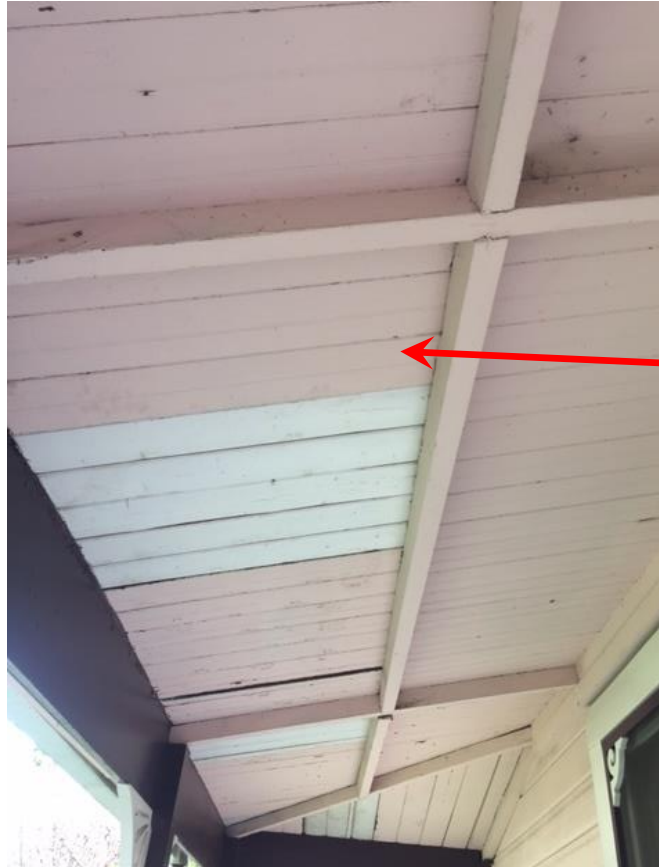
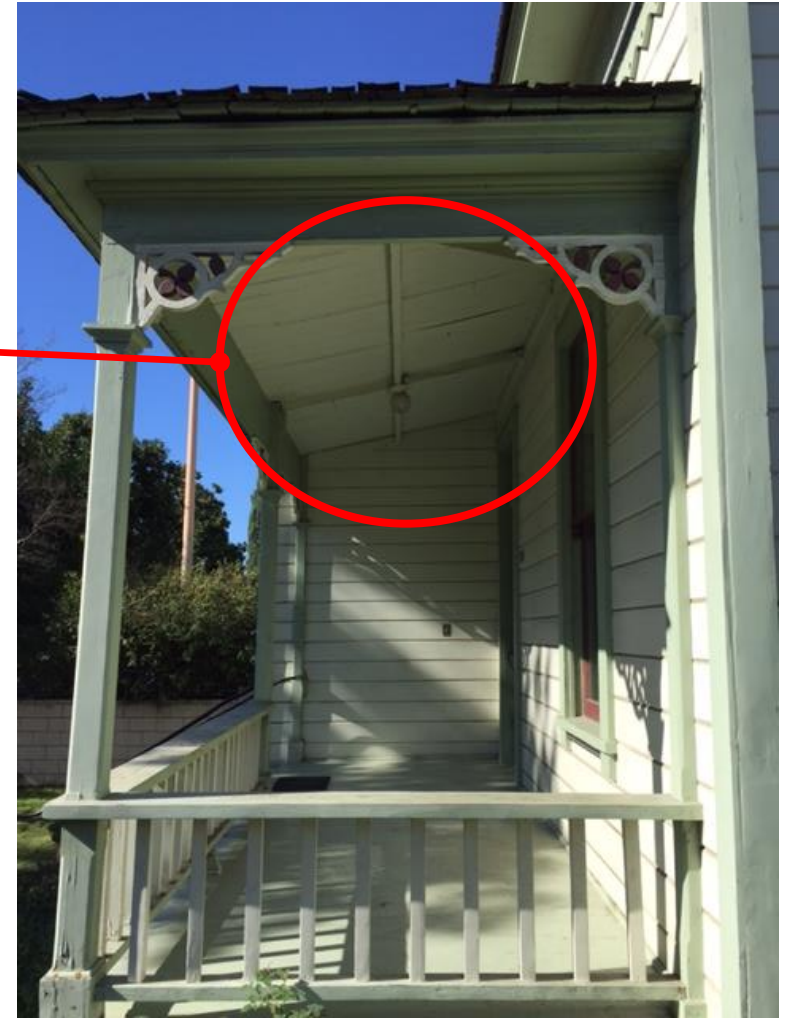
**4.b. Restoration—Porch Ceiling.** Replace incorrect porch ceiling planks (white) with in-kind planks matching original planks (pink). White planks are Home Depot-like patches that do not match original wood ceiling. End goal is to have ceiling look similar to historical Andersen House on Lime Street (right).

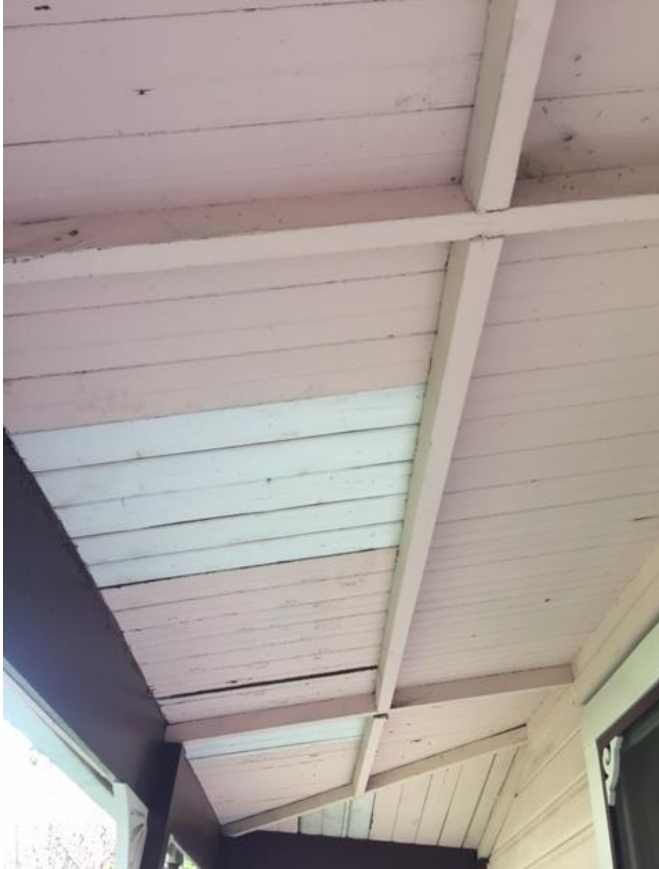
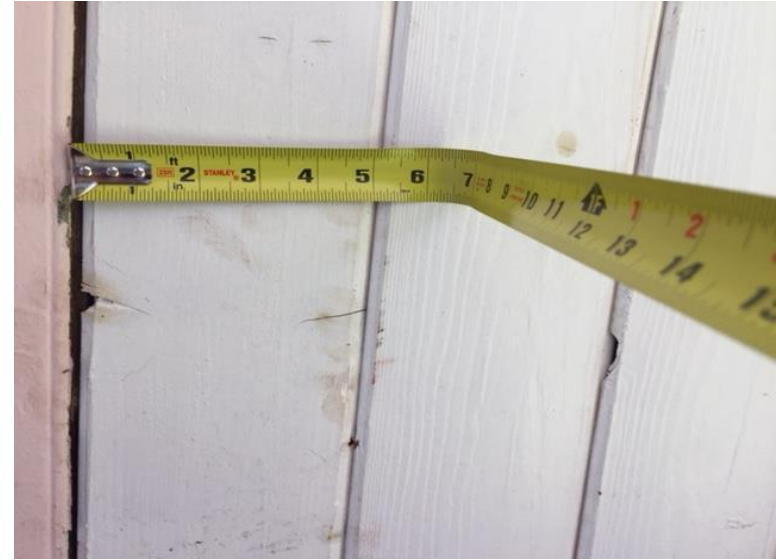
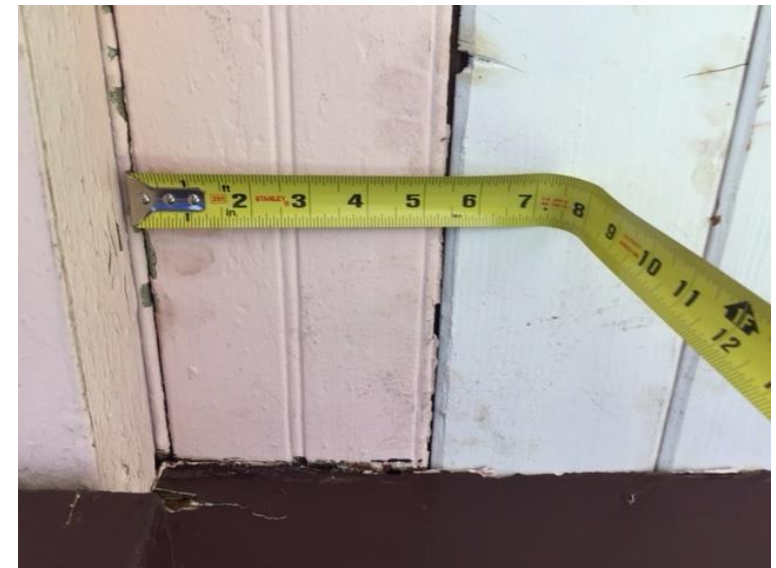
**4.b. Restoration—Porch Ceiling (continued).** A closer look at wood planking on ceiling. The white patches (top right) would be replaced with in-kind materials cut to match the façade of the existing planks (bottom right) and restore the original character.

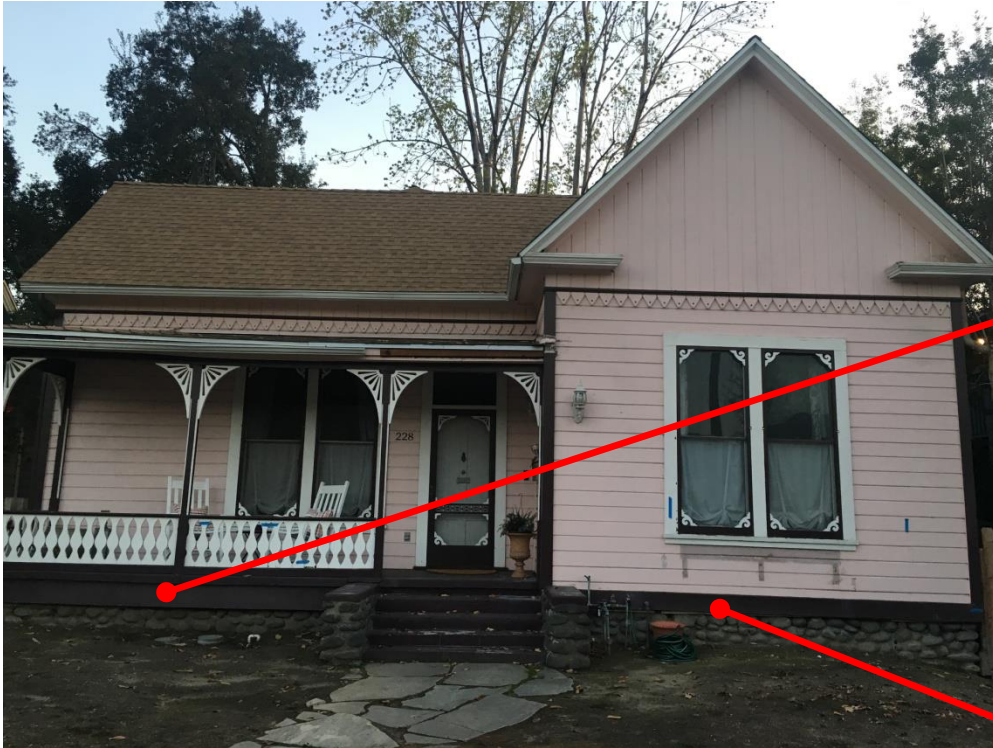
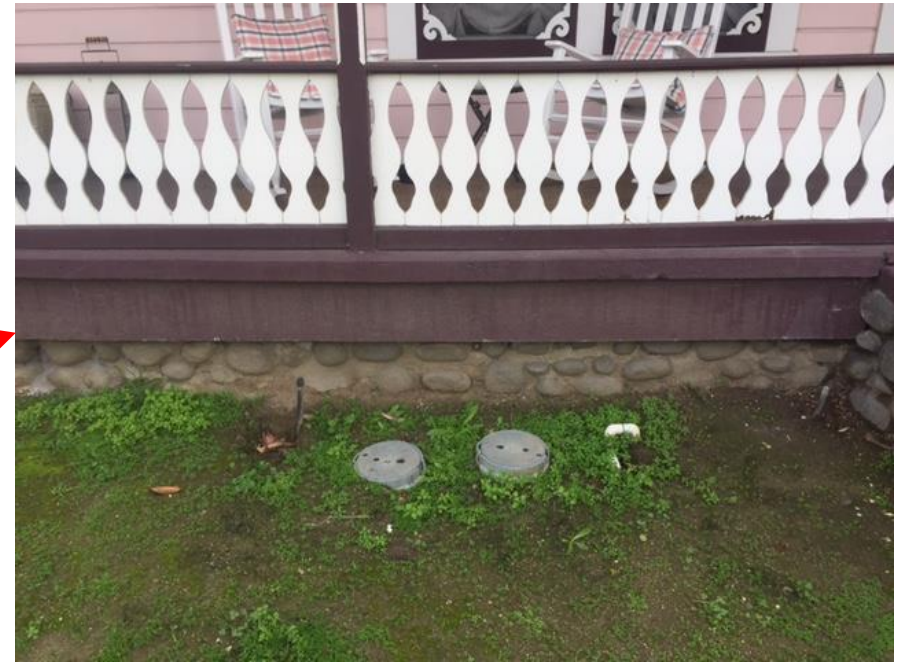
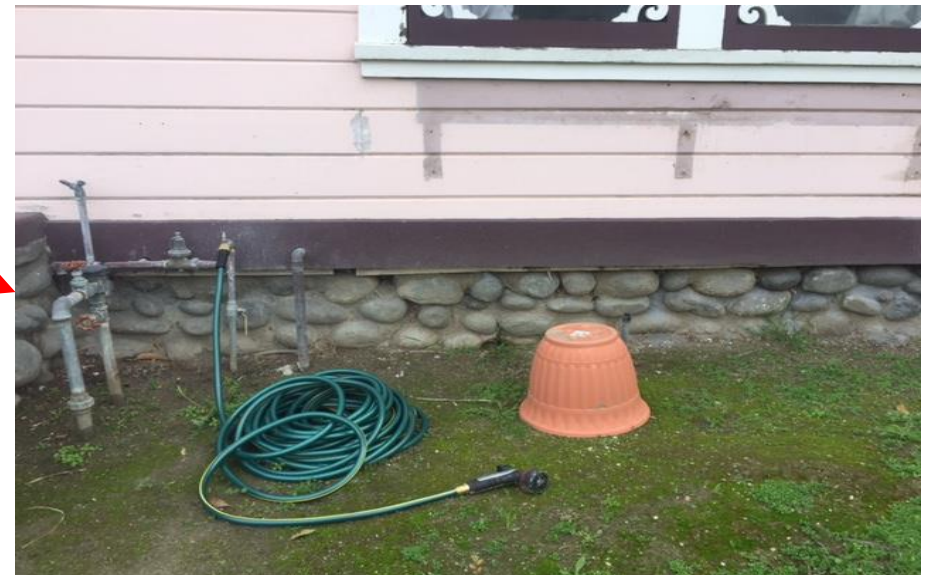
**5. Restoration—Porch Facade.** Make the wooden apron under the window (front right of house) with the same width as the one under the deck (front left side of house). Final width will be determined when porch is complete, likely around 9.0". Aprons around rest of home range from 7.5" - 9.75".
