NIST Technical Note 1635

**A Case Study of a Community
Affected by the Witch and Guejito
Fires**

April 2009

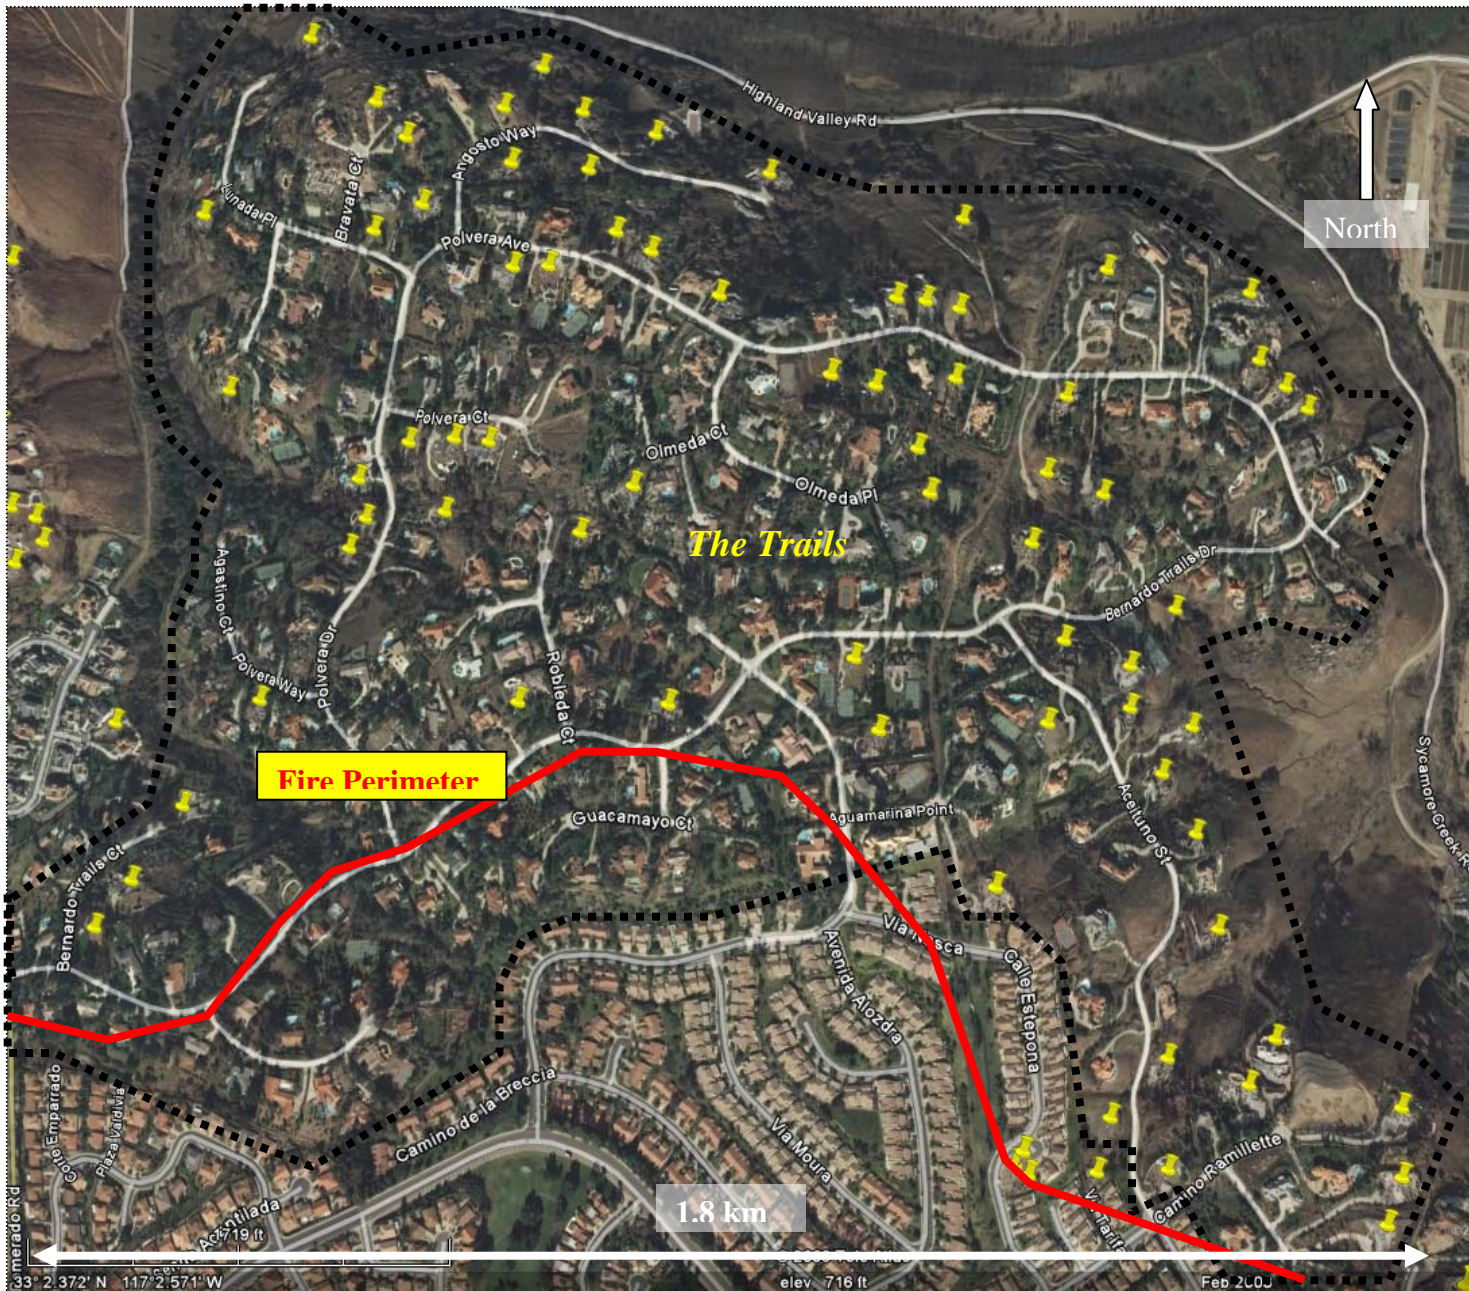
Figure 1: *The Trails* Community, Destroyed Homes (in Yellow) and Fire Perimeter after the Guejito and Witch Fires

The NIST WUI Team was invited by the California Department of Forestry and Fire Prevention (CAL FIRE) to collect post incident data from the California October 2007 fires. Early on, the NIST WUI Team initiated a case study within the Witch Fire perimeter. The case study is focused on The Trails development at Rancho Bernardo, 40 km (25 miles) north of the City of San Diego. There were 274 homes in The Trails, with 245 within the fire perimeter (Figure 1). Seventy four homes were completely destroyed and 16 were partly damaged.

445 feet). The community is 23 km (14 miles) east of the Pacific Ocean. The community consists of 283 residential lots (Figures 1 and 2). Although some lots on the perimeter of the community are larger, typical lots are approximately 6000 m² (1.5 acres). At the time of the fires there were 274 residences. Out of the 245 residences within the fire line, 74 were completely destroyed and an additional 16 sustained various degrees of damage. Housing density is approximately 116 homes per km² (300 homes per square mile). Figure 3 illustrates three different housing densities. The Trails is represented on the left, a community in Rancho Santa Fe, California is shown in the middle and a low density housing area is shown on the right. Note that the houses are not evenly distributed as the “density” becomes lower. The housing density within The Trails is greater than the densities seen outside of Rancho Bernardo but lower than the densities seen to the west of The Trails (Figure 2).

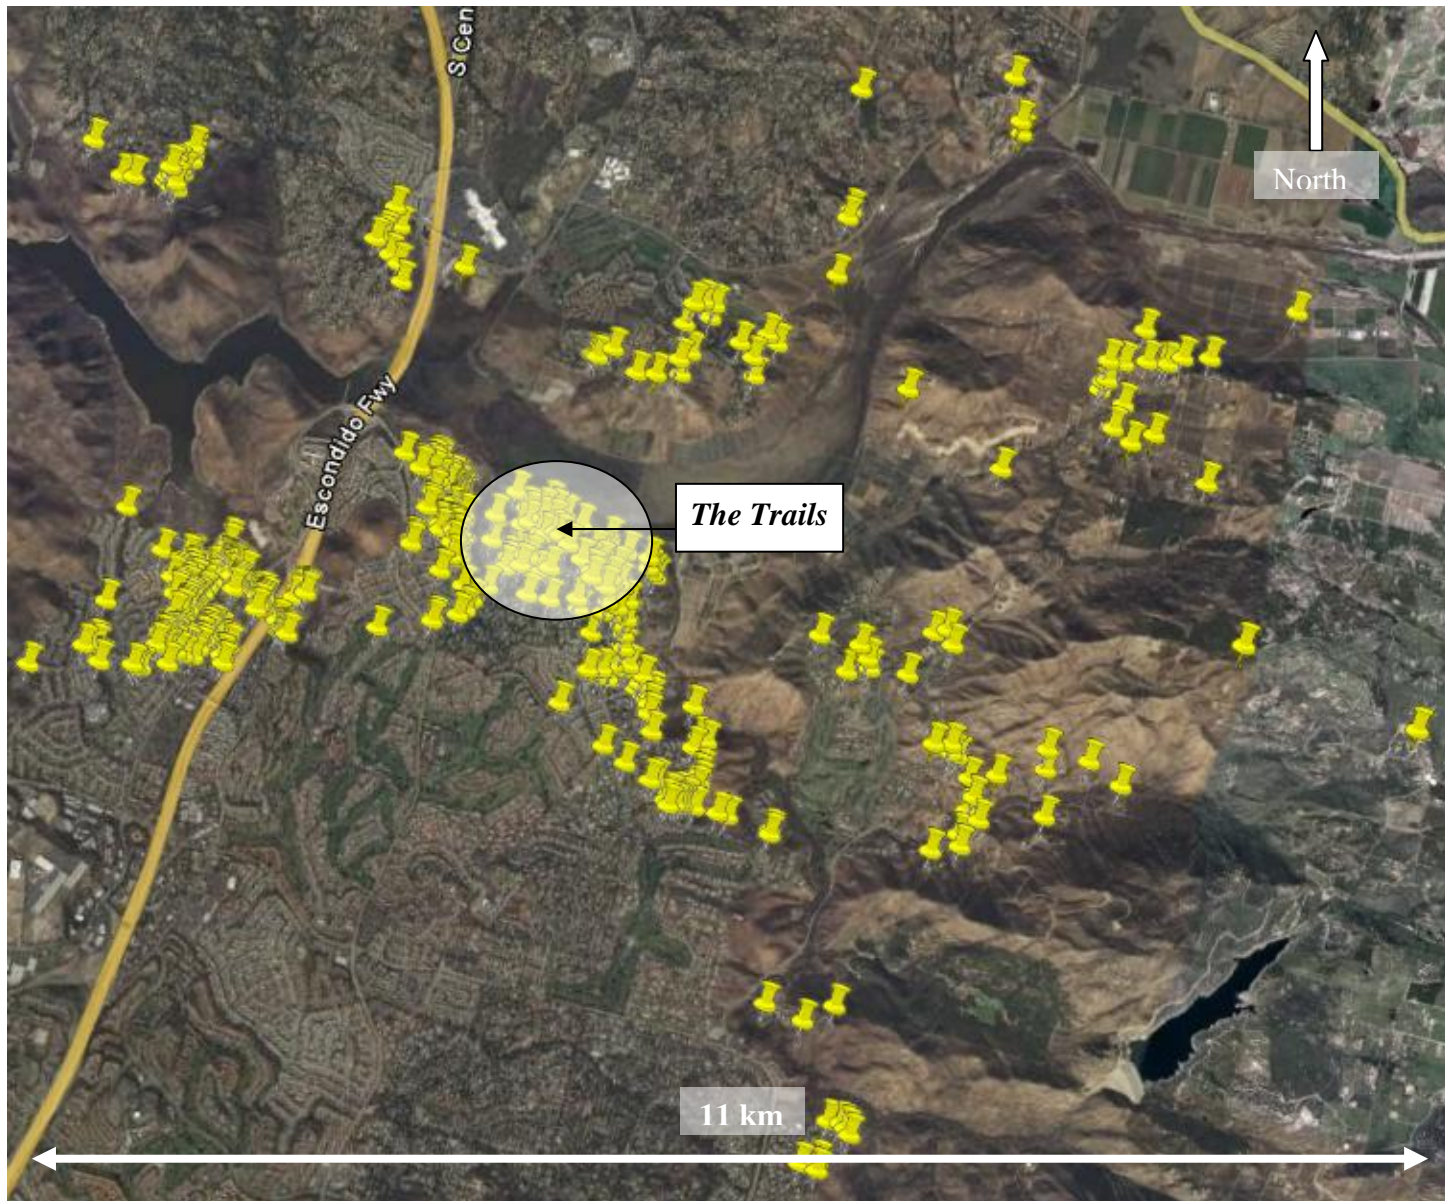
Figure 2: Destroyed Structures in the vicinity of Rancho Bernardo, CA

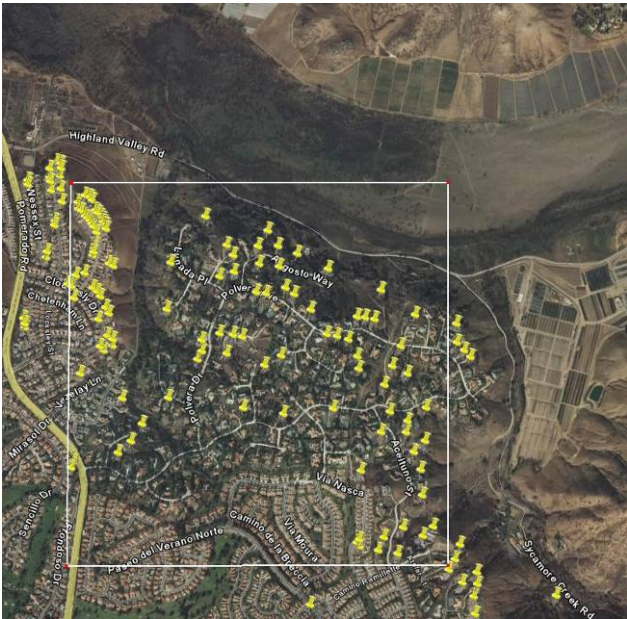
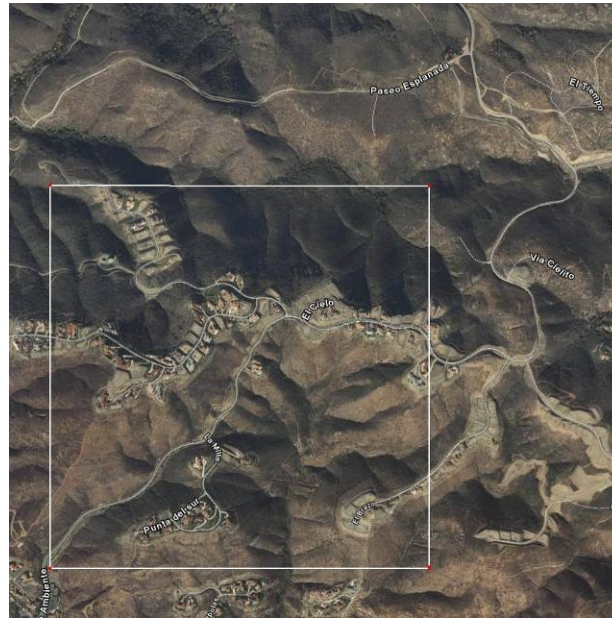
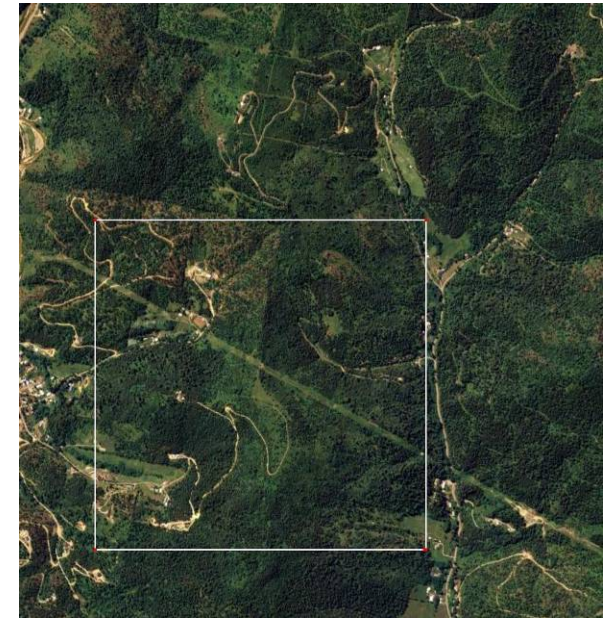
Figure 3: Structure Densities in Three Different WUI Settings

The Trails
 116 homes per km²
 (300 homes per square mile)

Rancho Santa Fe
 31 homes per km²
 (80 homes per square mile)

Rural Setting
 4 homes per km²
 (10 homes per square mile)

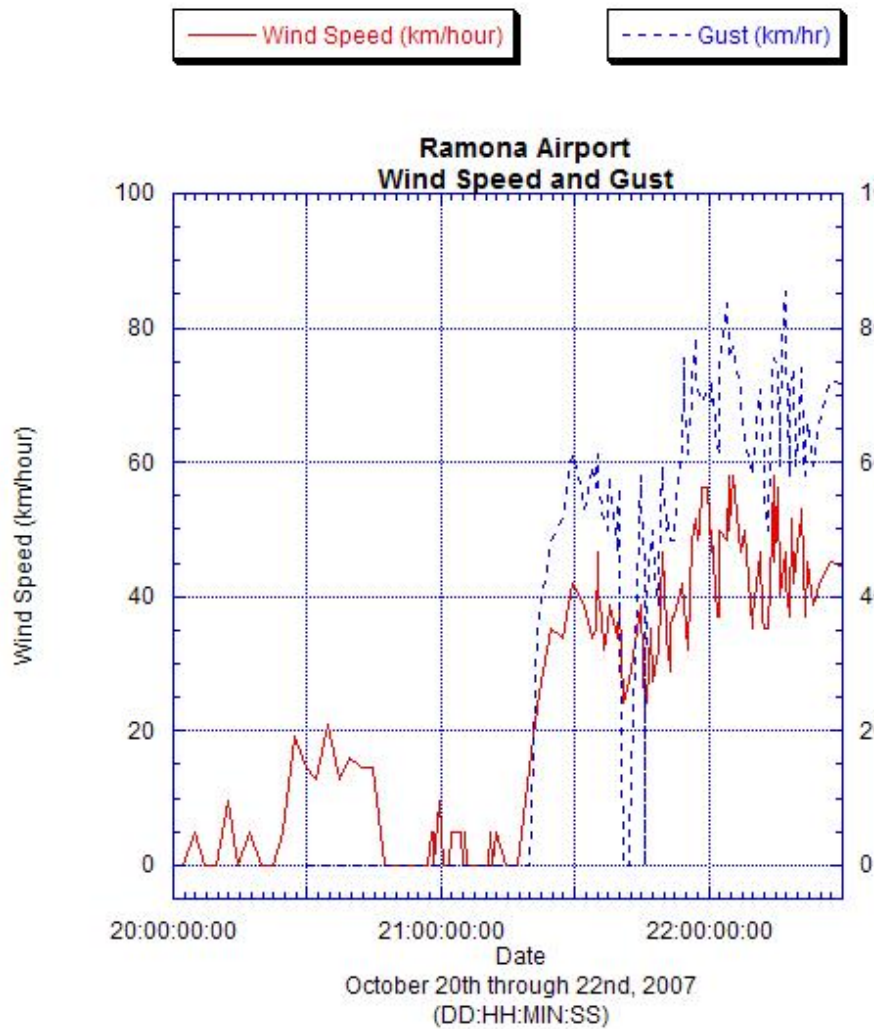
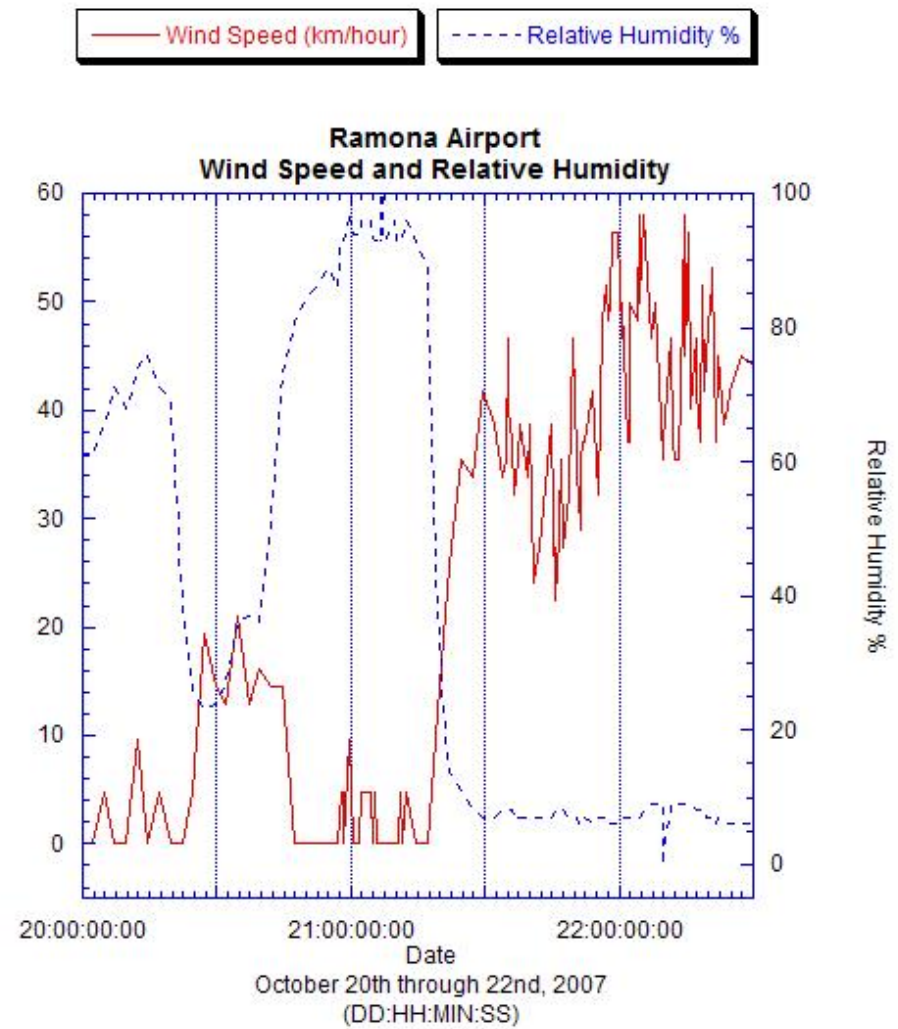
Figure 5: Weather data from Ramona Airport

The Ramona Airport weather station is 13 km due east from The Trails. The station recorded a dramatic drop in humidity while also recording a rapid increase in wind speed. Similar behaviors were recorded by the Poway NE1 station, located 10 km SSE of The Trails, and are summarized in Table 2. Figure 5 displays wind speed, wind gusts, wind direction and relative humidity at Ramona airport between October 20th and October 22nd.

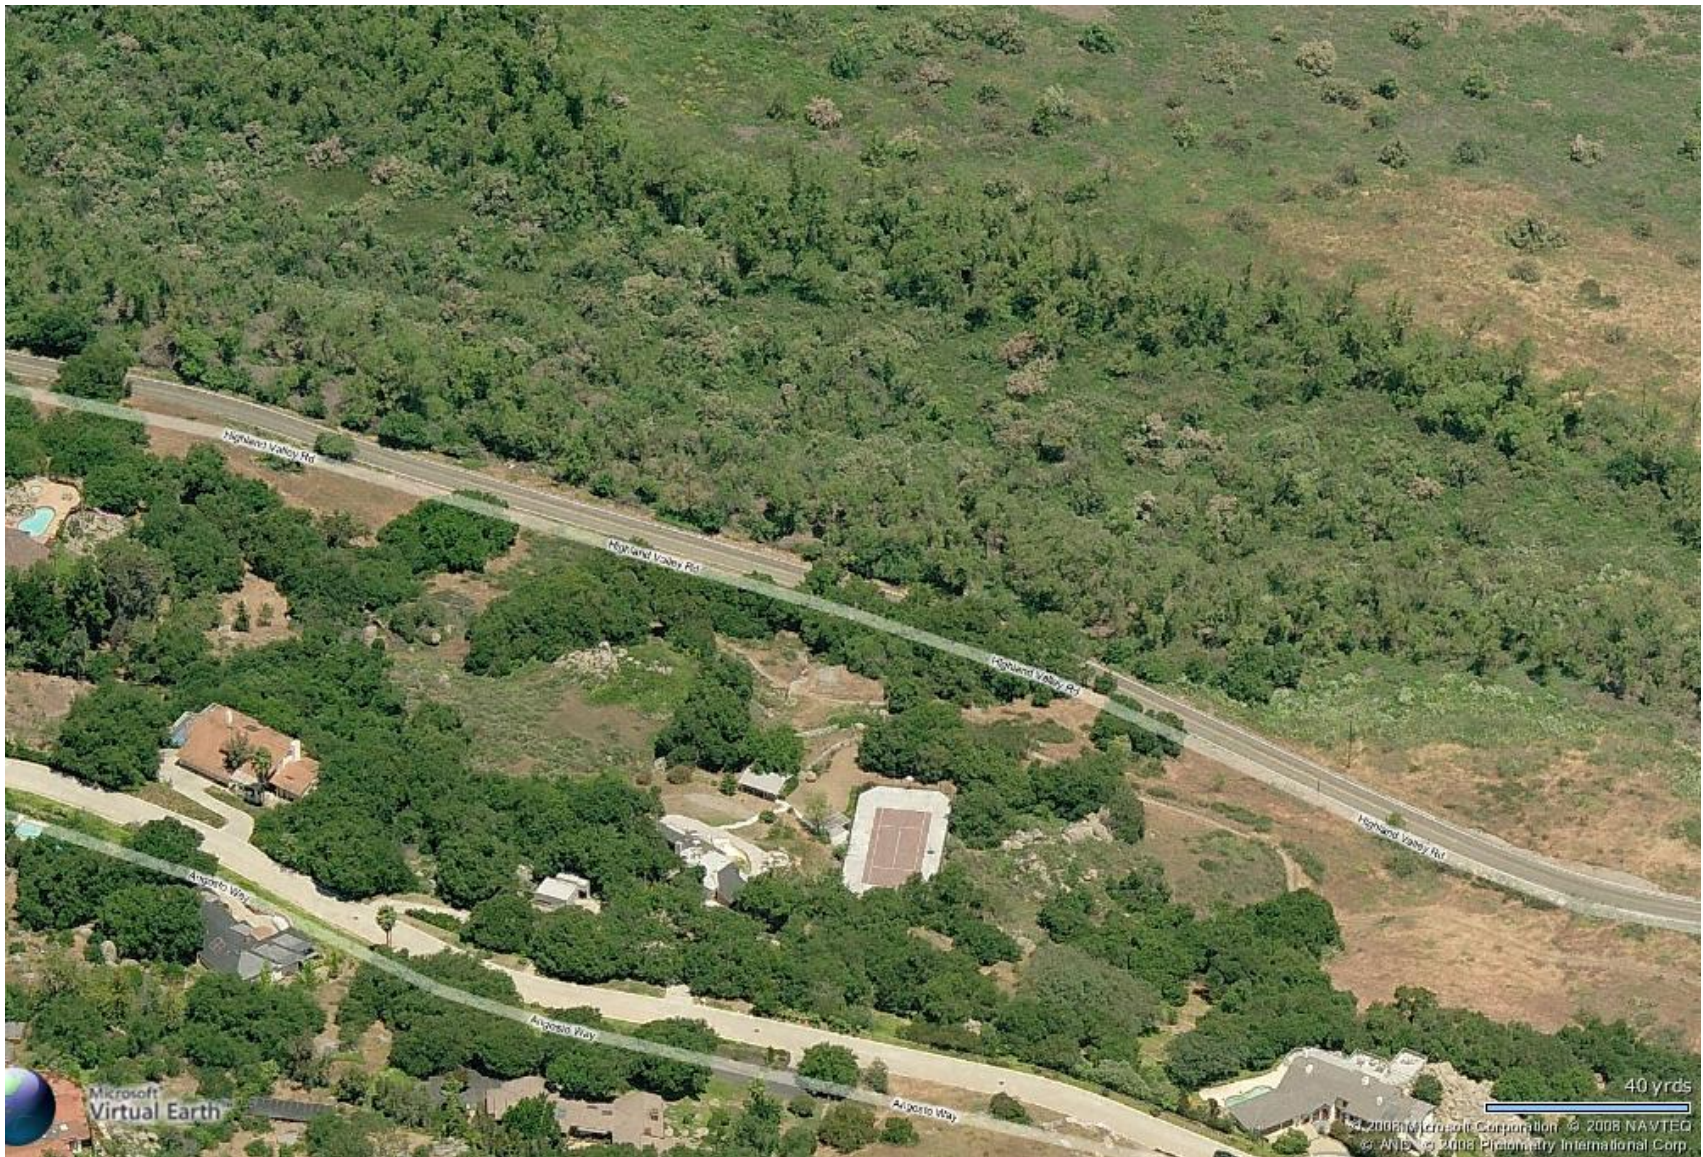
Figure 12: Angosto Way before October 22nd, 2007 (circa 2005)

The CALFIRE Witch Incident Fuel Map¹⁶ contains information on the Witch fire perimeter and wildland fuel type. Thirteen different fuel types were involved within the perimeter of the Witch Fire. The Highland Valley is covered primarily by Barren/Rock/Other (Fuel Model 99), with Brush (Fuel Model 5) on the western side and Agricultural Lands (Fuel Model 97) on the eastern side. The mount occupied by the Trails is surrounded by Hardwood/Longpole Pine (Fuel Model 8) to the north and west. A small amount of Brush (Fuel Model 5) can also be found on the western side of the mount and in the main ravine/chute on the northern side. The eastern side is primarily Brush, with a couple of patches of Grass (Fuel Model 1). At the base of Sycamore Creek, there is Barren/Rock/Other (Fuel Model 99) surrounding the Creek. Figures 5 through 11 show the inhomogeneities in wildland fuel on the slopes surrounding The Trails before the Witch and Guejito fires. Wildland fuels surrounding The Trails vary in type as well as density. Figures 12 and 13 show Angosto Way, which borders the northern edge of The Trails, before

and after the fires. The extent of damage to the canopy on the northern side of Highland Valley road is clearly evident as is the lack of canopy damage up slope, near the structures. Just before the fires reached The Trails, dead fuel moisture for 1 hour fuels is estimated at less than 10 %.

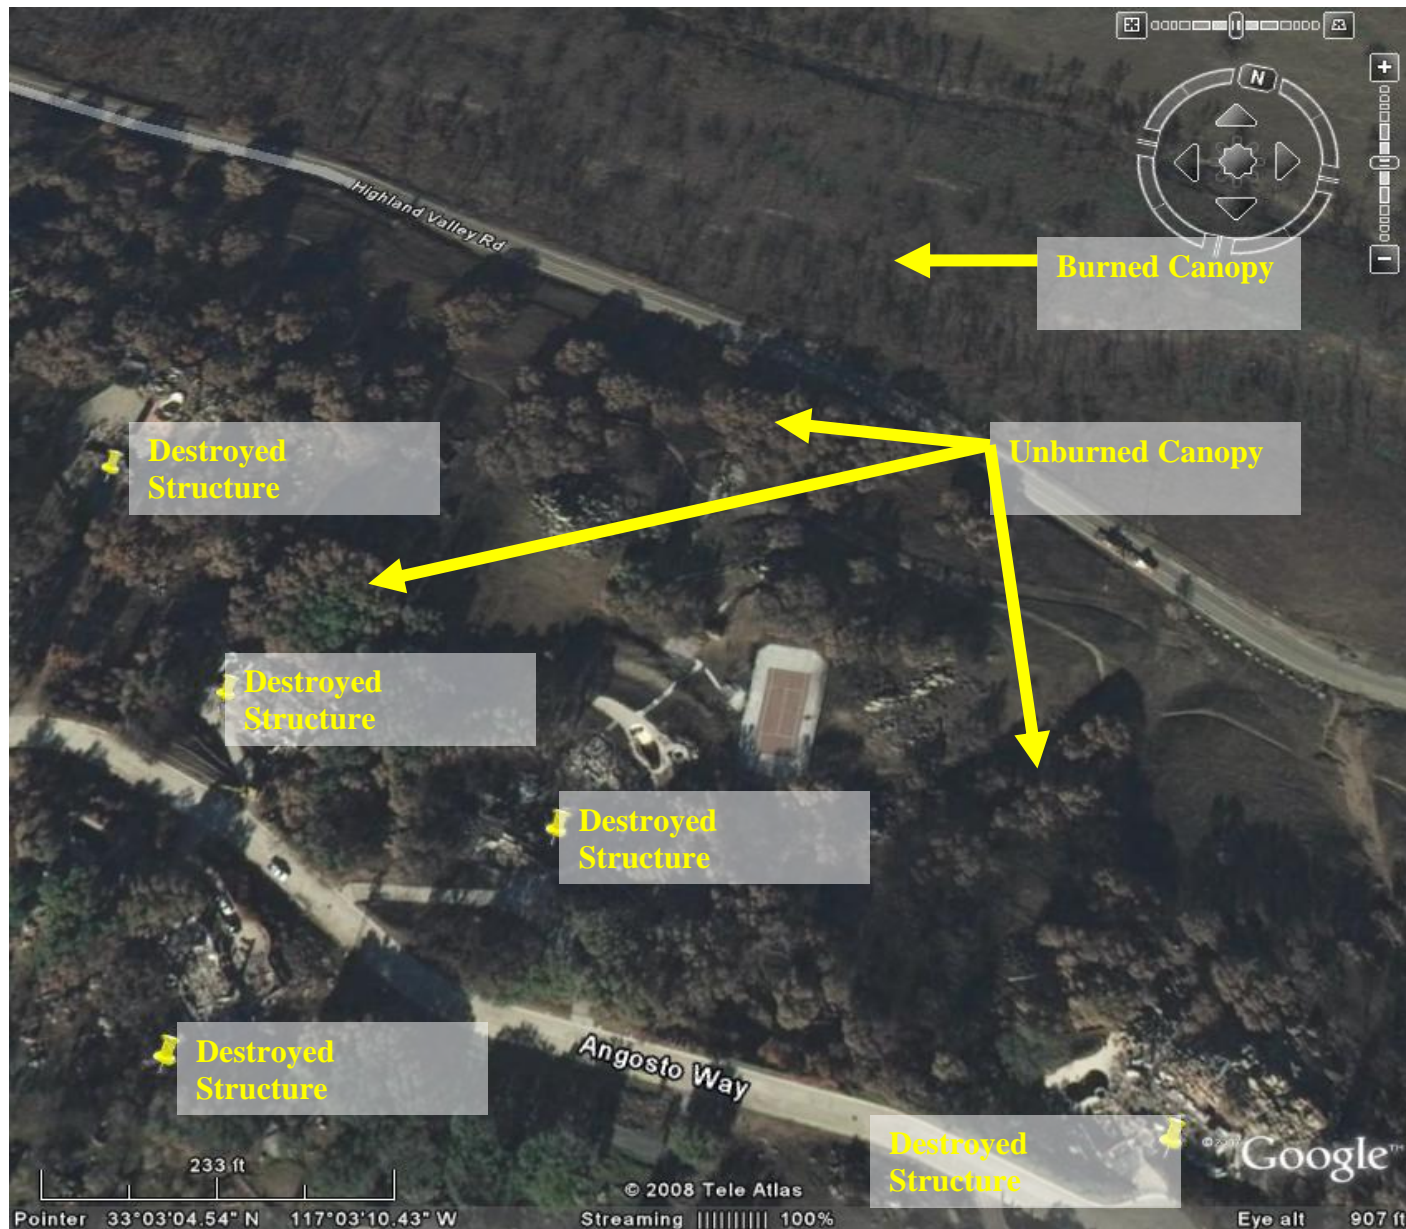
Figure 13: Angosto Way after October 22nd 2007

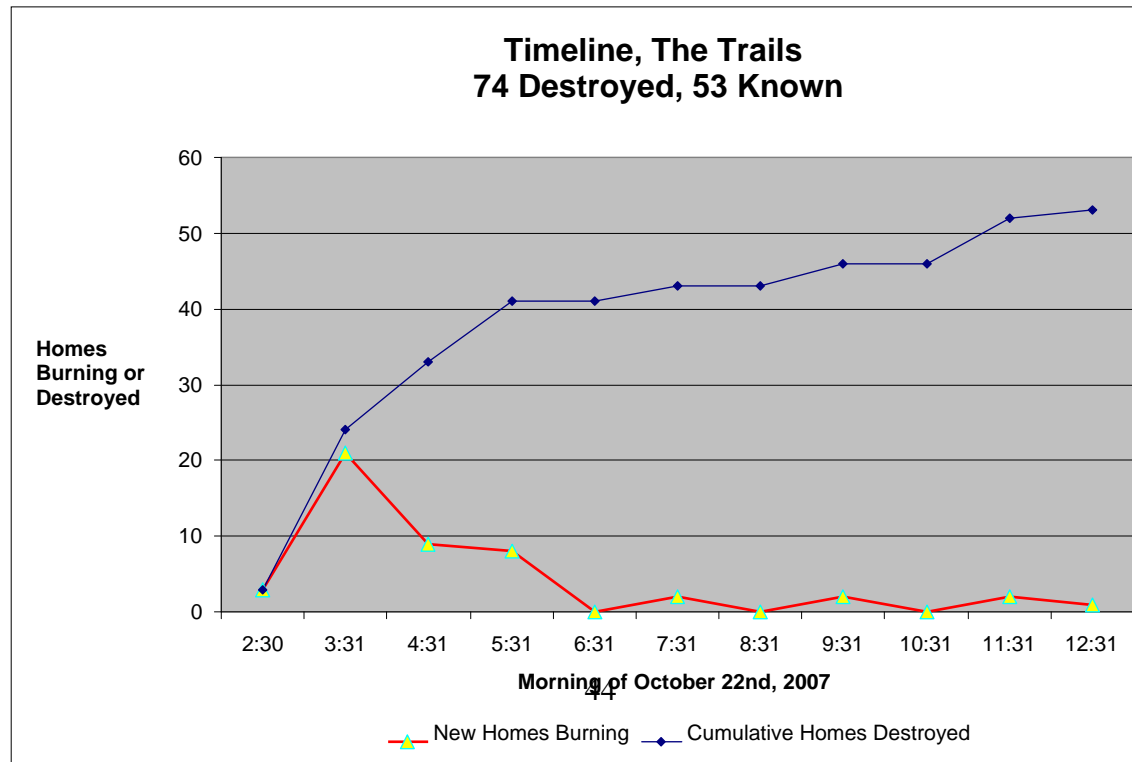
Figure 16: Timeline of Structures Burning in The Trails

Time window	2:30	3:31	4:31	5:31	6:31	7:31	8:31	9:31	10:31	11:31	12:31	Total
Ignited- some flames visible	3	11	7	2				1		2	0	
Fully involved	0	10	2	4		2			0		1	
Almost completely destroyed	0	0	0	2				1	0		0	
New burning	3	21	9	8	0	2	0	2	0	2	1	
No longer burning*	0	0	0	0	0			1	0	4		
Total	3	21	9	8	0	2	0	3	0	6	1	
Cumulative Total	3	24	33	41	41	43	43	46	46	52	53	53
Partial data*	2	7	3	3								15
Unknown												6
Grand Total												74

Burning occurred after listed time

2:30 – 3:55

In the following time reconstruction for destroyed structures, burning structures were reported along with their degree of burning, when the observation was made (Figure 16). In that respect, structures that are fully involved during a time interval and binned in one time step could possibly have ignited during the previous time interval. There is therefore potentially a significant temporal uncertainty associated with the actual ignition times of the structures. Even though smoldering could have been present for hours before the flaming occurred, it is estimated that initiation of flaming combustion can be estimated to within one hour. An attempt is made to estimate structure ignition times and total number of homes burning during each time interval. This is reported later in this section. Structure burning observations are documented in Figure 17.

Table 3 lists the breakdown of destroyed structures as a function of time. The category, “No longer burning” refers to structures that were already destroyed at the time of the first observation. The category “Partial data” refers to structures where observations were made prior to structure ignition, i.e.: subsequently destroyed home was not burning at the time of observation. The data in the table shows that new structure burning observations peak at 22 structures / hour between 3:30 to 4:30 am. The fire spread very rapidly within the community igniting over 50 % (41/74) of the destroyed structures within three hours after the first reported ignition. After 6:30 am, the number of new structure ignitions dramatically tapers off from eight, to one or two per hour. An expanded timeline table can be found in Figure 16.

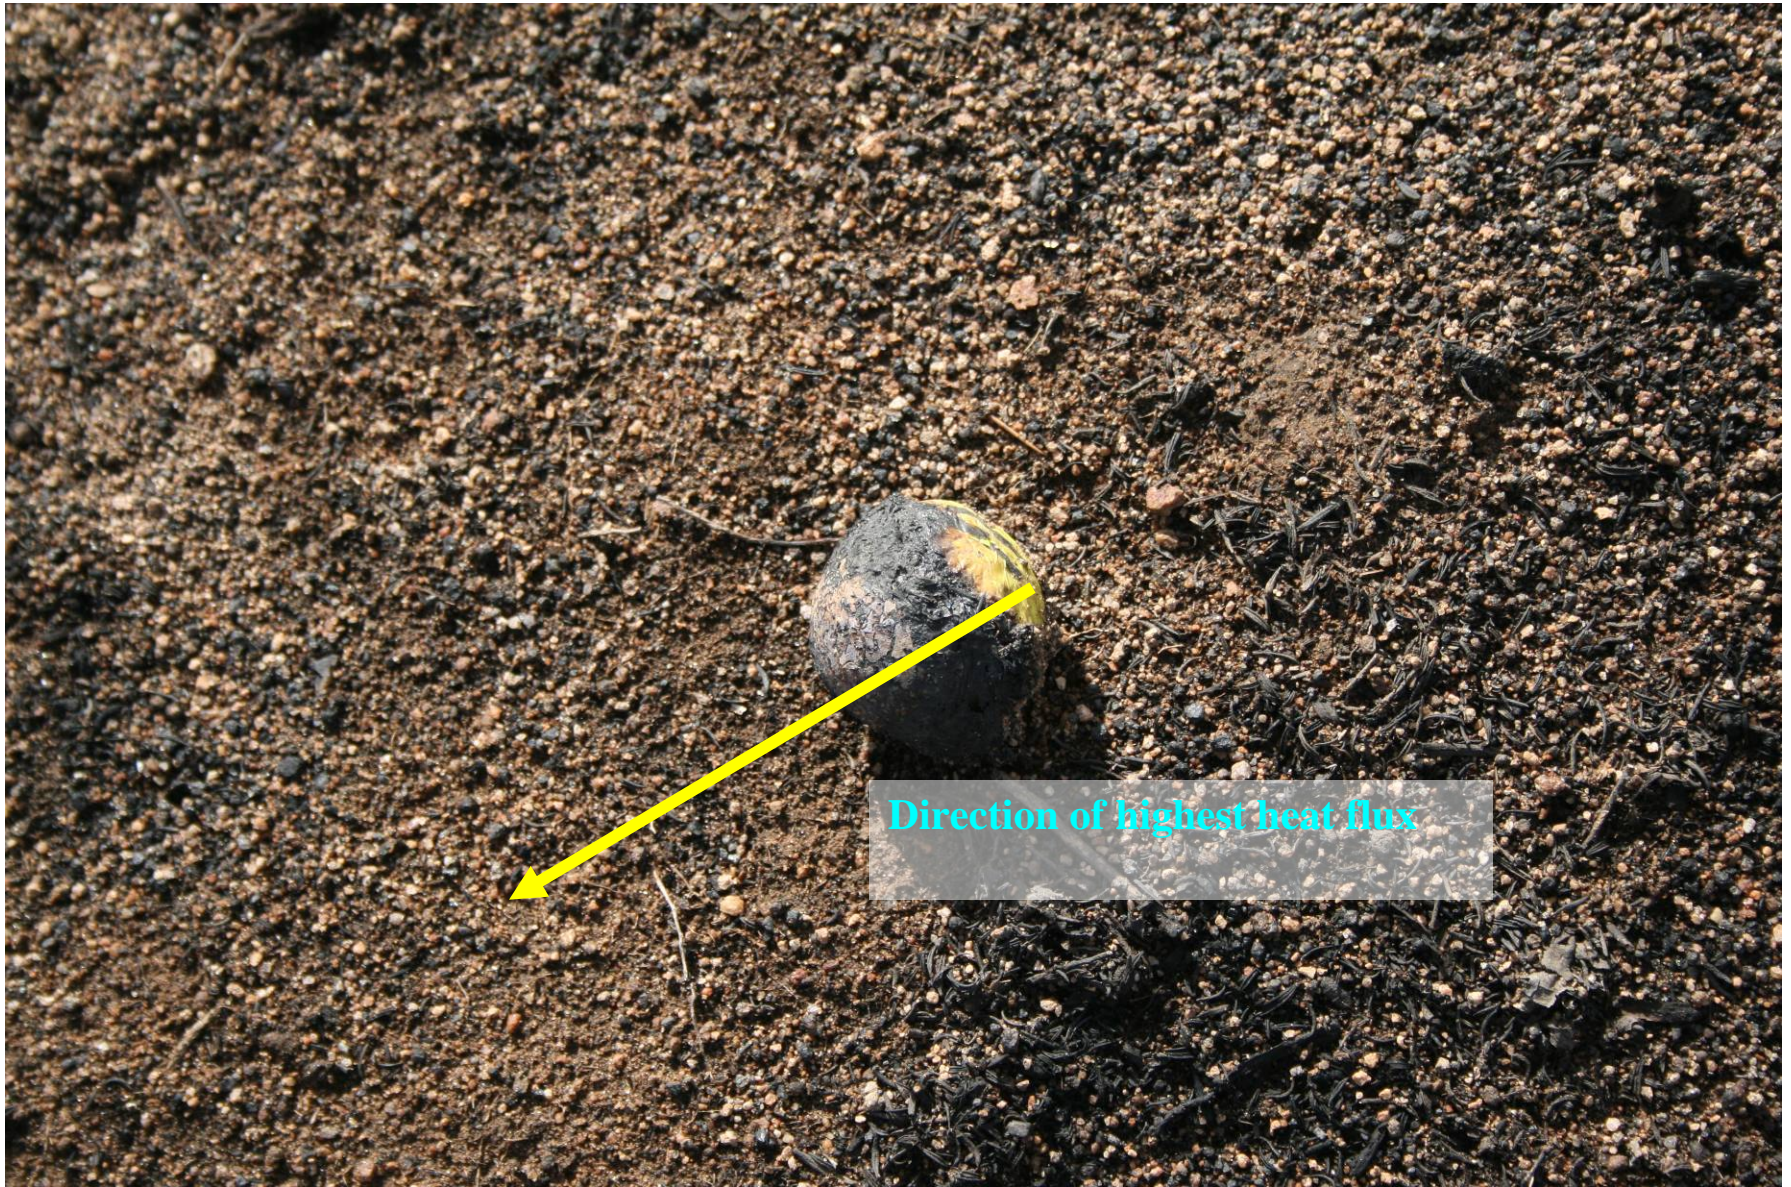
Figure 19: Golf Ball Providing Direction of Highest Heat Flux

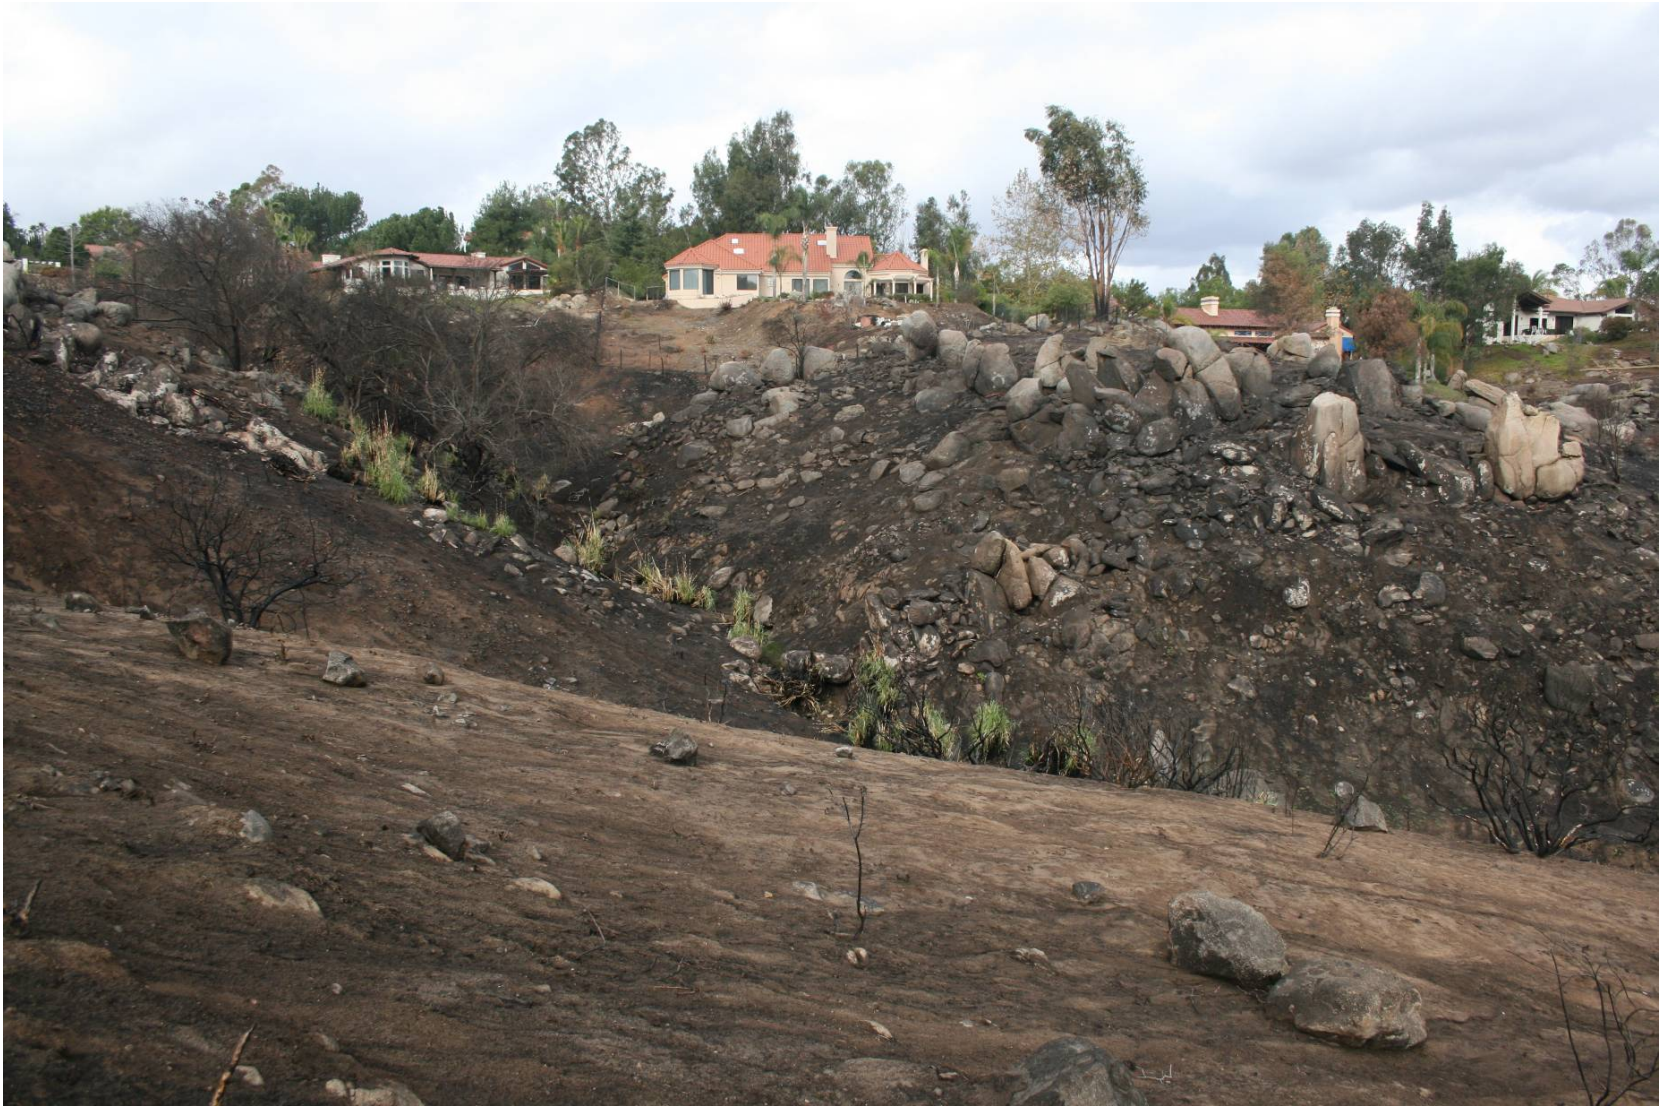
Figure 21: Rock Outcrop Acting as a Fire Break

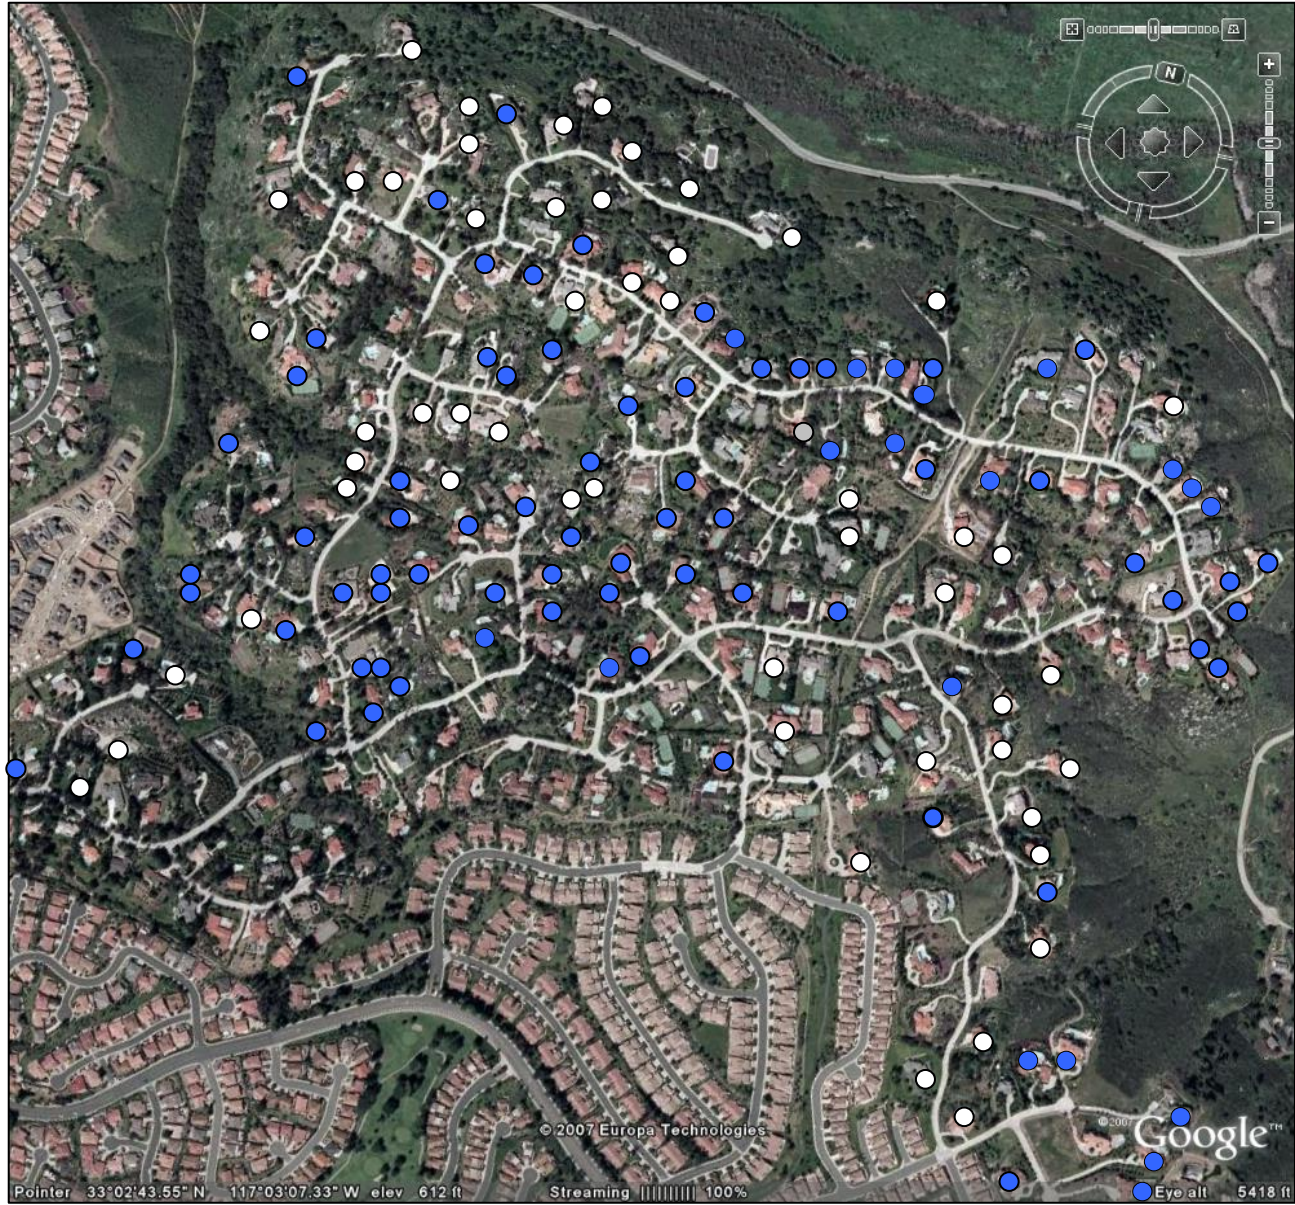
● (85) Defensive actions taken, including on 21 destroyed homes

○ (54) Destroyed home – unknown actions

Figure 22: The Trails Defensive Actions

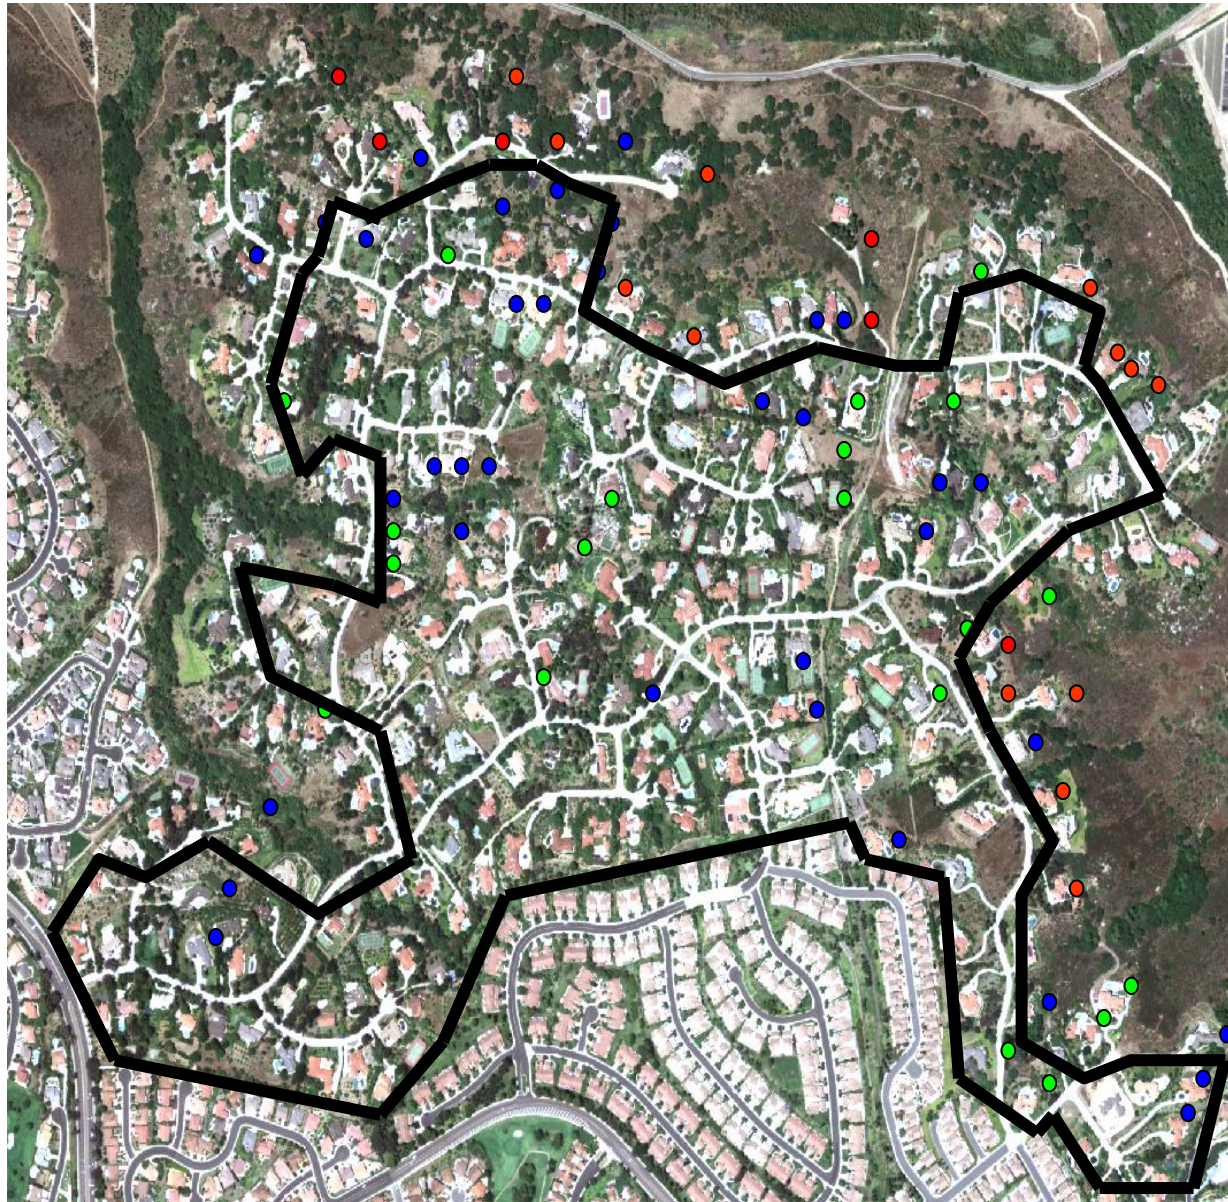
- A – Uninterrupted fire to structure
- B - Fire spotting
- C – Structure ignition from Embers

Figure 25: The Trails - Ignition categories of destroyed structures and perimeter/interior outline

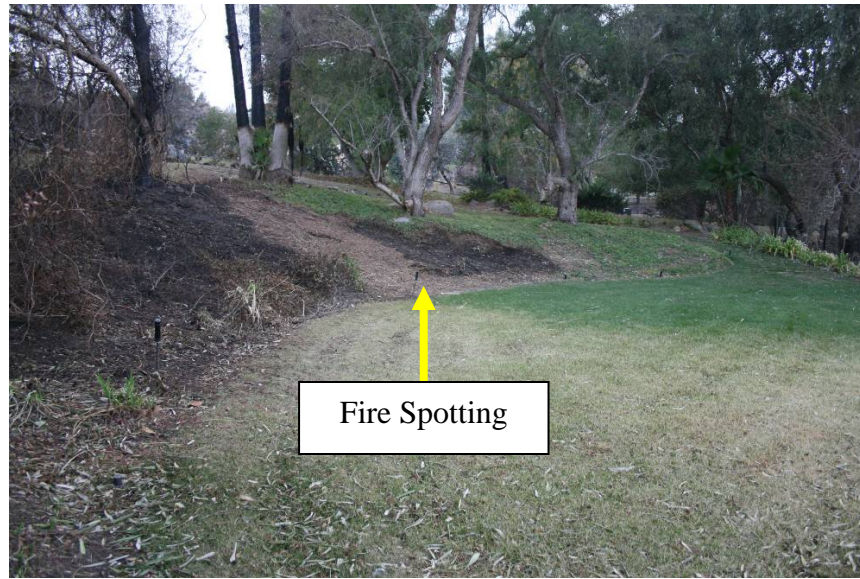
Figure 27: Structure Ignition Category B

Fire spotted to vegetation next to structure and possibly onto structure

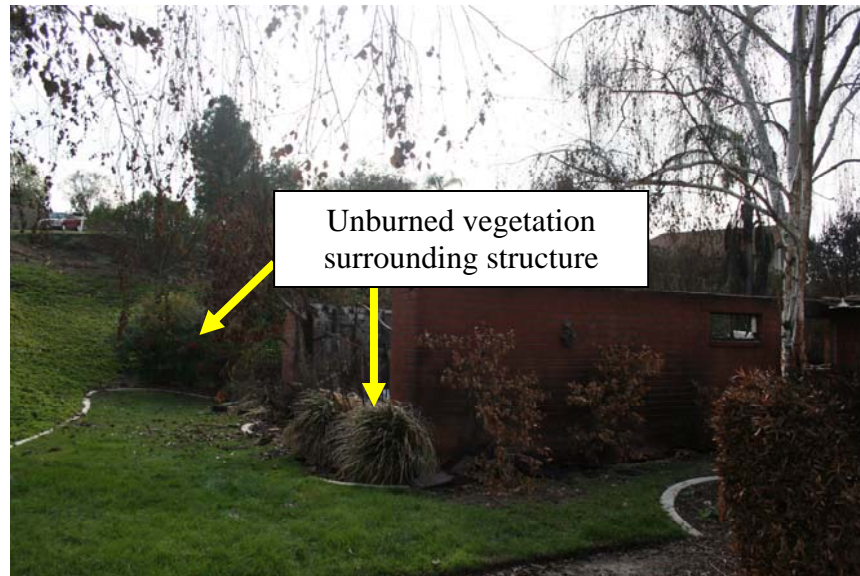
Figure 28: Structure Ignition Category C
