HISTORIC PRESERVATION COMMISSION STAFF REPORT

TITLE: Certificate of Appropriateness COFA2019-0001
HL-10/MA-56
311 West Foothill Boulevard

REQUEST: Review of proposed remodel of hotel guestrooms windows.

Aztec Hotel Windows Restoration and Replacement

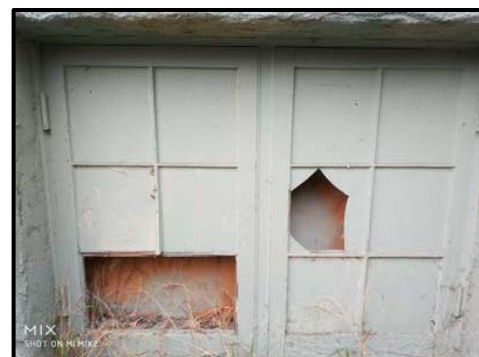
Figure 1 – Last Remaining Original Wood Window

On January 8, 2019, a wood window sample was submitted for review. At the second meeting of the Aztec Hotel Subcommittee on January 16, 2019, the subcommittee members compared the window sample to pictures of the last existing wood window on the building's north elevation, as well as to the architectural window details included in HSR. At the end of the meeting, the subcommittee concluded that they were very pleased with the proposed wood material, but indicated that decorative details, specifically the size and shape of the window mullions and muntins needed further design refinement.

Two additional meetings were held with the Subcommittee at the Aztec Hotel. On January 30, 2019, the subcommittee reviewed a second wood window sample and completed a side-by-side comparison with the last remaining wood window at the hotel. Although the second window was closer to the original window in styling, the Subcommittee determined that the frame, mullion, and muntin dimensions were still not appropriately matching. A final wood window sample was presented to the Subcommittee on February 11, 2019, and this window received unanimous approval. To finalize the window replacement approval process, the property owner submitted a Certificate of Appropriateness application on February 21, 2019.

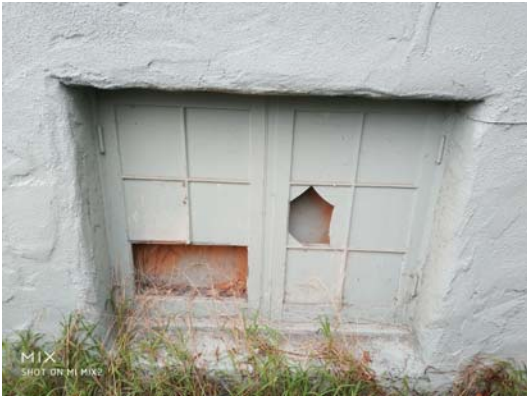
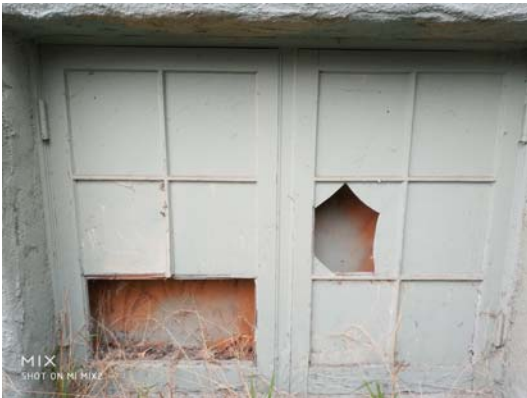
Image 01 - Basement Window

We were able to observe an original set of windows. This is the basement window located on the North side of the hotel. The window is made of wooden frame of 1-3/4" thickness on both side and 3" on the bottom with six independent single pane glass divided by thin mullions or grids.

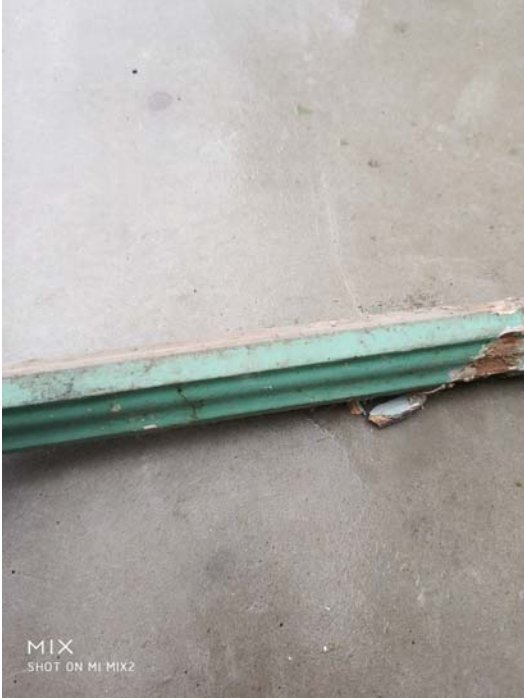
Image 03 - Inside View of Mullion (Grid)

The thin mullion or grid is made of 7/8" wooden moldings inside and window glaze putty on the outside, that is holding the windows to the frame, which is typical for a 1920's window structure. The windows open on the side with latches on the center. The latches hooks from the center window post or mullion. The center mullion is a 3" x 2" solid wood running from top to bottom of the window frame with indented pattern on both inside and outside. There are 2 hinges for each window. These are 5 segments level hinges a typical hardware of the '20's that is retained up to these days.

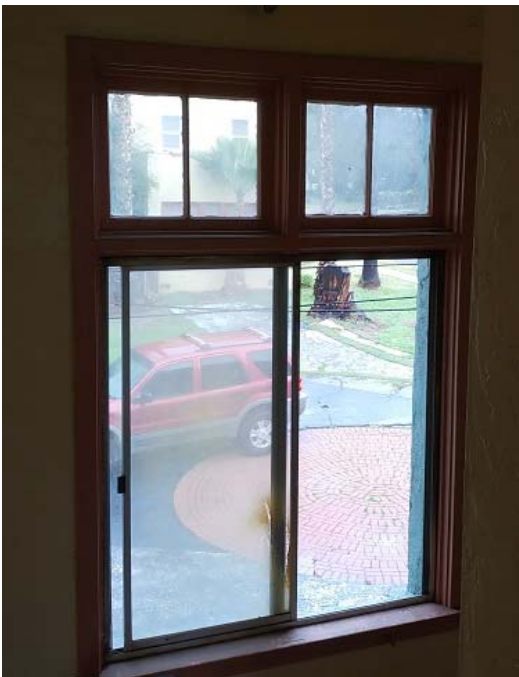
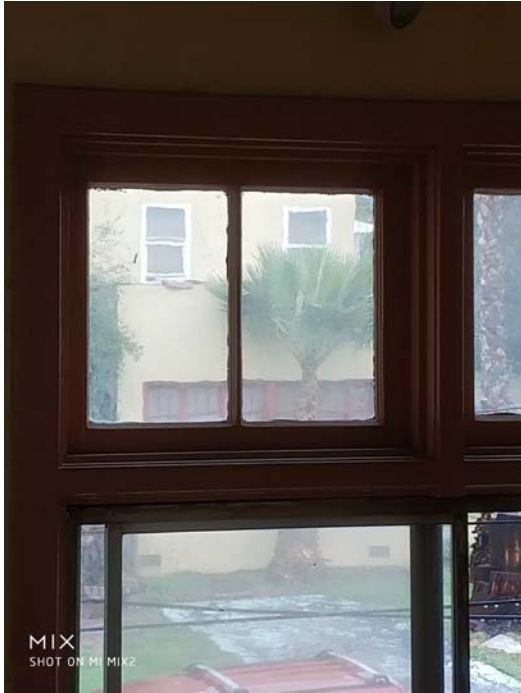
Image 03 - Stairwell Combination Window

Going to the stairwell window. The only added components that differs from the basement window are the 2 picture windows with thin mullion on top of the main windows. These are called Combination Windows in this case it consist of twin vertical swing out windows and top picture windows with grids. We noticed that the center post was deliberately removed to fit the contiguous replacement aluminum window frame. Whereby subjecting the top part of the window to less support. See bottom picture of the description.

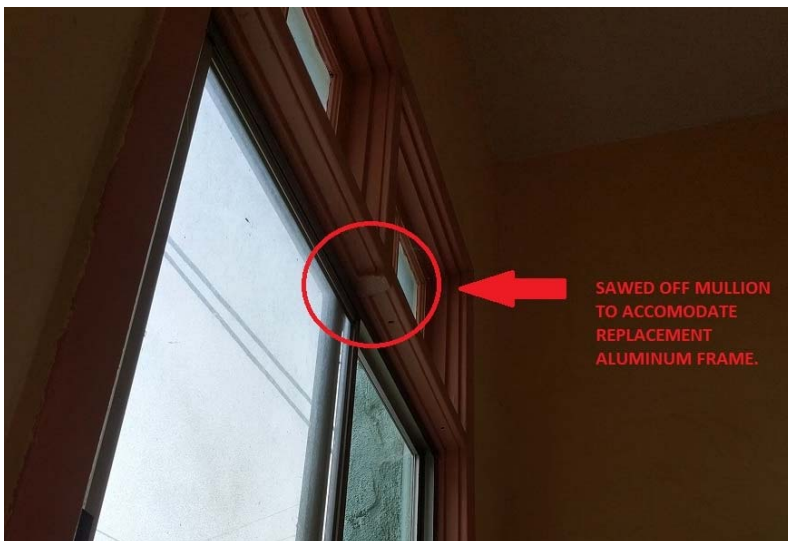
Image 05 - Removed Post

The removal of the center post could put into question the integrity of the window frame. Especially on wide windows, which needs center support to prevent windows from opening properly or sagging from the top frame.

In some case it might compromise the building structure but normally windows is not a integral support of the building so that is not a major concern here. However this has to do with the original design and framework of the hotel. Thus there is the need to reinstall the center post on all window frames that the original design requires it.

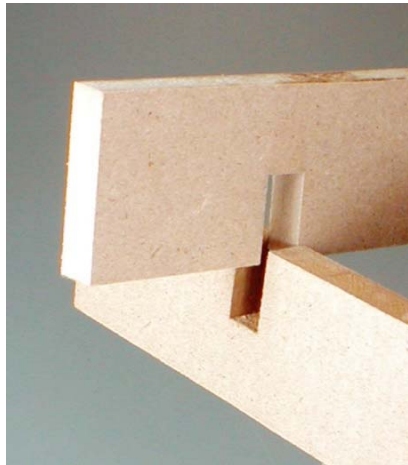
Image 06 - Notches on Sub-frames.

In a wooden window structure the grids are considered the weakest link in a window. Whereby we will be using notched sub-frames for each window to strengthen the carry the weight of each individual set of double pane glass and a molding one either side to hold the glass in place. Each molding and spacer are applied with silicone sealant to prevent condensation and moisture seepage.

To improve overall window strength, notched sub-frames and moldings on both sides of the window will hold each set of glass in place. The moldings and spacers will be secured using a silicone sealant to prevent condensation and moisture seepage. Lastly, 1920-style window handles and latches are proposed to further enhance the window design from the building's interior. This improvement is considered voluntary since the Certificate of Appropriateness review is limited to the building's exterior.

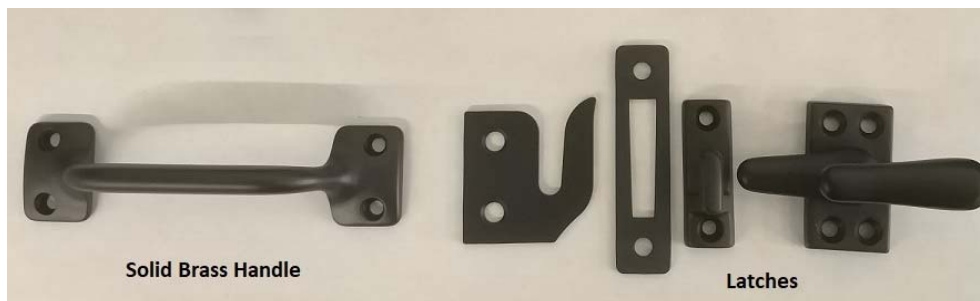
Image 05 - Hardware

It's imperative that all hardware has to be in consistent with the era. We have to step back to see if the hardware not only looks right but also has the

capability to hold the wooden window with the new modern glass, which are a tad heavier.

We also need to consider if the windows are fixed or can be opened, because if they are open then we have to make sure that original wooden frame can handle the hinges, if not then we have to add the use of top and bottom hinges.

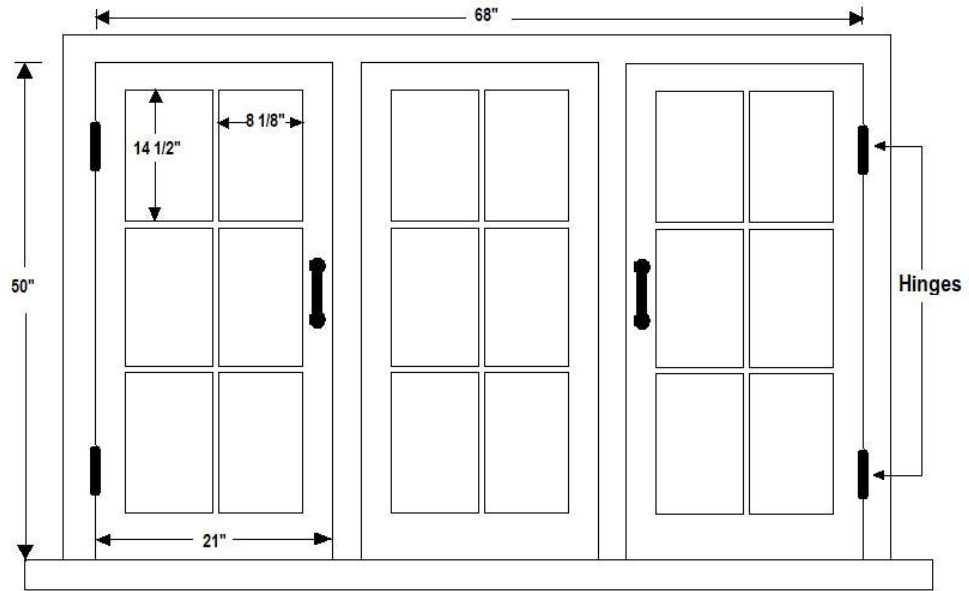
WINDOW TYPE A (22 UNITS) All Windows: Top & Sides = 2" / Bottom = 3" / Mullions = 3/4" / Surrounding Frames = 2-1/2"

- **Window Type "A"** – The proposal includes the replacement of twenty-two (22) Type "A" casement windows that consist of three sashes. The window functionality will match the original windows. The end sashes will open outward and the middle sash will be fixed. As shown on the corresponding elevation drawings, all of the windows visible from the Foothill Boulevard frontage will be of this window type.
- **Window Type "B"** – The proposal includes the replacement of seven (7) Type "B" casement windows that consist of two sashes. The window sashes will open outward, matching the functionality of the original windows. The corresponding elevation/floor plan drawings illustrate that this window type will primarily be installed within the existing apartment units on the South Magnolia Avenue building frontage.
