North Encinitas Historic District

Historic Context and Survey

Prepared by
Craig Jimenez, AICP
City of Monrovia
Department of Community Development

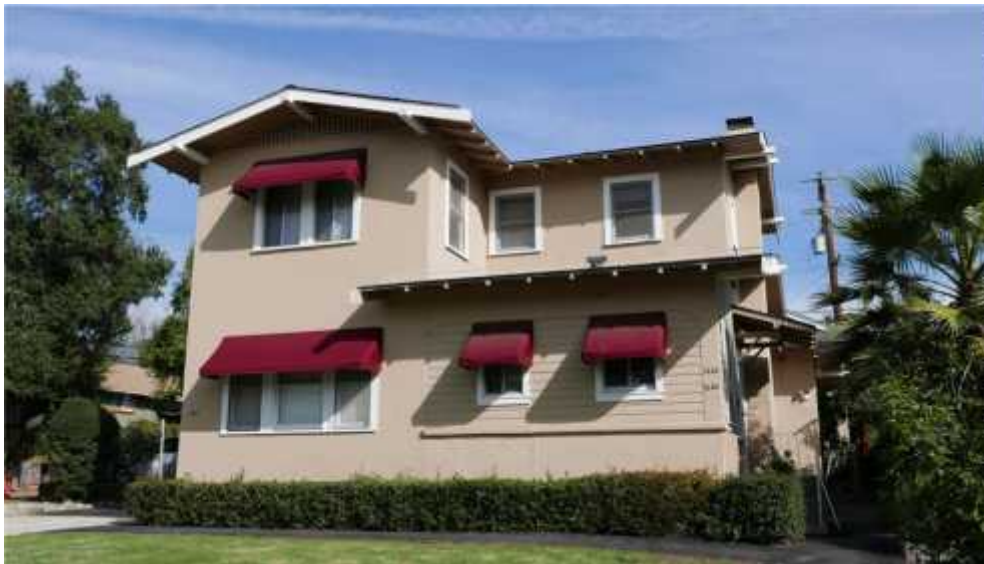
Facing east, 1/31/2017

This two-story gable-front-and-wing National style residence has a cross gable, low pitch roof and sided with non-original stucco. Originally built in 1888 as a single story structure, this house has been modified substantially over time. A second story was added after the turn of the century, original windows have been replaced and the original front porch has been completely enclosed and is sided with clapboard. Roof elements include overhanging eaves with exposed rafter tails, projecting beam-ends and a triangular lattice work vent in the front gable peak. A tripartite window of double-hung sash is located on the north end of the primary façade. These elements show Craftsman era influence, consistent with the building permit history. A low cobblestone wall retains the front yard. This house has been converted to a triplex. The original garage / barn have been converted to a duplex with an additional carport.

1888 – Built for A.L. Brown (Tax Assessor/Monrovia Planet)
 1907 – Sanborn Map indicate a single story structure
 1913 – Sanborn Map indicate a 1½ story structure
 2/9/1914 – permit issued to owner F.A. Slosson to construct garage and sleeping rooms
 6/19/1924 – permit issued to J.P. Daniel (contractor) to remodel house
 9/13/1924 – permit issued to J.P. Daniel (contractor) to remodel house (possible second story addition based on Sanborn)
 12/3/1936 – permit issued to J.P. Daniel (contractor) for reroof
 1955 – convert 2 apartments above garage
 2005 – foundation bolting/seismic

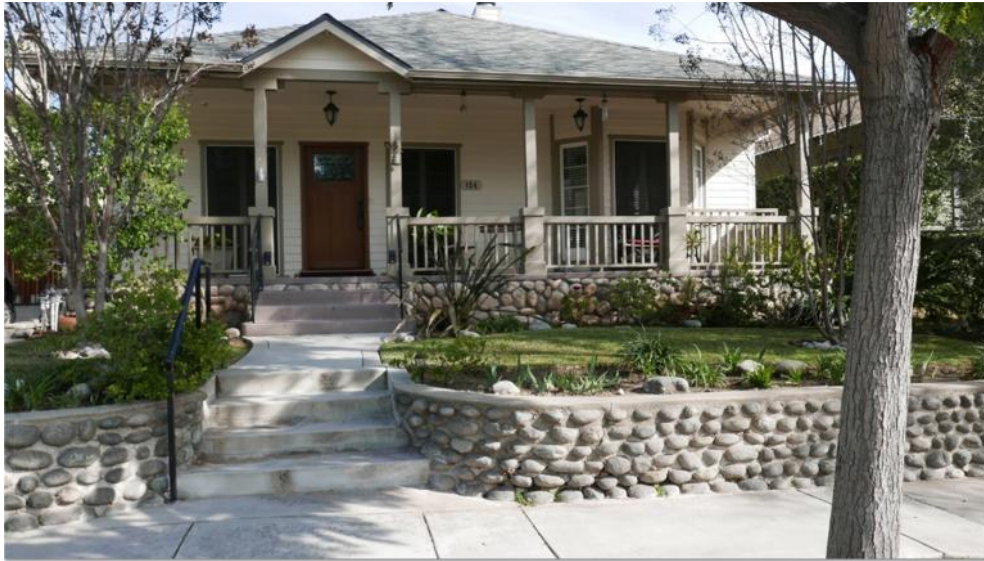
Facing east, 1/31/2017

This (1140 Sq. Ft.) single family vernacular cottage with a low pitch hipped roof broken by an off-center small gable entry to the full porch. The eaves are shallow with exposed rafters capped with a simple fascia. The porch is supported by six square wood piers at rail height and six 4x4 posts supporting roof. The railing consists of vertical wood slats. Two pair of ten light French doors flanks the wood front door. An additional pair of French doors with divided sidelights forms a bay on the south end of the porch. This portion of the house was added in 1998. At the time of the 1998 addition, the majority of the roof structure was replaced (possibly changing from a gable to a hipped roof) to accommodate the addition. The chimney on the south that punctuates the roof was likely on the exterior at one time. The porch ceiling is solid with narrow slats. River rock veneer was added along the foundation of the porch. The steps leading to the front door and the front door appear to be in their original location. The siding on house and the fireplace are wide lapped clapboard. A detached garage sits at the rear of the property which is accessed by a concrete driveway along the north property line. The roof is asphalted. This home has been significantly changed several times. The County Tax Assessor lists the construction date as 1908; however, the house appears on the 1907 Sanborn Map.

1912 – sewer permit issued to owner Pat Davies
 1921 – permit issued to owner Hiram Newman for an alteration (unspecified) to the house
 1933 – permit issued to Geo. Gorsyth for alterations (unspecified)
 1935 – permit issued to owner G.R. Forsyth for alterations
 1970 – permit issued to owner Mr. Smith to add 70 SF service porch to rear of house
 1983 – permit issued to owner John Molden for fire damage repair
 1983 – permit issued to owner John Molden to demolish garage, back bedroom and fireplace
 1988 – permit issued to owner John Molden for a 500 SF two-car garage
 1988 – permit issued to owner John Molden for earthquake repairs (chimney and foundation)
 1998 – permit issued to owner Brent Thompson for a 498 SF addition to the south elevation (Jim Kuhn, architect)

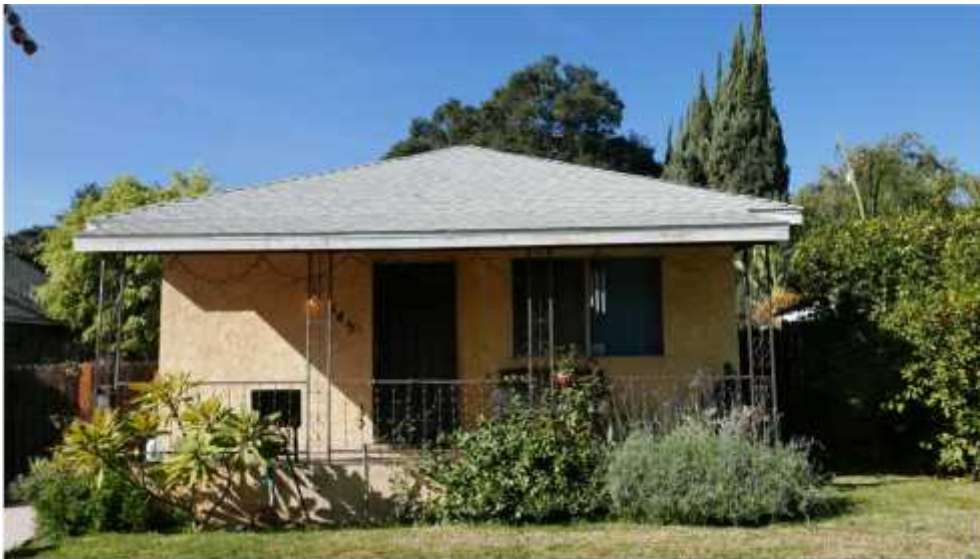
Facing west, 5/14/2015
P6 Date Constructed: 1910
Source: Tax Assessor
P7 Owner and Address:
Adrienne M Hatch Trust
441 La Mesa Drive
Portola Valley, CA 94028
P8 Recorded by:
City of Monrovia
Planning Division
415 South Ivy Avenue
Monrovia, CA 91016
P9 Date Recorded: 1/2017
P10 Survey Type: District

This mass-plan vernacular residence may have originally been classified as a Folk Victorian, however, with the exception of the pyramidal hipped roof appears to retain no original features. The full width shed roof porch is supported by decorative wrought iron and a wrought iron balustrade encloses the porch. The front elevation contains the front door and an aluminum sliding window. It is sided with a textured stucco finish. The wood frame structure rests on a raised foundation.
