# **HISTORIC PRESERVATION COMMISSION STAFF REPORT**

**APPLICATION:** DPR2017-04

**TITLE:** Determination of Historic Significance  
419 Lotone Street

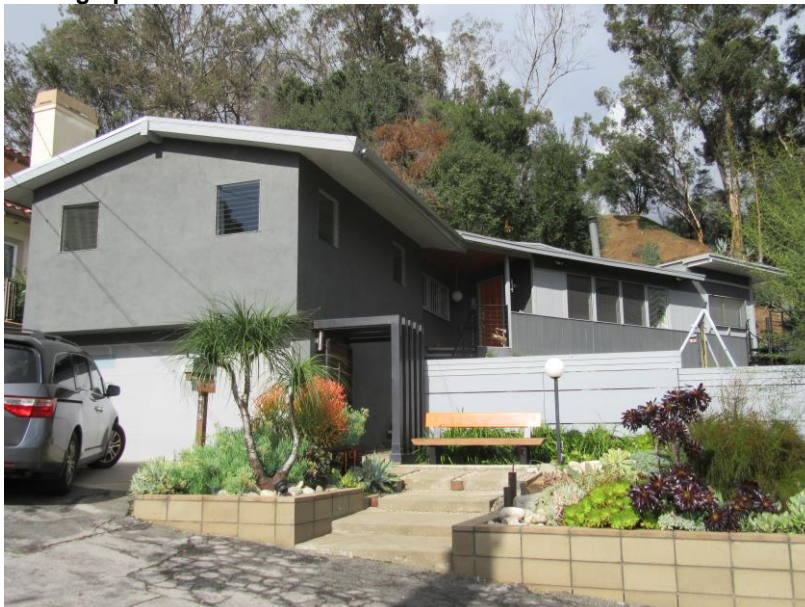
P5a Photograph

The subject building is a 1,578 square foot single-family home built in 1912, per LA County Assessor. The residence is a two-story structure. The main entrance is located on the second floor and is accessed by an exterior steel staircase with concrete steps. The floor plan contains three bedrooms and two bathrooms on the second floor and a two-car garage on the first floor. The plan is asymmetrical. At the rear of the property there is also a detached accessory structure.

A bedroom above an attached one-car garage was demolished from the front of the structure and replaced with a 756 square foot addition. The addition consisted of a two-car garage with a second floor bedroom above. The residence is clad in several materials, including stucco on the front (south) elevation, vertical wood panel siding on portions of east elevation, and vertical aluminum siding on the rear (north) elevation of the building. The stucco exterior covers the addition in 1965, as well as the ground level storage area located behind the two-car garage. The vertical wood panel siding encompasses a portion of the east elevation and it is not clear if the siding is an original physical feature. Along the west and north elevations, the exterior is clad in vertical aluminum that was installed in 1970. A combination of several window types exists throughout the building elevations, including louvered windows, wood casement windows, and aluminum sliding windows. The wood windows are primarily located by the front door, on the side (west) elevation, and on rear (north) elevation. The roof is comprised of three different low-pitched gable pieces that intersect into a shed roof at the rear of the structure.

Facade (view from south) January 2017
