R E V I T A L I Z A T I O N

M O N R O V I A

RESTORATION
RECONSTRUCTION
REHABILITATION

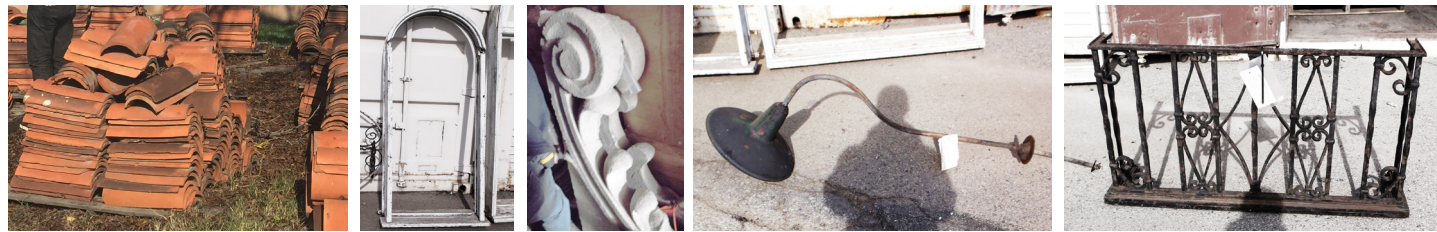
ENTRANCE DETAIL DIAGRAM _A

RESTORATION
reinstall salvaged historical elements
at original locations

RECONSTRUCTION
rebuild historical elements and
install at original locations

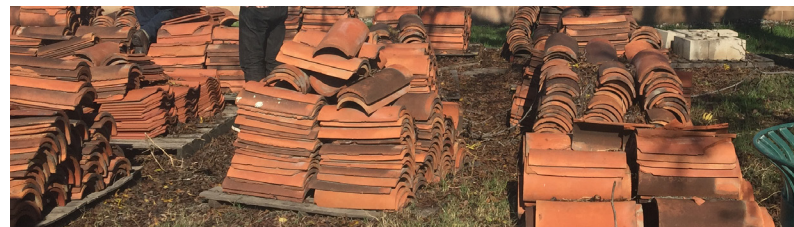
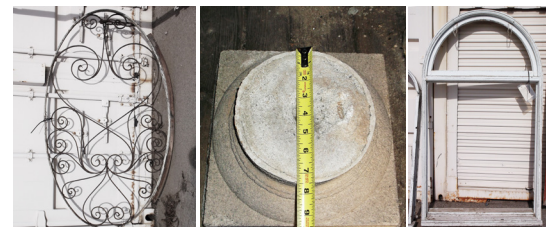
ENTRANCE DETAIL DIAGRAM _ B

RESTORATION
reinstall salvaged historical elements
at original locations

RECONSTRUCTION
rebuild historical elements and
install at original locations

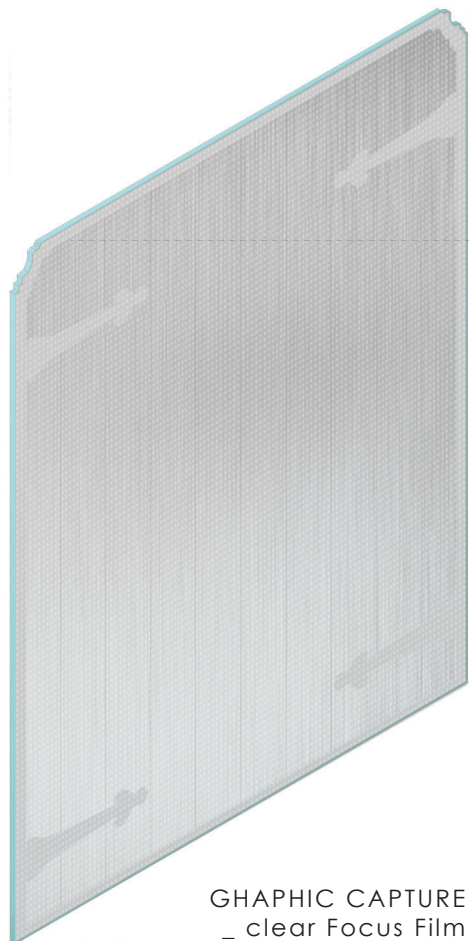
GHAPHIC CAPTURE
_ clear Focus Film

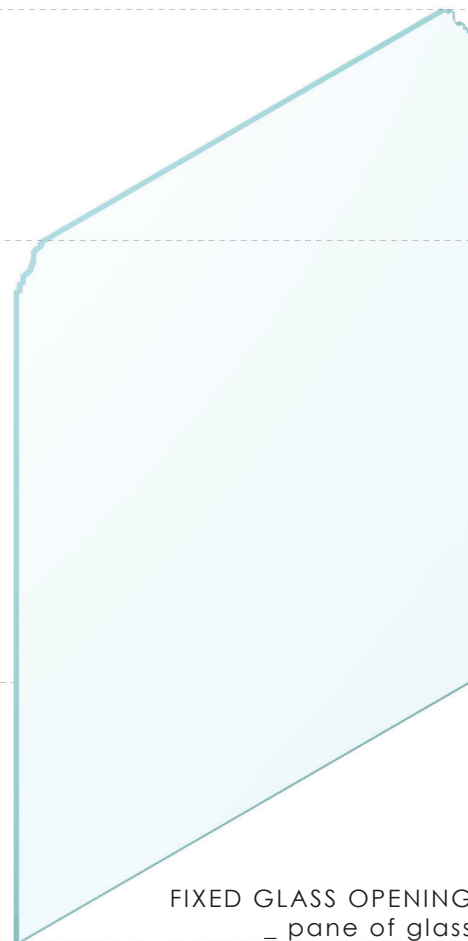
FIXED GLASS OPENING
_ pane of glass

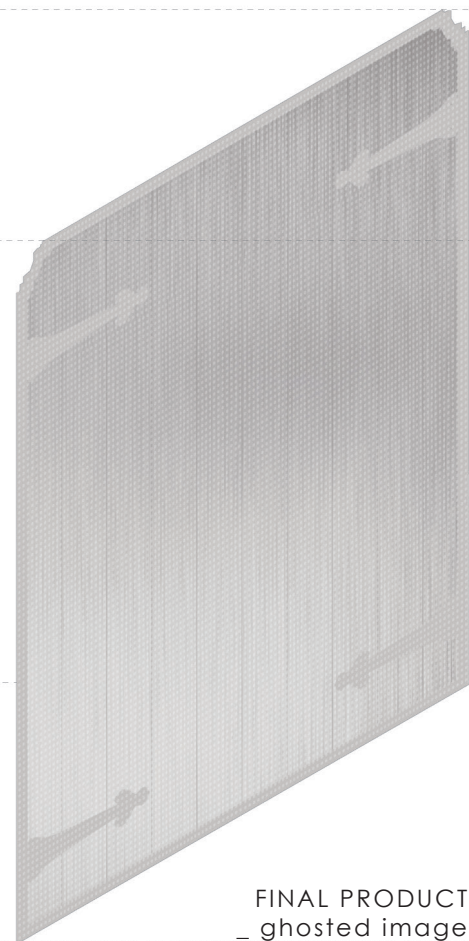
FINAL PRODUCT
_ ghosted image

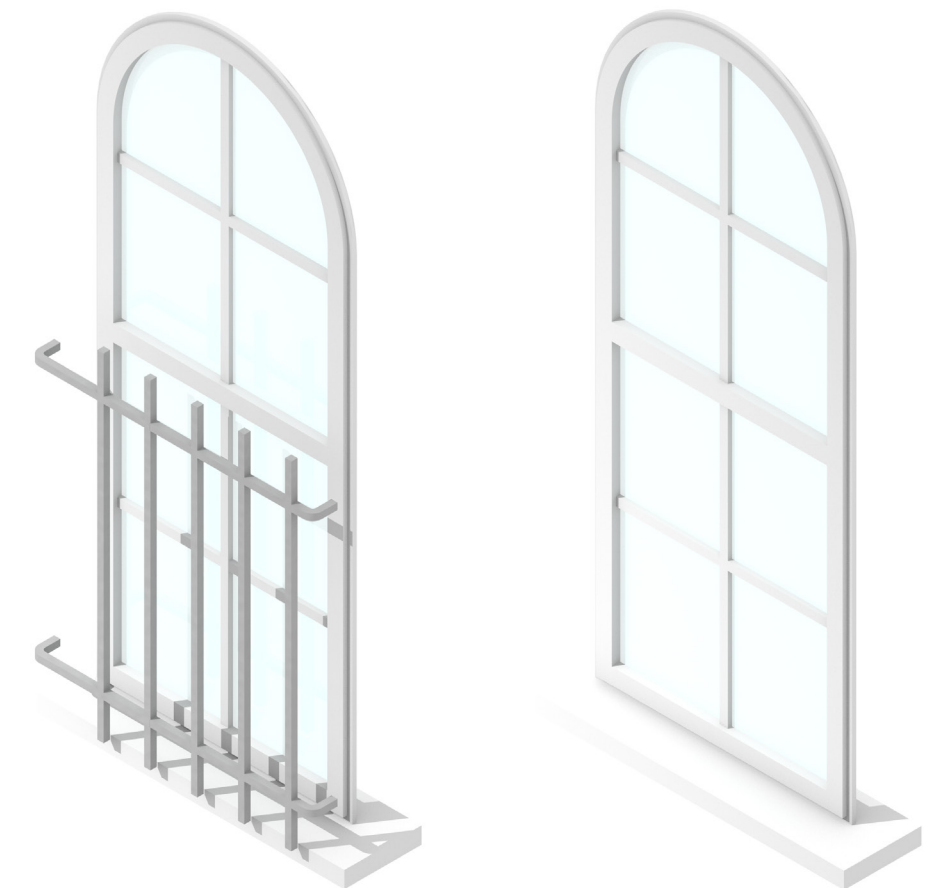
REMOVAL OF METAL BARS AT REPLICATED TRUE LIGHT DOUBLE PANE WINDOWS

Historic train depot windows are to be replicated utilizing wooden framed true divided light, double pane windows in order to provide a more energy efficient solution, provide additional acoustic insulation while maintaining the aesthetic integrity of the original aperture system.

The metal security bars at the windows are to be removed. It is unclear if these elements have accompanied the building from its inception, this security measure is not appealing to restaurant operators and thanks to the improvement in the area, security bars are no longer necessary.

EXISTING METAL SECURITY BARS TO BE REMOVED

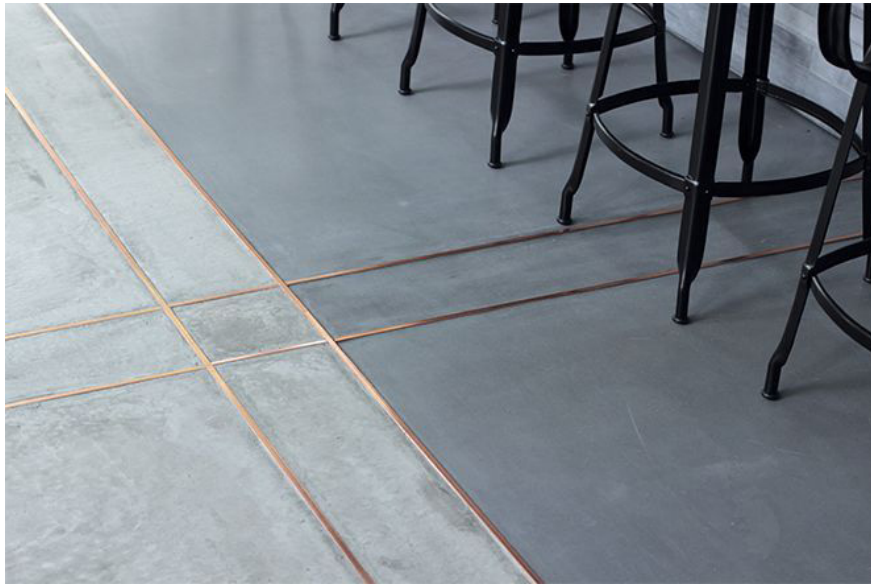
COPPER INLAY FLOORING

The Copper inlay provides not only an aesthetically pleasing and durable finish, but is intended to demarcate the size and shape of original historic elements. The copper inlay reveals the original location of the Monrovia Train Depot platform and partition walls.
