## **HISTORIC PRESERVATION COMMISSION STAFF REPORT**

**APPLICATION:** Demolition Review

**SUBJECT:** Demolition Review of Pre-1940's Residential Structure (continued)  
118 North Alta Vista Avenue

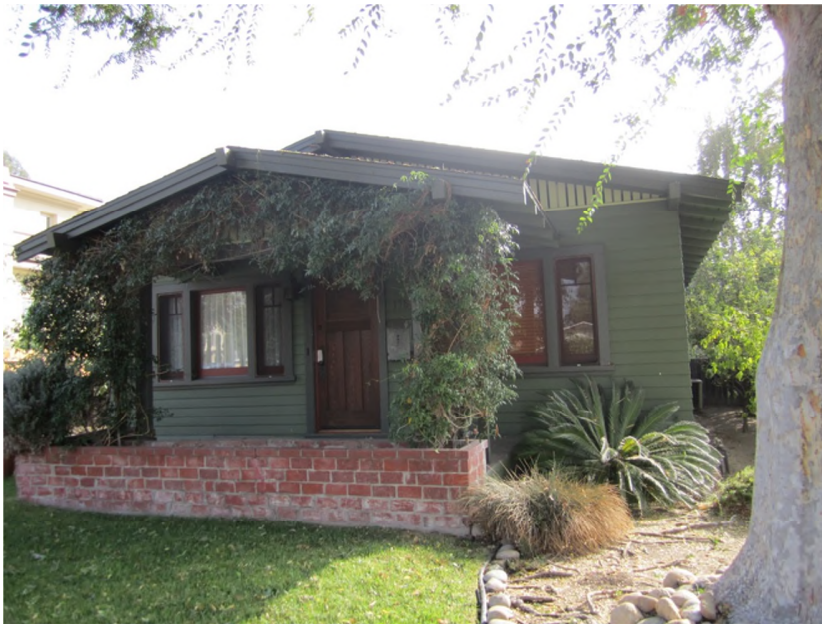
P5a Photograph

This one-story Craftsman bungalow is capped by a front-facing gable roof and clad in clapboard siding. Roof elements include overhanging eaves with exposed rafter ends and projecting roof beams that extend over the cornice. A partial front projecting gabled porch is located on the primary (west) elevation with a roof shape and detail echoing the vertical vent details of the main roof. It is supported by simple paired posts elevated on a low brick enclosing wall. Within the porch area is the front entrance and flanking tripartite picture windows with thick wood casing. The brick detail is continued on an exterior chimney covered with stucco below the roof.

P5b Description of Photo: Front,  
October 2014

Although this dwelling does not appear eligible for listing in the National Register, California Register, or for local designation, it is of local interest as a representative example of the early housing stock constructed in Monrovia during the first quarter of the 20<sup>th</sup> century, Therefore, this property appears eligible for special consideration in the local planning process.
