HISTORIC PRESERVATION COMMISSION STAFF REPORT

APPLICATION: Demolition Review

SUBJECT: Demolition Review of Pre-1940's Residential Structure
118 North Alta Vista Avenue

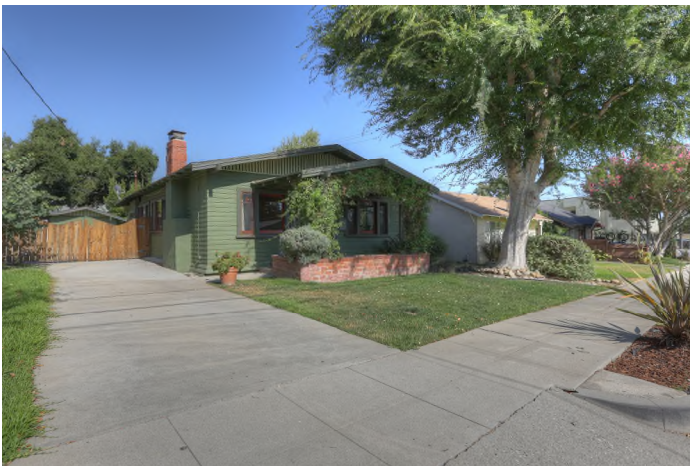
This one-story Craftsman bungalow is capped by a front-facing gable roof and clad in clapboard siding. Roof elements include overhanging eaves with exposed rafter ends and projecting roof beams that extend over the cornice. A partial front projecting gabled porch is located on the primary (west) elevation with a roof shape and detail echoing the vertical vent details of the main roof. It is supported by simple paired posts elevated on a low brick planter wall. Within the porch area is the front entrance and flanking tripartite picture windows with thick wood casing. The brick detail is continued on an exterior chimney covered with stucco below the roof.

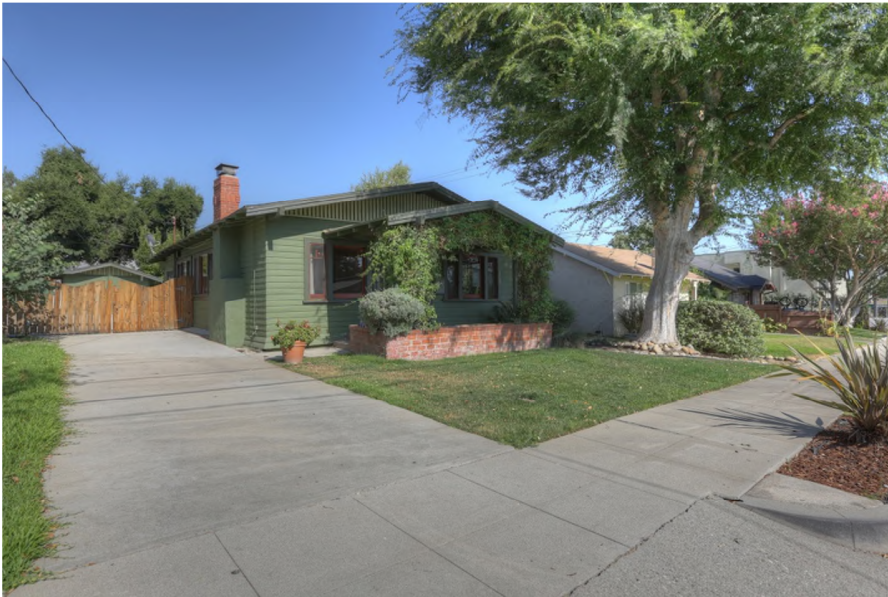
P5a Photograph

This one-story Craftsman bungalow is capped by a front-facing gable roof and clad in clapboard siding. Roof elements include overhanging eaves with exposed rafter ends and projecting roof beams that extend over the cornice. A partial front projecting gabled porch is located on the primary (west) elevation with a roof shape and detail echoing the vertical vent details of the main roof. It is supported by simple paired posts elevated on a low brick enclosing wall. Within the porch area is the front entrance and flanking tripartite picture windows with thick wood casing. The brick detail is continued on an exterior chimney covered with stucco below the roof.

P5b Description of Photo: Front,
October 2014
