HISTORIC PRESERVATION COMMISSION STAFF REPORT

APPLICATION: Demolition Review

SUBJECT: Demolition Review of Pre-1940's Residential Structure
1720 South Mayflower Avenue

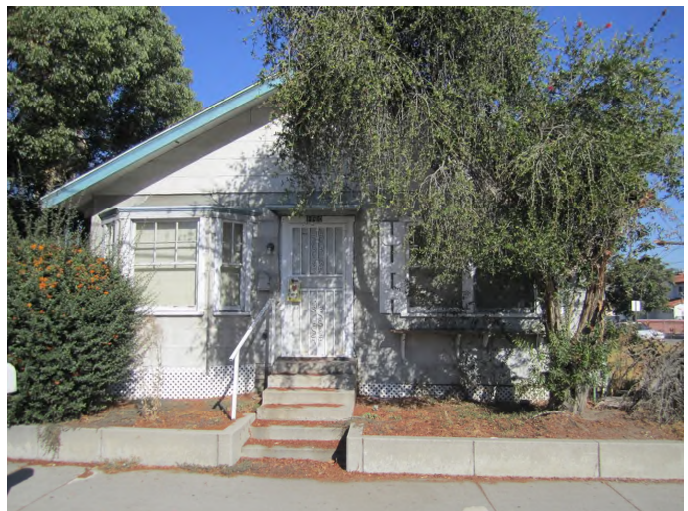
DISCUSSION: This single-family Craftsman bungalow is 1,026 square feet and has three bedrooms and one bathroom. It is made of wood-frame construction and sits on a raised foundation. It is capped by a high pitched front facing gable roof and features exposed rafter tails under the extended eaves. The one-story dwelling is clad in asbestos siding and features a centrally located entry with flanking tripartite windows in a projecting bay on one side and a pair of double hung windows on the other side.

Due to the addition of asbestos siding and the lack of architectural elements, Staff has assigned a California Historical Resources Status Code of 6Z. A 6Z means the home does not meet any of the criteria required for landmark designation.

Staff recommends that the Historic Preservation Commission find that the residence at 1720 South Mayflower Avenue is not eligible for landmark status and may be demolished. If the Commission concurs with this recommendation, then following the public meeting the following motion is appropriate:

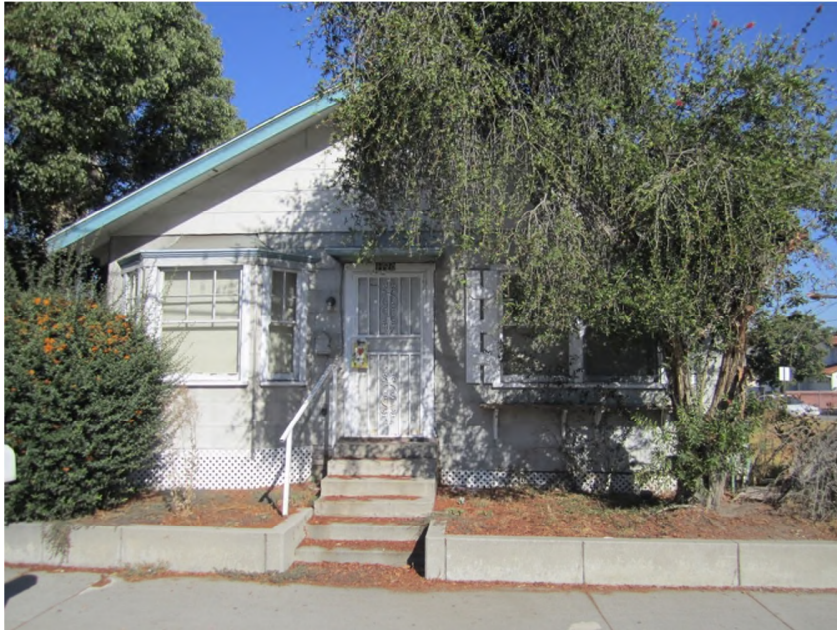
P5a Photograph

This single-family Craftsman bungalow is made of wood-frame construction and sits on a raised foundation. It is capped by a high pitched front facing gable roof and features exposed rafter tails under the extended eaves. The one-story dwelling is clad in asbestos siding and features a centrally located entry with flanking tripartite windows in a projecting bay on one side and a pair of double hung windows on the other side.

P5b Description of Photo: Front,
September 2014

This building appears ineligible for the National Register and the California Register. It also appears ineligible for local designation. Due to inappropriate alterations made to the property, it lacks sufficient physical integrity necessary for designation at any level.
