## **HISTORIC PRESERVATION COMMISSION STAFF REPORT**

**APPLICATION:** Demolition Review

**SUBJECT:** Demolition Review of Pre-1940's Residential Structure  
256 North Encinitas Avenue

Page 1 of 2 \*Resource Name or #: 256 North Encinitas Avenue

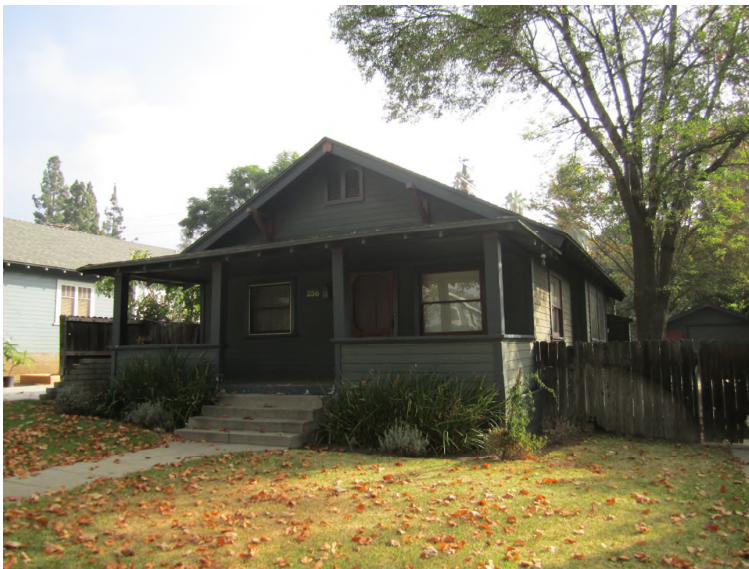
**DISCUSSION:** According to current Tax Assessor information, the existing 1,070 square foot single-story residence was built in 1921 and has two bedrooms and one bathroom. This one-story Craftsman bungalow is capped with a front-gabled roof and sheathed in clapboard siding with corner boards. Roof elements include overhanging eaves, exposed rafter tails, knee braces, and a pair of vertical slat vents in the gable face. The projecting, full-width front entrance porch is located on the primary (west) elevation. Four, square wood

posts atop clapboard-sided balustrades support the shallow hipped porch roof. Within the porch area is the paneled front entrance and flanking double-hung sash windows with plain surrounds. The wood-frame house rests on a raised foundation.

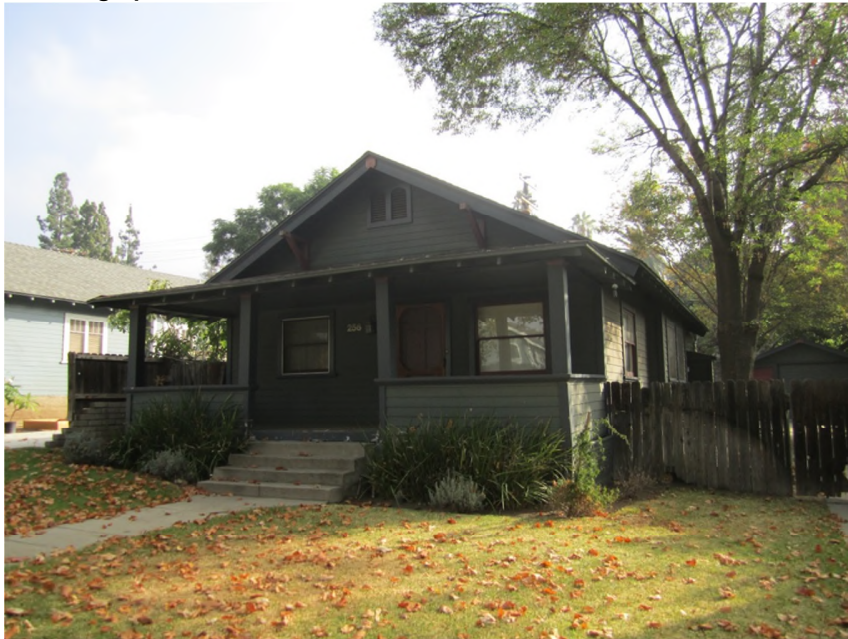
\*P4 Resources Present:  Building  Structure  Object  Site  District  Element of District  Other  
P5a Photograph

This one-story Craftsman bungalow is capped with a front-gabled roof and sheathed in clapboard siding with corner boards. Roof elements include overhanging eaves, exposed rafter tails, knee braces, and a pair of vertical slat vents in the gable face. The projecting, full-width front entrance porch is located on the primary (west) elevation. Four, square wood posts atop clapboard-sided balustrades support the shallow hipped porch roof. Within the porch area is the paneled front entrance and flanking double-hung sash windows with plain surrounds. The wood-frame house rests on a raised foundation.

P5b Description of Photo: Front,  
October 2014
