HISTORIC PRESERVATION COMMISSION STAFF REPORT

APPLICATION: Demolition Review

SUBJECT: Demolition Review of Pre-1940's Residential Structure
521 South Alta Vista Avenue

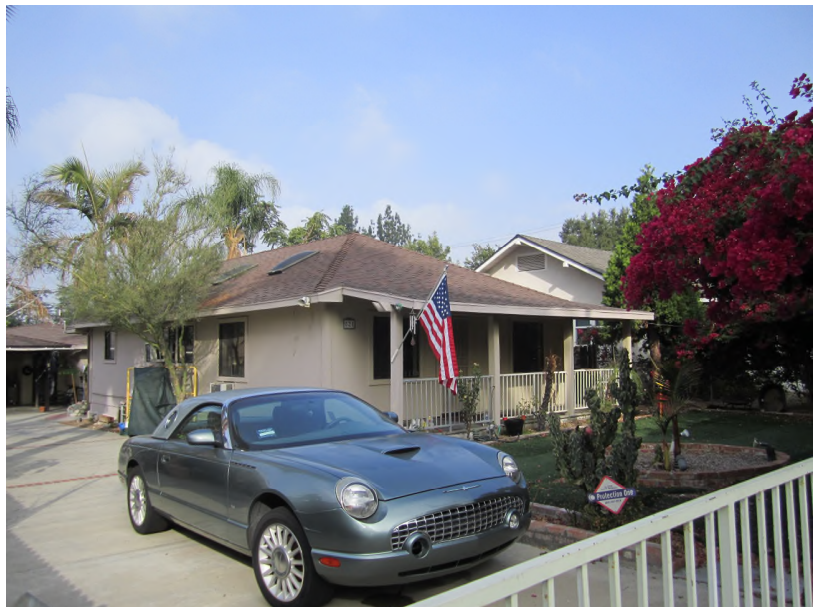
The one-story mass plan vernacular bungalow is capped by a pyramidal roof which has been altered to include flat oval sun lights. Roof elements include slightly overhanging eaves and a thick cornice. The single-family residence has a full-front width projecting shed roof porch on the primary (east) elevation. It is supported by simple posts and a balustrade and features exposed rafter beneath the porch roof. Within the porch area is the centrally located replacement front door flanked by wide picture windows. The wood-framed dwelling is clad in stucco.

Staff has assigned a California Historical Resources Status Code of 6Z due to its altered exterior and its lack of architectural integrity and therefore, does not meet any of the criteria required for landmark designation.

Staff recommends that the Historic Preservation Commission find that the residence at 521 South Alta Vista Avenue is not eligible for landmark status and may be demolished. If the Commission concurs with this recommendation, then following the public meeting the following motion is appropriate:

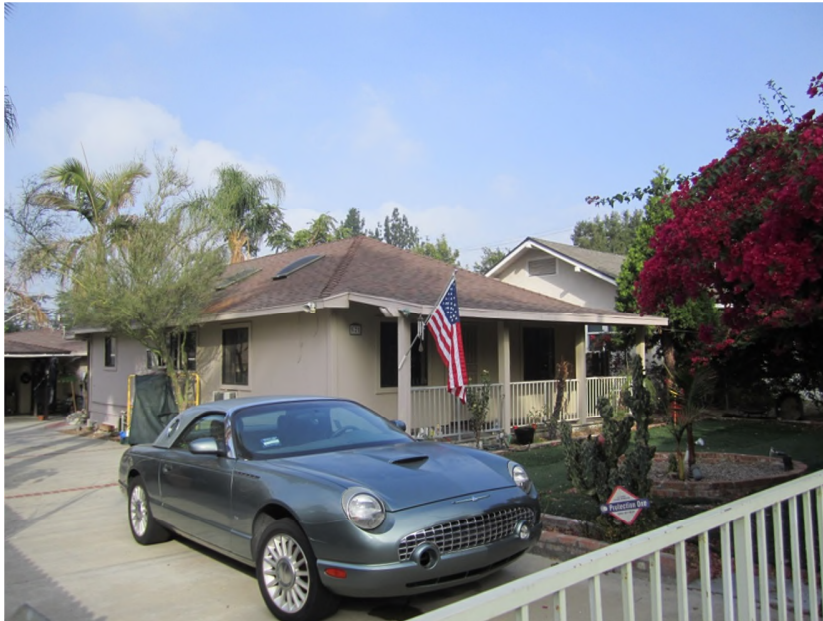
P5a Photograph

The one-story mass plan vernacular bungalow is capped by a pyramidal roof which has been altered to include flat oval sun lights. Roof elements include slightly overhanging eaves and a thick cornice. The single-family residence has a full-front width projecting shed roof porch on the primary (east) elevation. It is supported by simple posts and a balustrade and features exposed rafter tails under the porch roof. Within the porch area is the centrally located replacement front door flanked by wide picture windows. The wood-framed dwelling is clad in stucco.

P5b Description of Photo: Front,
October 2014

Due to the extensive alterations, this building no longer retains integrity and has no apparent historical significance.
