# **HISTORIC PRESERVATION COMMISSION STAFF REPORT**

**APPLICATION:** CA2018-02

**TITLE:** Certificate of Appropriateness CA2018-02; HL-143/MA-133  
228 West Olive Avenue

## Maintenance and Restoration Proposal 2018

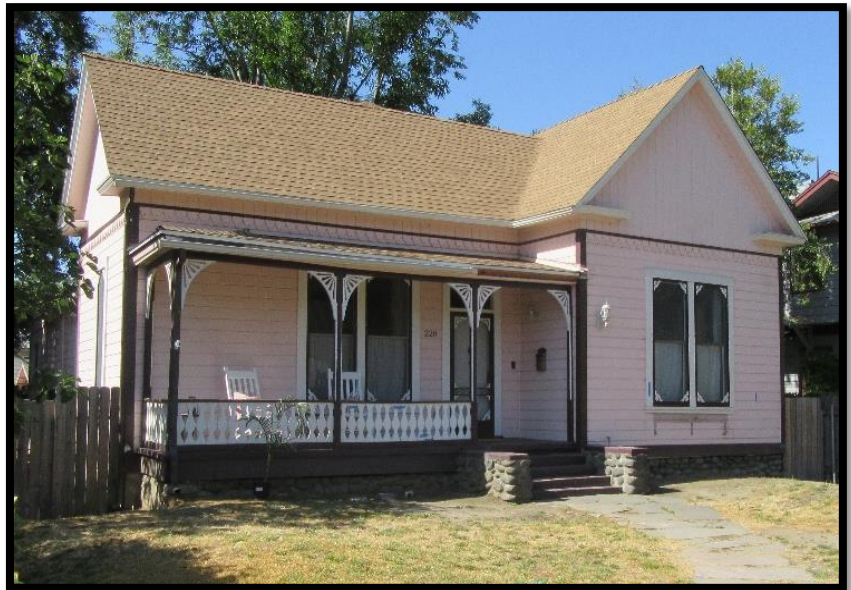
**BACKGROUND:** The property located at 228 West Olive Avenue was approved by the City Council on June 6, 2017 as a historic landmark with a Mills Act Contract. The 1,187 square foot home was built 1887 and embodies several distinctive characteristics of Folk Victorian architecture, including a steeply pitched gabled front and wing roof system with boxed eaves and eave returns, recessed front porch with decorative spindles and spandrels, and elongated wood framed double hung sash windows. The

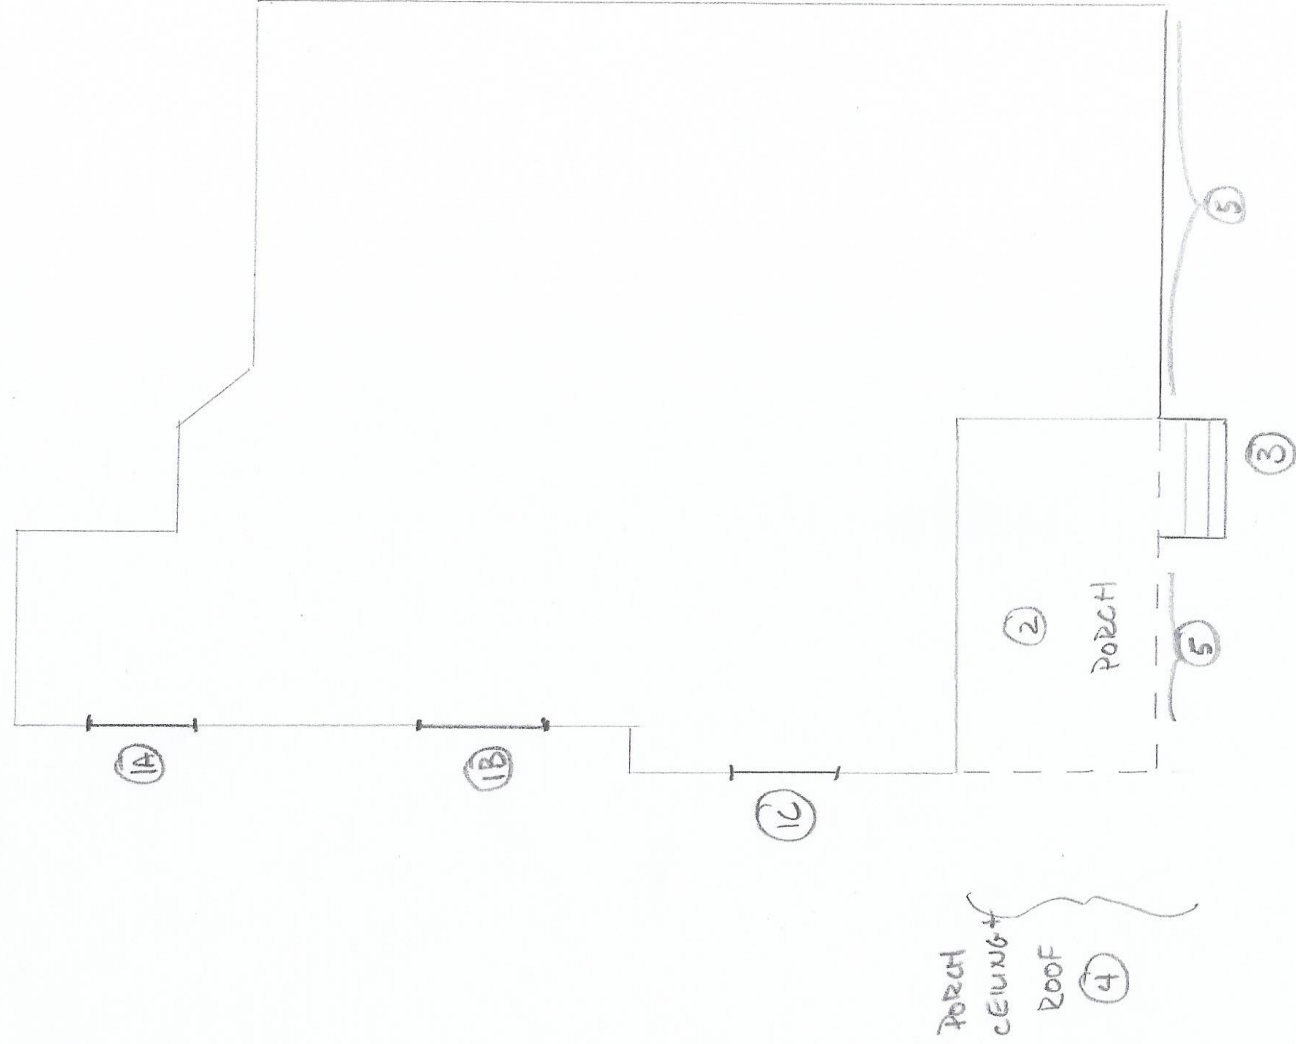
FERRELL - 228 WEST OLIVE AVE

- 1A-1C: 1A + 1B ARE WINDOW FRAMES TO BE REPLACED TO MATCH 1C.
- 2: PORCH
- 3: PORCH STEPS
- 4: ROOF + CEILING OVER PORCH
- 5: Porch and window aprons.

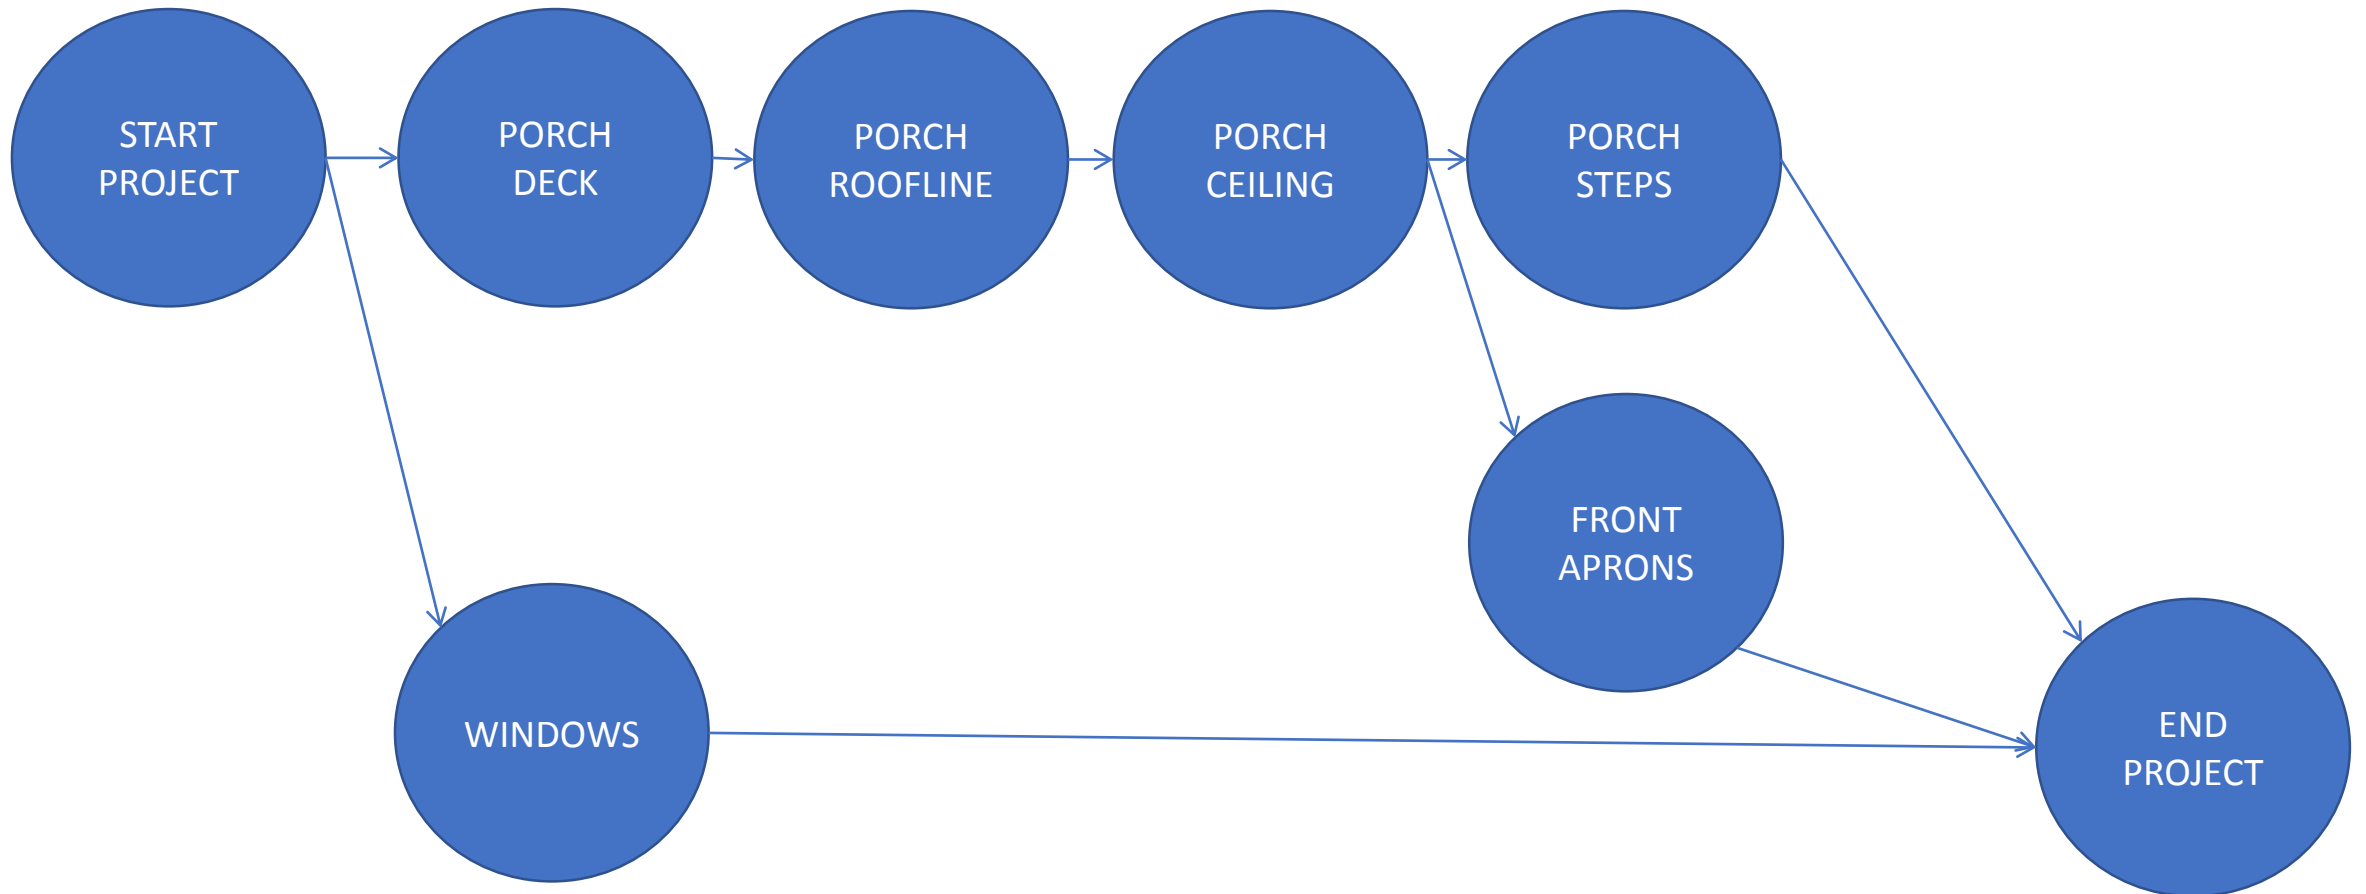
- 1<sup>st</sup>: Porch deck.
  - Remove concrete top to determine scope of damage and repair, if any, that is needed.
  - Under concrete, deck is only half wood planking; plywood covers other half.

- Removal of concrete will also reveal condition of support posts for roofline
  - New wood deck will serve as secure base for roofline support posts.
