HISTORIC PRESERVATION COMMISSION STAFF REPORT

APPLICATION: CA2017-01

TITLE: Certificate of Appropriateness CA2017-01;
HL-107/MA-101

REQUEST: Review the exterior renovations on a single-family Craftsman residence which includes new wood shingles and clapboard siding, replacement of window and door surrounds, repair of overhanging eaves, rafter tails and gabled front porch roof. Review the exterior remodel of the rear (north) building elevation.

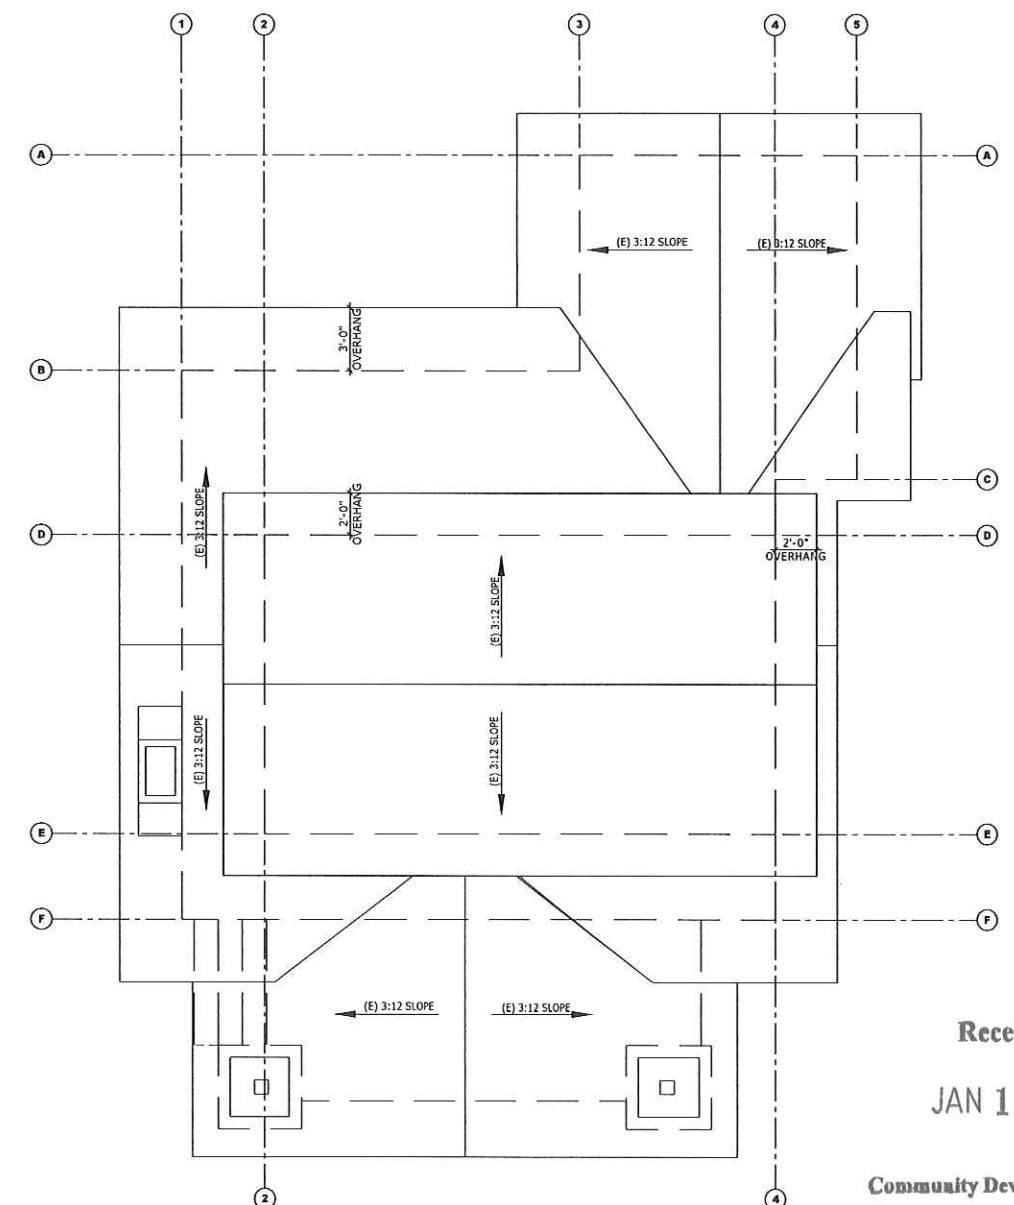
EXISTING ROOF PLAN

DESCRIPTION OF WORK: TO UPDATE THE REVIEW PROCESS AND THE STATUS OF THE RESTORATION AND REHAB OF THE 100 YEAR OLD RESIDENCE AT 311 E. LEMON AVENUE REPAIR IS IN PROGRESS ON ALL EXTERIOR ELEVATIONS. DUE TO DETERIORATION CAUSED BY TIME, WEATHER, VERMIN INFESTATION AND DRYROT, REPLACEMENT IS REQUIRED IN MANY AREAS. SIMILAR MATERIALS HAVE BEEN USED FOR REPLACEMENT, REPLACEMENT MAY BE REQUIRED FOR THE FRONT ROOF PORCH DUE TO STRUCTURAL DETERIORATION.

- K** EXISTING SHINGLE ROOFING TO BE REPLACED IN KIND AND IN APPEARANCE - ALL ROOF AREA
- L** EXISTING CONCRETE STEPS AND PORCH FLOOR
- M** NEW WOOD FRENCH GLASS DOORS AND REPLICATED FRAME. REPLACED ORIGINAL DOOR AND WINDOW TO THE KITCHEN AREA
- N** NEW HORIZONTAL 1"x6" WOOD SIDING RAINSKIRT MADE OF HORIZONTAL REDWOOD SIDING, LOCATION AND SHAPE REPLICATES THE ORIGINAL - SEE LETTER "A" ABOVE FOR SIZING OF REDWOOD
- O** NEW WOOD PORCH CEILING. STRUCTURAL FRAMING TO BE REQUIRED TO CONFORM WITH CURRENT CODE

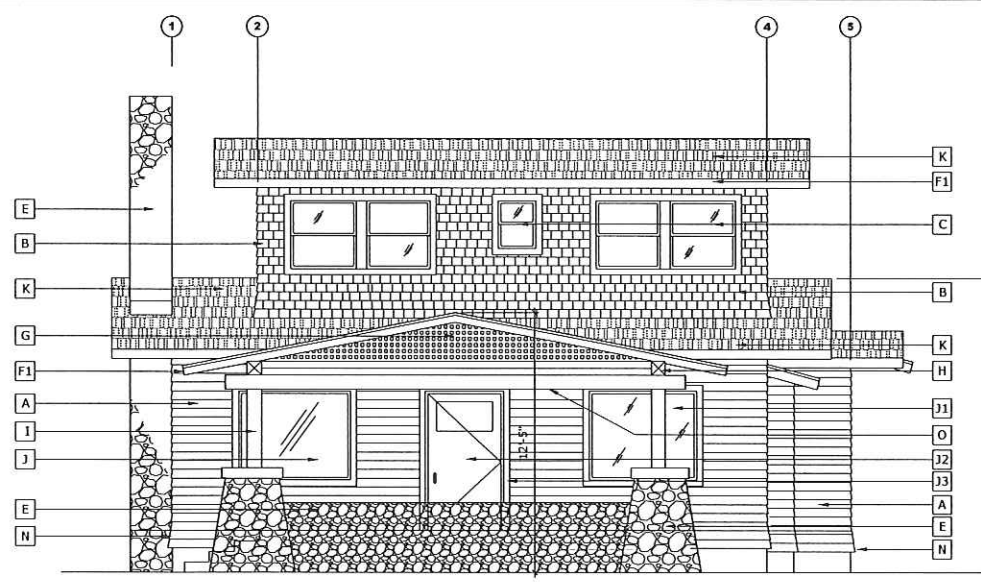
EXISTING FRONT ELEVATION

The remaining work to be done is repair and “in kind” replacement of termite damage and dry rotted wood under the roof eaves, fascia boards and front projecting gabled porch. The exposed ends of several rafter tails will be repaired or replaced depending on the extent of damage.
