## **Geotechnical Study**

December 6, 2016  
(Revised April 2, 2018)

Subject: Revised Geotechnical Feasibility Investigation  
AvalonBay Monrovia  
825 S. Myrtle Avenue  
Monrovia, California  
GPI Project No. 2775.IR

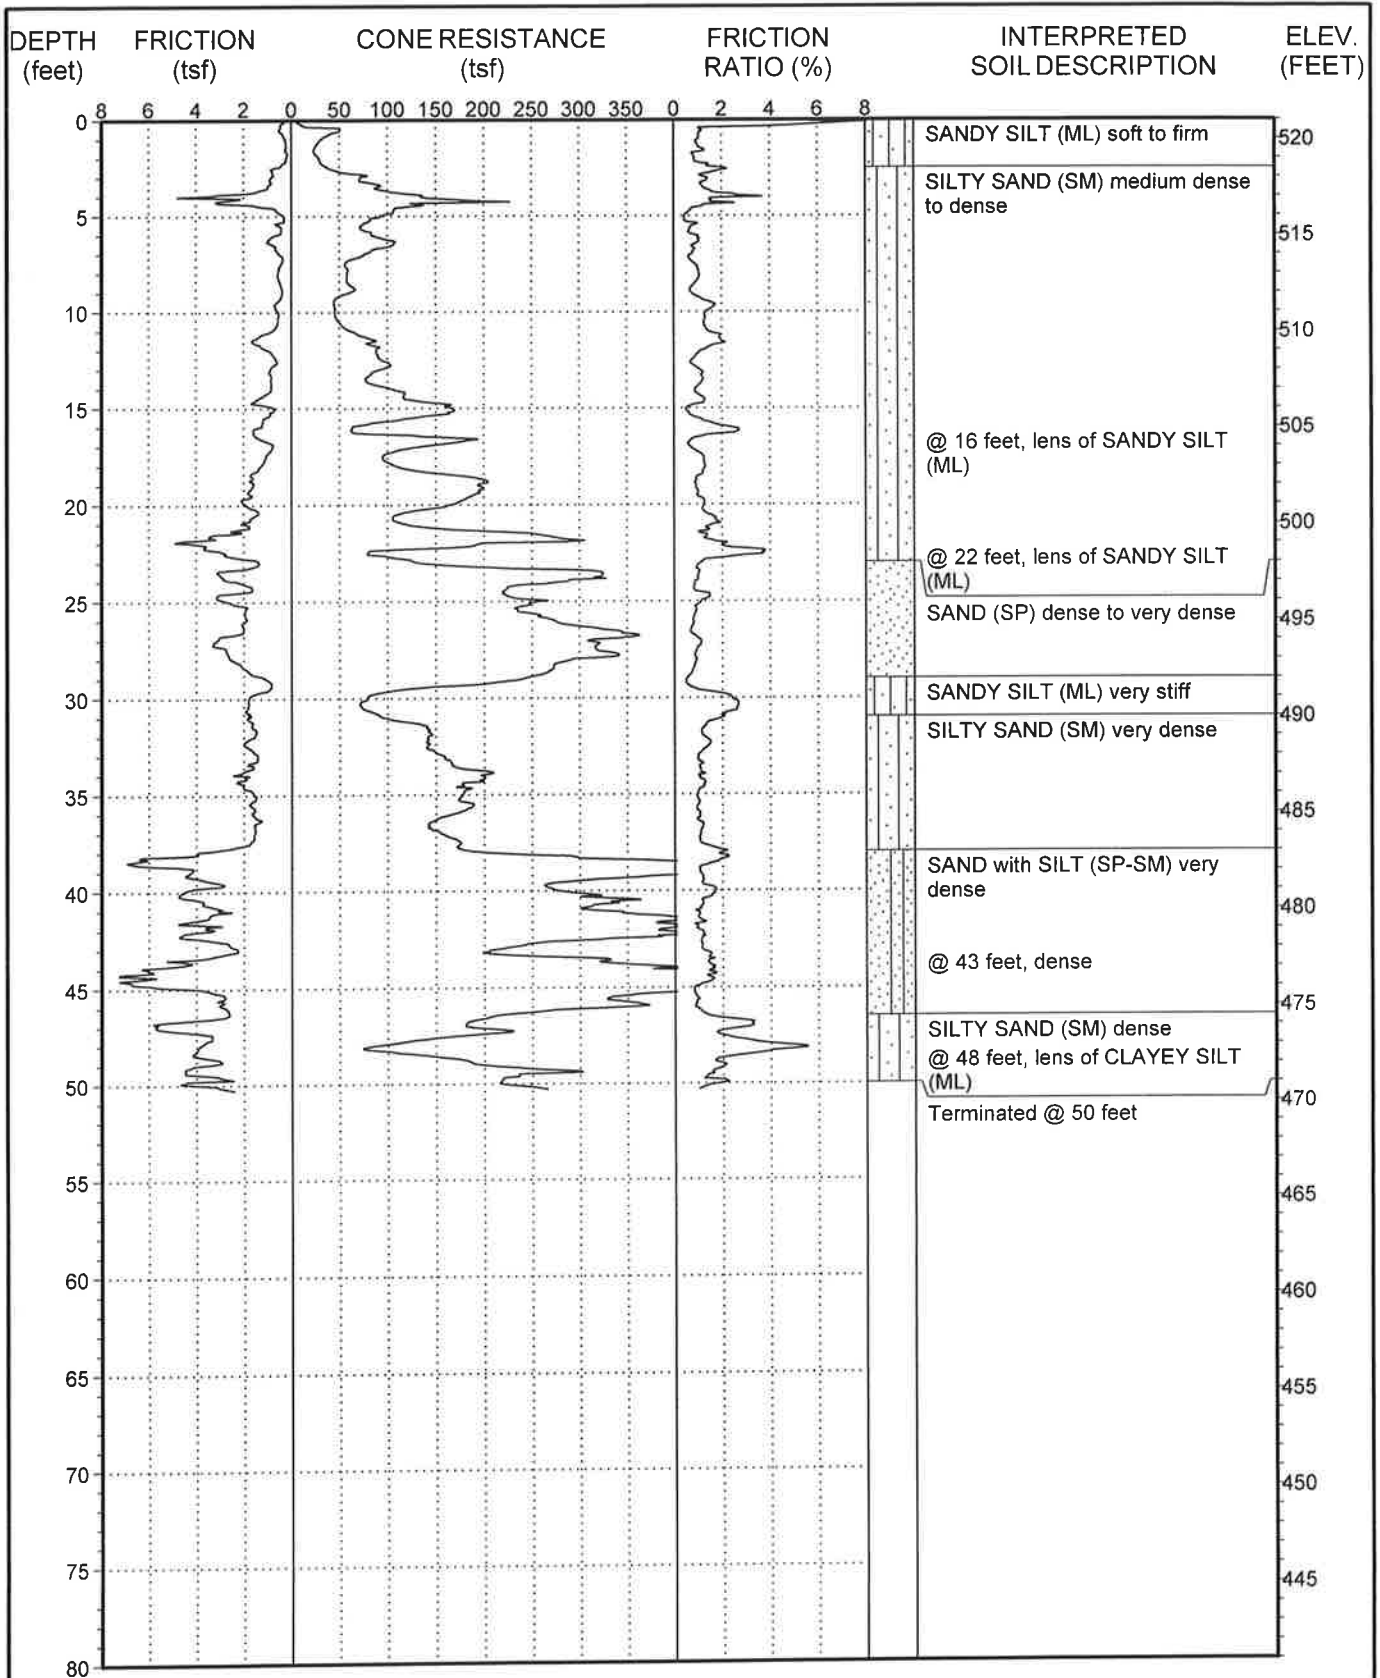
FIGURE A-2

This summary applies only at the location of this cone penetration test and at the time of the exploration. Subsurface conditions may differ at other locations and may change at this location with the passage of time. The interpreted soil description is derived from the friction ratio and cone resistance and is a simplification of actual conditions encountered.

**LOG OF CPT NO. C-1**

The subsurface conditions encountered during our field investigation, consisted of interbedded layers of sands, silty sands, sandy silts, clayey silts, and silty clays in the upper 50± feet. While difficult to distinguish in CPT's, man-made fills appear to extend approximately 2 to 5 feet below existing grades. The sandy soils range from loose to very dense. The fine-grained soils are typically hard. Detailed descriptions of the materials as interpreted for the CPT's are shown on the Logs of CPT's in the Appendix.

Computer plots of the reduced CPT data acquired for this investigation are presented in Figures A-2 through A-5 of this appendix. The field testing and computer processing was performed by Kehoe Testing and Engineering under subcontract to Geotechnical Professionals Inc. (GPI). The interpreted soil descriptions were prepared by GPI.
