# HISTORIC PRESERVATION COMMISSION STAFF REPORT

APPLICATION: HL-141/MA-131 AGENDA ITEM: PH-1

SUBJECT: Historic Landmark HL-141/Mills Act MA-131

438 West Duarte Road

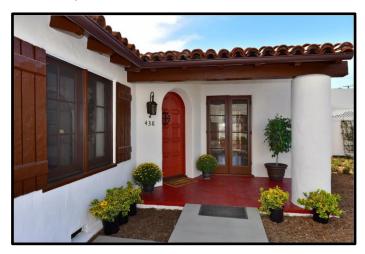
**ANALYSIS:** The 2,078 square foot stucco-sided single-story residence was built in 1927 and has four bedrooms and three bathrooms. The Spanish Colonial Revival house is crowned by a low-pitched, side-gabled roof with a front gabled roof over the front porch. Red tiles cover the roof and smooth stucco sheathes the exterior. Roof elements include shallow

overhanging eaves with exposed rafter tails on the rear and most of the front elevation. overhang. gable ends have no Traditional Spanish Colonial Revival features include. recessed multi-pane casement windows, a turned spindle wood screen covering the rectangular window, and a deeply recessed front entrance. porch roof overhang is supported by a circular stucco substantial column that supports a wide beam beneath the roof. Decorative wood shutters flank the casement windows located on the front and east sides. An interior chimney is located on the west side.
