HISTORIC PRESERVATION COMMISSION STAFF REPORT

APPLICATION: HL-142/MA-132

TITLE: Historic Landmark HL-142/Mills Act Contract MA-132
518 East Colorado Boulevard
Monrovia, CA 91016

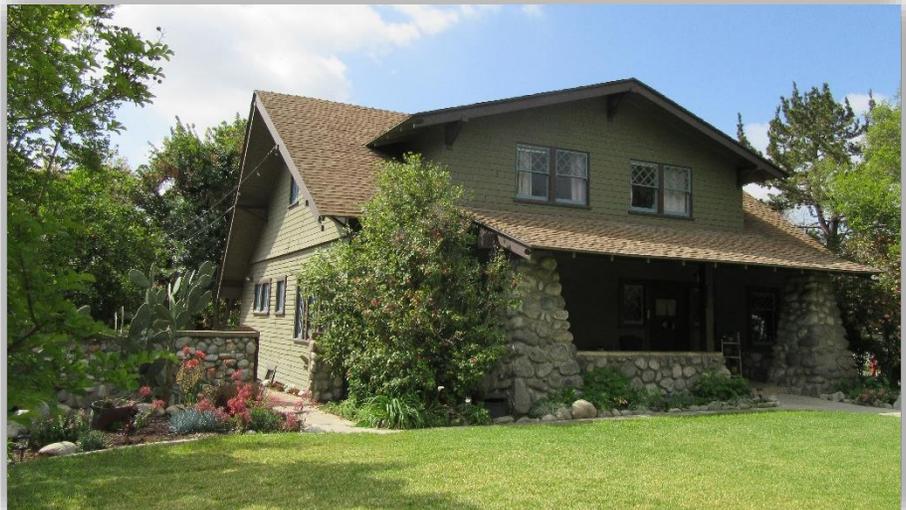
The two-story home features a side gabled roof with a wide eave overhangs, exposed beams, and decorative knee braces. The roof also has exposed rafter tails, and the bargeboards have decorative teardrop cut outs on the ends. The home is clad in contrasting wood siding materials, with clapboard siding on the first floor and shingle siding on the second floor. A partial-width, projecting front porch is located on the front (north) elevation. The shed roof of

the porch is supported by large battered river rock piers. The porch is enclosed by a low river rock wall with concrete caps. Decorative river rock elements are also featured on the fireplace and chimney that emerges near the ridgeline, and a garden wall to the east of the structure, which is considered to be a contributing feature. Window types include casement and double-hung, and many of the windows have original wood-framed screens. Diamond multi-paned lights are featured on many of the windows, both casement and the upper sashes of double-hung windows. Each window that incorporates this diamond shape, multi-pane detailing, was made with a unique pane size and shape. The three east facing windows have narrow and elongated diamond panes and the west facing windows have a shorter, wider diamond pattern. Lastly, the window surrounds on the first floor are wide. On the second floor, they are very narrow. The house is set back from the public right-of-way.

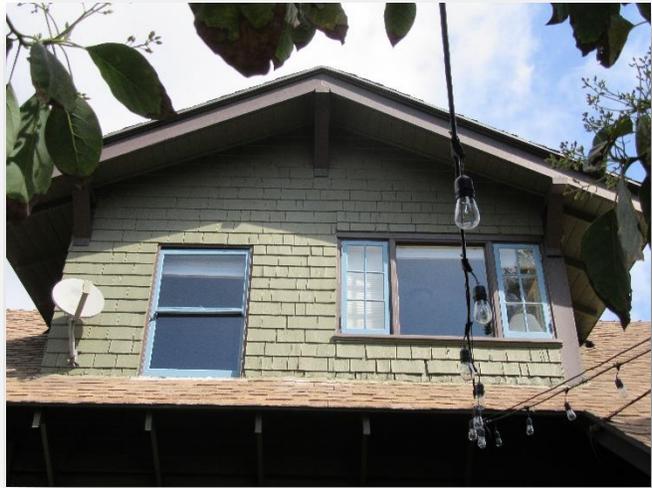
Furthermore, the owner has submitted a 10 year plan for the property that includes replacing the roof with roofing of similar color and material, painting, and conducting repairs as needed. Additionally, there is an original window on the rear (south) facing second story gable that may need replacing. The fenestration is awkward; the current window extends down to the roofline and interferes with the flashing, creating a potential for leaks. The repair work would reframe the window and provide new starter board to prevent potential water damage. If an alternative window is proposed, the replacement window would require approval by the Historic Preservation to ensure that it is appropriate.

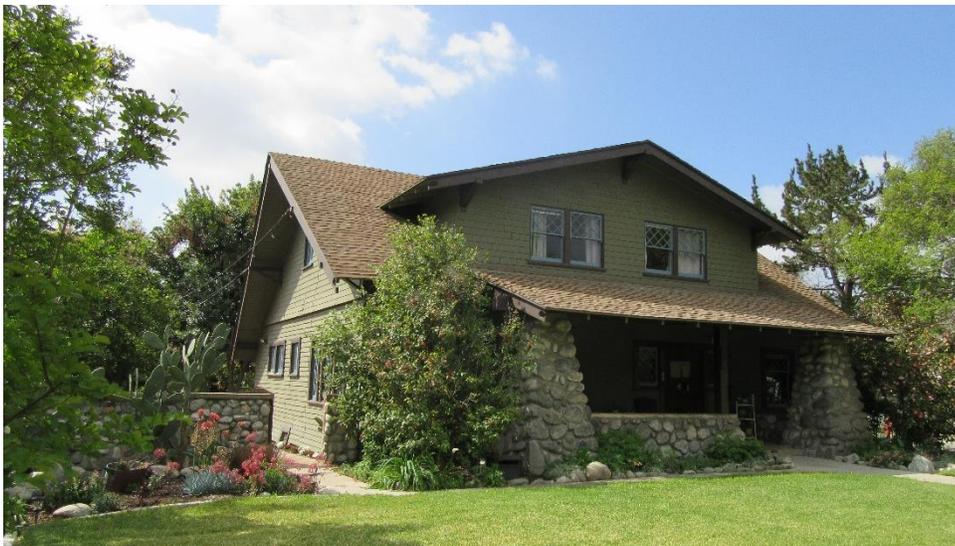
P5a Photograph

Facing southwest, March 2017
